CALSPAN ON-SITE SMALL OVERLAP/OBLIQUE CRASH INVESTIGATION

SCI CASE NO.: CA11002

VEHICLE: 2010 LEXUS ES350

CRASH DATE: DECEMBER 2010

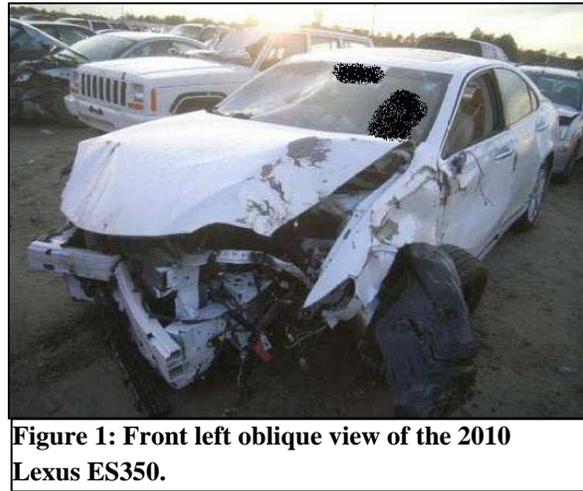
Figure 1: Front left oblique view of the 2010 Lexus ES350.

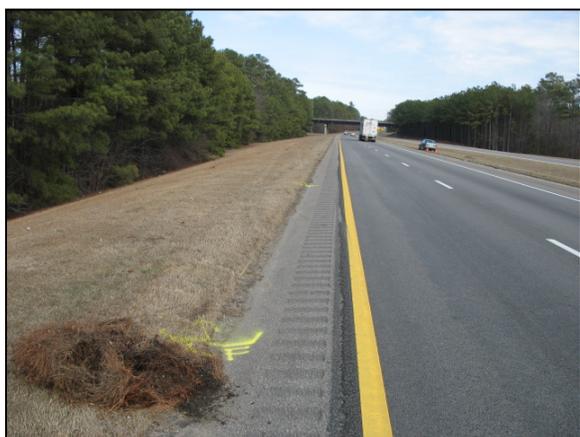
Figure 2: Northbound trajectory view of the Lexus at the roadside departure.

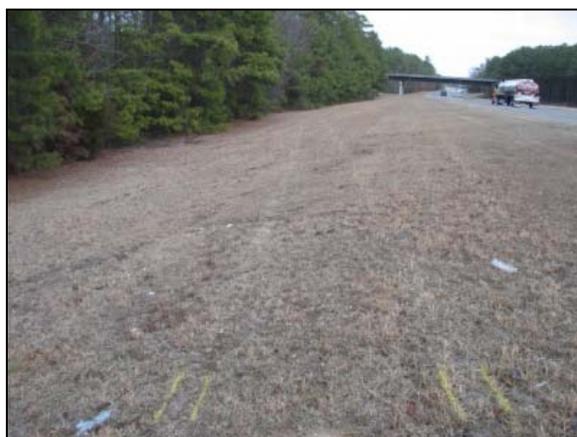
Figure 3: Trajectory view of the Lexus at the central aspect of its northerly off-road travel.

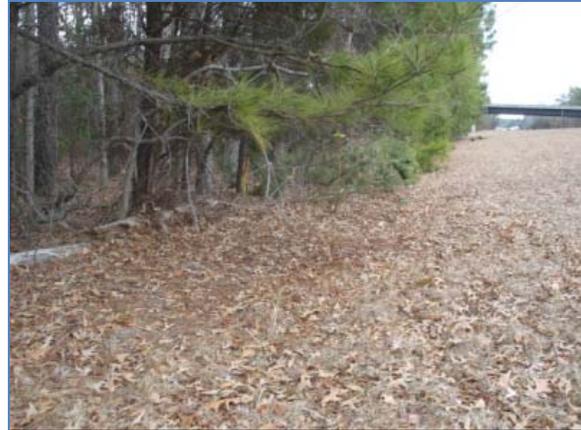
evidence at the scene in conjunction with imaged EDR data, there were no attempted steering, braking, or acceleration maneuvers made by the driver in an attempt to avoid the crash. The Lexus maintained its tracking attitude to the tree line (**Figure 4**).

Figure 4: Northbound trajectory view of the Lexus approaching the tree line points of impact.

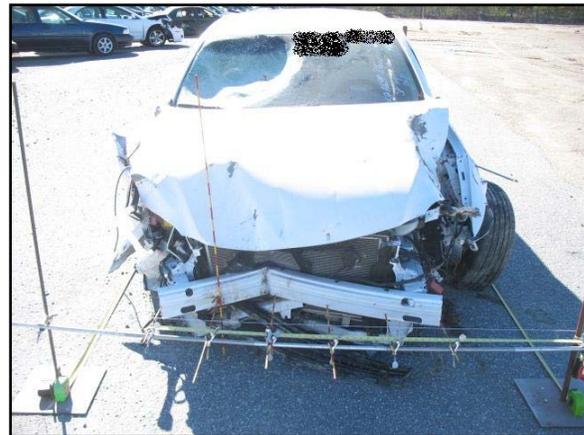
The front, left, right and top planes of the Lexus sustained moderate damage in this multiple impact crash sequence (**Figure 5**). In the initial impact (Event 1), the Lexus impacted tree #1 with its front left corner. This impact was located outboard of the left end of the bumper beam. The initial impact damage began at the left corner and extended rearward down the left side of the vehicle a distance of 338 cm (133 in) and ended at the aft end of the left rear door, 22 cm (8.7 in) forward of the left rear axle. The maximum deformation from the initial impact was located on the left plane of the vehicle 293 cm (115.4 in) forward of the left rear axle and measured 10 cm (3.9 in). The left wheelbase was reduced 20 cm (7.8 in). The corner configuration of this Event 1 damage invalidated a reconstruction with the WinSMASH program. For reference purposes, the imaged EDR data reported a maximum frontal delta-V of 17.2 km/h (10.7 mph). The Collision Deformation Classification (CDC) assigned for this impact was 12FLEE9.

Figure 5: Frontal and oblique damage to the Lexus.

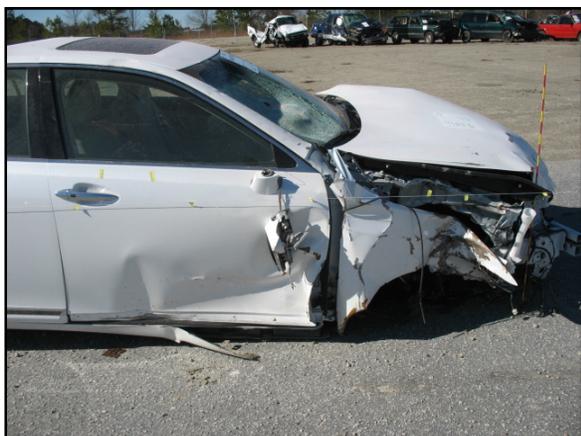
The Event 4 damage to the Lexus is depicted in **Figure 6**. The right front corner of the Lexus impacted Tree #4 outboard of the right frame rail end. The direct damage to the Lexus began at the front right corner with continuous engagement rearward down the right plane of the vehicle. The length of the damage measured 199 cm (78.3 in), started at the corner of the vehicle and ended 161 cm (63.3 in) forward of the right rear axle. The front right suspension was fractured and the wheel had separated. The corner configuration of the impact with Tree #4 invalidated a WinSMASH reconstruction. The CDC assigned to Event #4 was 12FREE8.

Figure 6: Event 4 sideswipe damage to the Lexus.

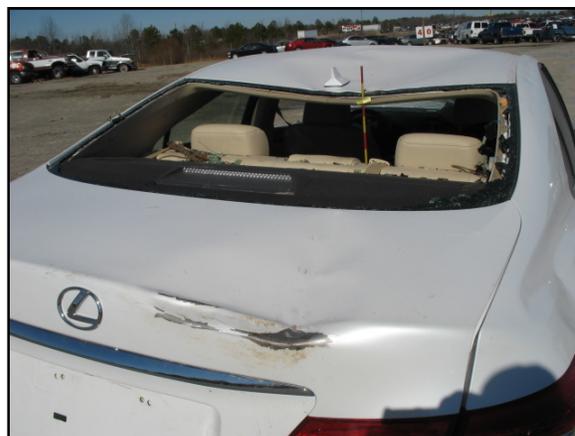
At the point when the Lexus was coming to final rest, one of the trees impacted earlier in the crash sequence fell onto the vehicle (Event 5), impacting the roof with a non-horizontally direction of force (**Figure 7**). The direct damage was 24 cm (9.4 in) wide and 186 cm (73.2 in) long. It began at the center aspect of the roof, and extended over the backlight header to the aft edge of the trunk lid. The maximum crush was located on the backlight header, 48 cm (18.9 in) inboard of the right, and measured 7 cm (2.8 in). The CDC assigned for this non-horizontal impact was 00TZZN2.

Figure 7: Non-horizontal roof damage to the Lexus.

The Lexus sustained moderate severity interior damage that was attributed to passenger compartment intrusion and air bag deployment. As a result of the non-horizontal impact to the roof (Event 5), the roof and backlight header intruded into the second row seating positions. The intruded values of the roof into the second row were 3 cm (1.2 in), 7 cm (2.8 in) and 6 cm (2.4 in) from left to right. The respective backlight header intrusions were 2 cm (0.8 in), 7 cm (2.8 in) and 3 cm (1.2 in).

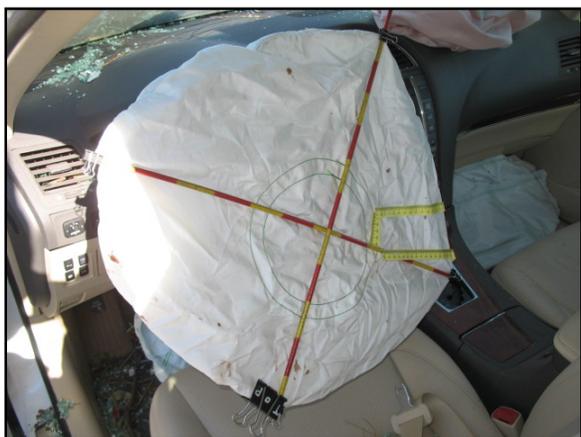
Figure 8: Overall view of the driver's frontal air bag.

tethers that attached to a 23 cm (9.1 in) dual-circular tear seam at the center of the face of the air bag. The deployed driver's frontal air bag is depicted in **Figure 8**. The steering wheel was rotated approximately 180 degrees post-crash and was locked in place.

There was a scuff mark that included several small holes on the face of the air bag. This contact was located in the lower left quadrant, 1-4 cm (0.4-1.6 in) below the horizontal centerline of the

air bag and 11-26 cm (4.3-10.2 in) left of the vertical centerline of the air bag. This contact was attributed to the driver's chest. There were also multiple droplets of blood on the front and top aspects of the air bag. Blood was present at all four quadrants, but the highest concentration of blood droplets were on the upper right quadrant of the air bag. Due to the rotation of the steering wheel, this would have placed the upper right quadrant at the bottom of the assembly when the vehicle came to final rest.

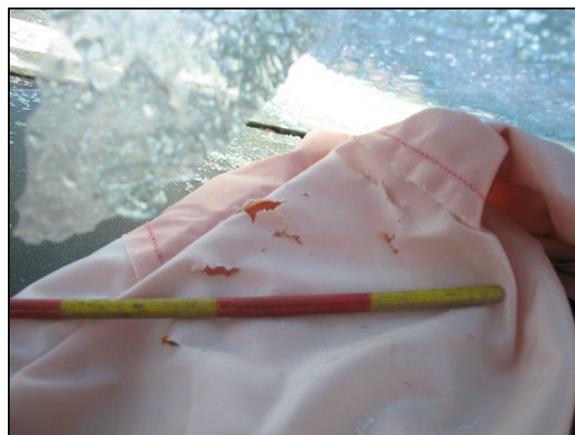
The front right passenger's frontal air bag was concealed within the upper aspect of the right instrument panel by two cover flaps. The upper cover flap measured 10 cm (3.9 in) in width and 6 cm (2.4 in) in height. The lower flap was 10 cm (3.9 in) in width at the upper tear seam, 20 cm (7.9 in) in width at the lower edge and 8 cm (3.1 in) in height. There was no damage to either cover flap. The air bag consisted of two symmetrical panels. Each panel was 50 cm (19.7 in) in length and 34 cm (13.4 in) in width. Including the slight overlap where the panels were joined by a 12 x 11 cm (4.7 x 4.3 in) oval patch, the air bag was 66 cm (26 in) in width. There was a 15 cm (5.9 in) damaged area at the top center on the left half of the air bag. Within this area there were several 1-2 cm (0.4-0.8 in) cuts from contact with the windshield (**Figure 9**).

Figure 9: 1-2cm cuts in the upper aspect of the front right air bag, near the windshield.

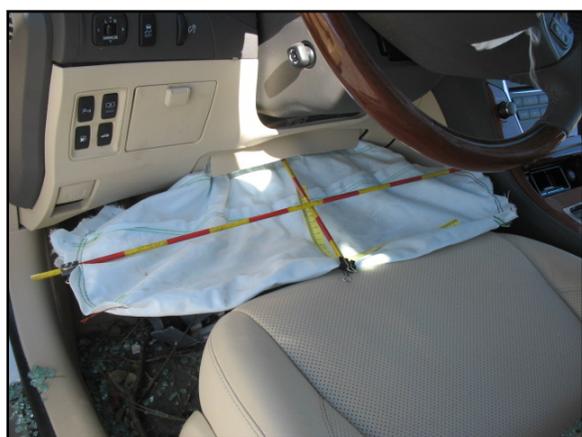
Figure 10: Driver's knee air bag.

The Lexus was equipped with knee air bags for the driver and front right passenger seating positions. Both of these air bags deployed from the lower aspect of the left and right instrument panels as a result of the frontal impact. The driver's knee air bag is depicted in **Figure 10**. The driver's air bag was concealed by two cover flaps. The upper flap was 3 cm (1.2 in) in height and 25 cm (9.8 in) in width. The lower flap was 5 cm (2 in) in height and 25 cm (9.8 in) wide. The driver's knee air bag was 30 cm (11.8 in) tall and 60 cm (23.6 in) wide. There

was a dark scuff mark on the top aspect of the air bag 13-24 cm (5.1-9.4 in) below the upper edge of the air bag and 17-29 cm (6.7-11.4 in) left of the right side of the air bag. There were no tethers or vent ports in left knee air bag.
