On-Site Child Restraint System Investigation
Dynamic Science, Inc. (DSI)
Case Number DS11004
2002 Honda Odyssey
Arizona
March 2011

Dynamic Science, Inc.
Crash Investigation
Case Number: DS11004

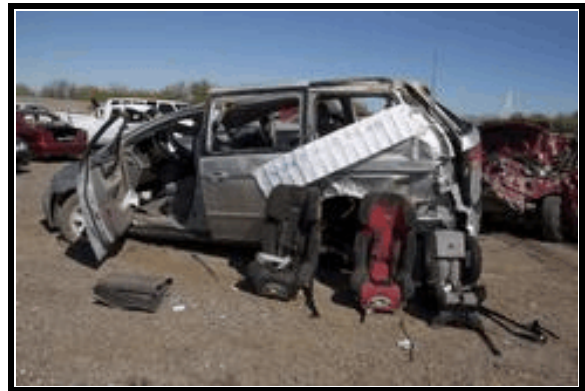
Figure 2. Left side of Honda and view of three CRSs (owner photo)

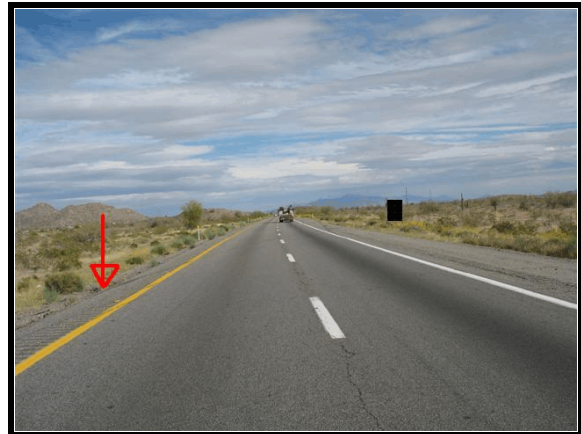
Figure 4. Honda returning to roadway

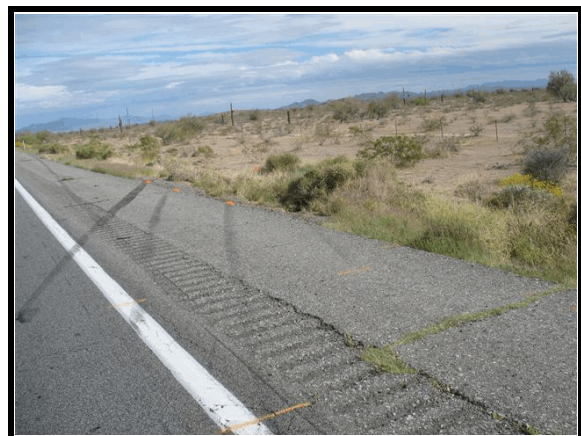
Figure 5. Right side roadway departure

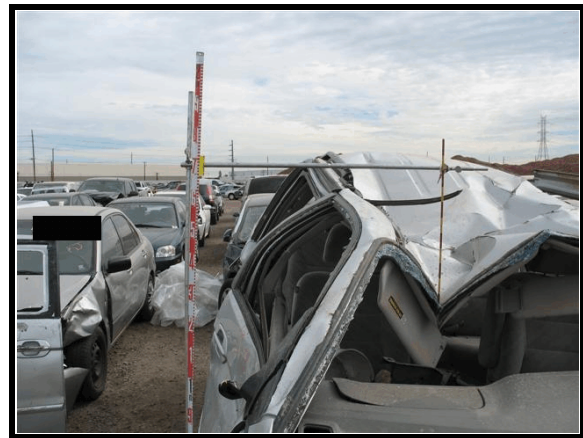
The Honda sustained damage to the left side, right side, and roof during the rollover event. The direct damage to the top of the vehicle extended laterally from roof side rail to roof side rail and measured 104.0 cm (40.9 in). The damage extended from the front hood edge to the D-pillar area. The left rear wheel assembly was partially displaced from the vehicle. The left upper arm separated from the axle and the rear shock absorber had been pulled apart. The maximum vertical crush measured 36.0 cm (14.1 in) and was located along the windshield header 38.0 cm (14.9 in) to the left of the right A-pillar (**Figure 6**). The maximum lateral crush measured 12.0 cm (4.7 in) and was located at the right A-pillar. The Collision Deformation Classification (CDC) for Event 1 was 00TDDO4.

Figure 6. Maximum vertical crush

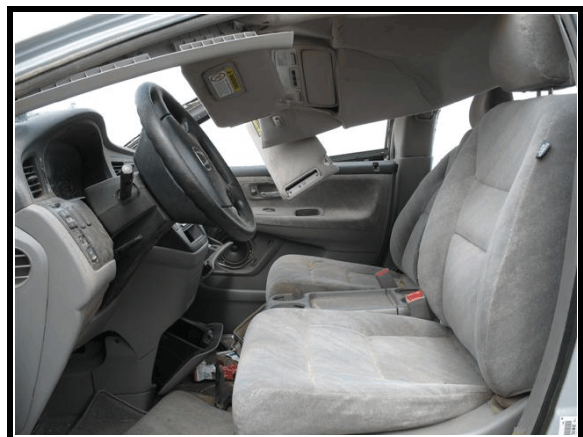
The Odyssey sustained moderate interior damage as a result of intrusions, occupant loading, and contacts. Vertical intrusion was located in the front row at the A-pillars, windshield header, roof, and roof side rail (**Figure 7**). Vertical intrusion was also in the second row at the roof and roof side rails. Evidence of occupant contacts was documented at lower instrument panel, roof, visor, window frame, side interior surfaces, and seat arm rest. Blood was located on the second row headrest, C-pillar, and on the roof. The right side doors were jammed shut. All the glazing was either fixed or closed. The windshield was cracked and holed. All the side and rear hatch glazing was disintegrated.

Figure 7. Overview of front row roof intrusion

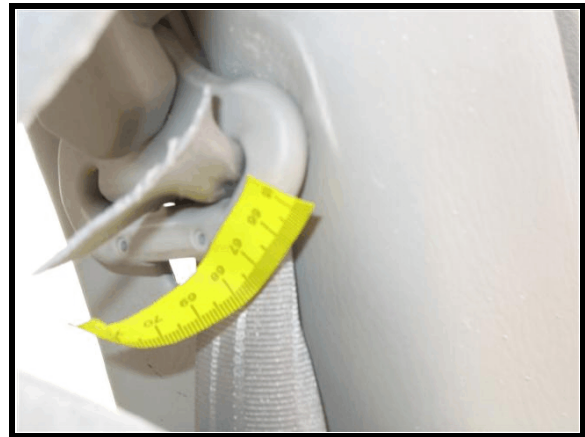
The driver's safety belt was equipped with a retractor pretensioner that did not actuate. The anchorage adjustment was in the full-up position. A portion of the seat belt webbing was trapped in the D-ring and showed evidence of loading (**Figure 8**).

Figure 8. Driver's seat belt D-ring

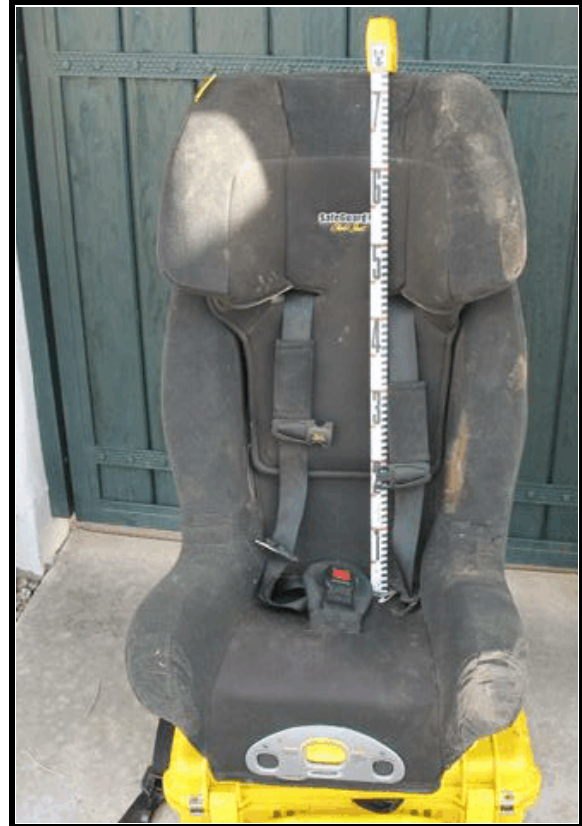
Figure 9. Safeguard Child Seat

The Honda's second row left seat position was occupied by the 6-year-old female occupant. She was seated in a Safeguard F100118 Child Seat (Figure 9). The CRS model number was F100118 and the date of manufacture was 10/24/2007. The CRS was equipped with an adjustable head restraint [adjusted to 14.0 cm (5.5 in) above the seat back], a 5-point internal harness, and the hardware for the Lower Anchors and Tethers for Children (LATCH) system. It was also equipped with safety belt lock-offs which are designed to lock the belt in place in lieu of other belt locking systems such as ALR retractors, locking latch plates or locking clips. The CRS was designed to be used in the forward-facing direction only and by children along the following parameters:

The CRS was secured to the vehicle by the lap and shoulder belt. The belt was routed through the belt paths and the belt lock-offs were engaged. The LATCH tether was also used and was attached to the upper tether anchor. The shoulder harness was routed through the single set of top slots and the retainer clip was adjusted to be at the arm pit level. The harness was tightened around the child with the harness adjustment controls.

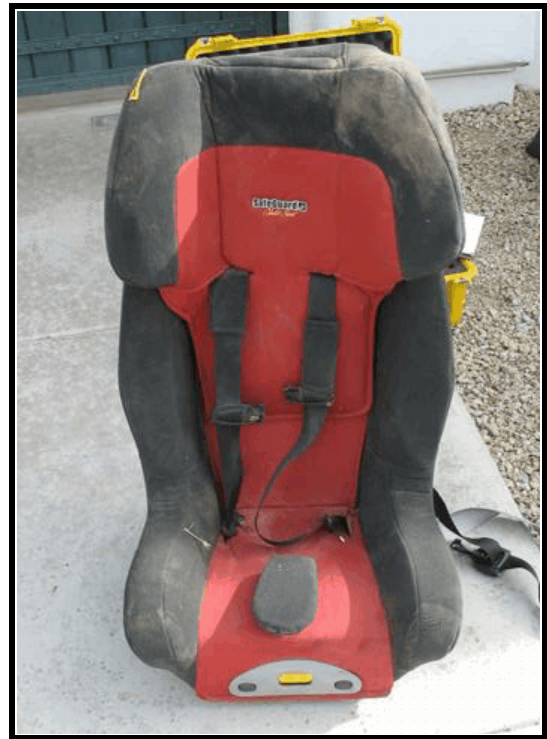
Figure 10. Safeguard Child Seat

The Honda's third row left position was occupied by the 6-year-old female occupant. She was seated in a Safeguard F17510 Child Seat (**Figure 10**). The CRS model number was F17510 and the date of manufacturer was 10/18/ 2007. The CRS was equipped with an adjustable head restraint [adjusted to 16.0 cm (6.3 in) above the seat back], a 5-point internal harness, and the hardware for the LATCH system. It was also equipped with safety belt lock-offs which are designed to lock the belt in place in lieu of other belt locking systems such as ALR retractors, locking latch plates or

The vehicle safety belt was threaded through the rear CRS belt path and the shoulder portion of the belt was placed in the CRS shoulder belt lock-off. According to the interviewee, the belt retractor had not been switched and was in the ELR mode. In addition to the safety belt, the CRS was anchored to the vehicle using a single tether. The tether was routed over the vehicle seat back and attached to the tether attachment hardware on the tailgate sill¹. The shoulder harness was routed through the single set of top slots and the retainer clip was adjusted to be at the arm pit level. The harness was tightened around the child with the harness adjustment controls.

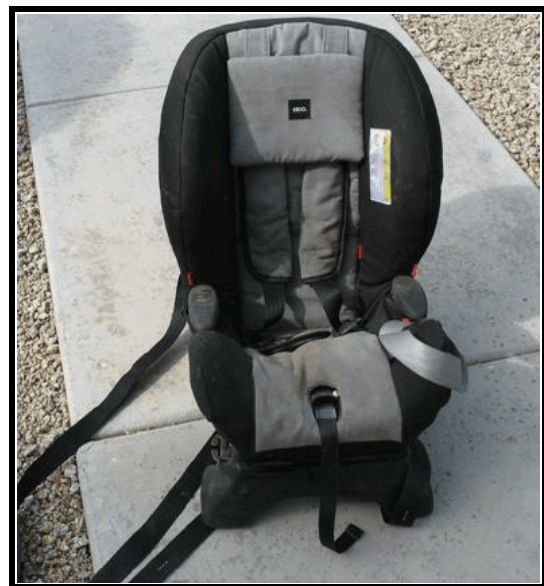
Figure 11. Brio Zento Child Seat

It should be noted that the CRS used in this position was from a foreign manufacturer and was not tested using American federal motor vehicle safety standards.

The Honda's third row right seat position was occupied by the 2-year-old female. She was seated in a Brio Zento rear-facing Child Seat (**Figure 11**). The CRS was configured with upper and lower tethers. The lower tether straps are used to create an anchor point. The straps are looped around the vehicle seat bight of the seat in front of the CRS position. The upper tethers attach to the anchor point created by the lower tether straps. The seat was not equipped with standard LATCH hardware. The vehicle lap and shoulder belt was routed through the belt path toward the foot area of the CRS.

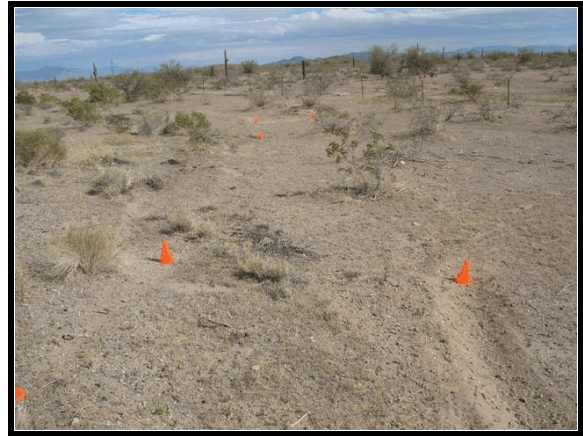
The Honda was traveling eastbound in the left travel lane at a police-reported speed of 121 km/h (75 mph). The vehicle drifted onto the left shoulder and the driver steered to the right and began braking. It began a clockwise rotation, crossed both lanes of travel, and departed the roadway on the right. The Honda continued rotating as it traveled down a descending embankment. The vehicle had traveled approximately 16.0 m (53.0 ft) before both left side tires engaged the ground inducing at left side leading trip rollover (**Figure 12**).

Figure 12. Left side tire trip points

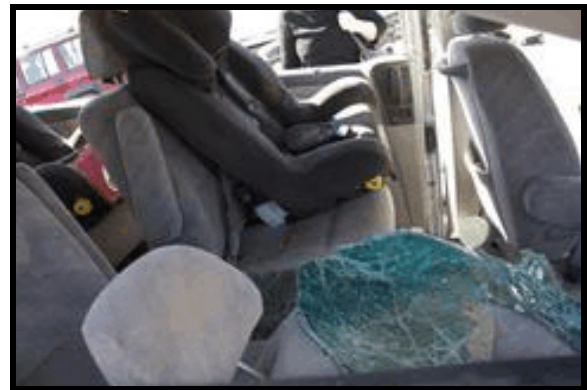
The 6-year-old female second row left occupant was seated in a tethered forward-facing CRS and was asleep. The shoulder harness was routed through the single set of top slots and the chest clip was adjusted to be at the arm pit level. The harness was tightened around the child with the harness adjustment controls. As the vehicle went out of control and tripped, this occupant was displaced to the left. She was displaced in multiple directions as the vehicle rolled. She likely contacted the left door and sustained abrasions on the left arm from flying glass. The bottom of the CRS was displaced to the left during the rollover sequence (**Figure 13**). The child came to rest upside down in the CRS.

Figure 13. Second row left CRS (owner photo)
