# INDIANA UNIVERSITY

## ON-SITE CHILD RESTRAINT SYSTEM INVESTIGATION

CASE NUMBER - IN11005  
LOCATION - MINNESOTA  
VEHICLE - 2002 DODGE DURANGO  
CRASH DATE - January 2011

1. <i>Report No.</i> IN11005		2. <i>Government Accession No.</i>		3. <i>Recipient's Catalog No.</i>	
4. <i>Title and Subtitle</i> On-Site Child Restraint System Investigation Vehicle - 2002 Dodge Durango SXT Location - Minnesota			5. <i>Report Date:</i> July 22, 2011

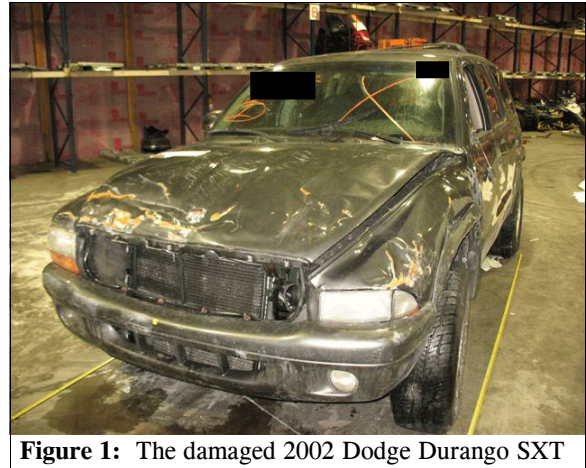
**Figure 1:** The damaged 2002 Dodge Durango SXT

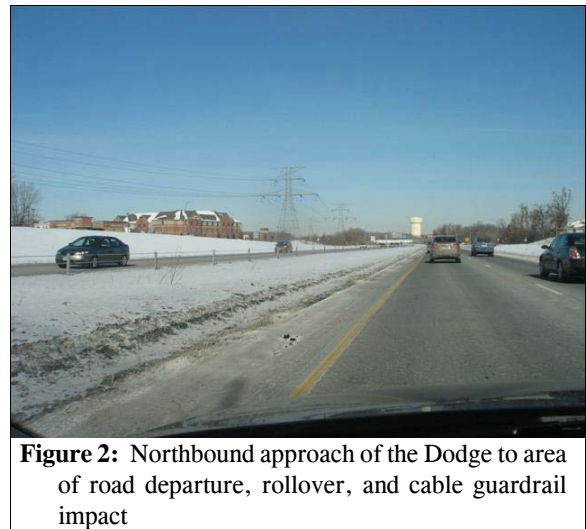
**Pre-Crash:** The Dodge was traveling north (**Figure 2**) and the driver intended to continue straight ahead. For an unknown reason, the vehicle departed the west side of the roadway. It is unknown if the driver made any avoidance maneuvers.

**Figure 2:** Northbound approach of the Dodge to area of road departure, rollover, and cable guardrail impact

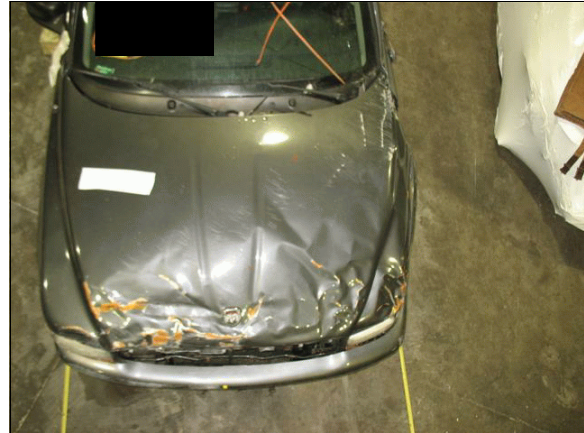
**Exterior Damage Event 1:** The Dodge sustained damage on the hood, left fender, and luggage rack during the rollover. The direct damage on the hood began 4 cm (1.7 in) left of the right front bumper corner and extended 125 cm (49.2 in) left, across the hood and onto the left fender (**Figure 3**). The damage on the luggage rack consisted of scuffs and scratch marks. There was no lateral or vertical crush to the roof of the vehicle from ground contact.

**Figure 3:** Rollover and cable guardrail damage to hood/left fender of the Dodge

**Damage Classification Event 1:** The Collision Damage Classification (CDC) was 00TYDO1. The WinSMASH program could not be used on this event since rollovers are out of scope for the program. The severity of the damage from the rollover was minor based on the extent of the roof damage.

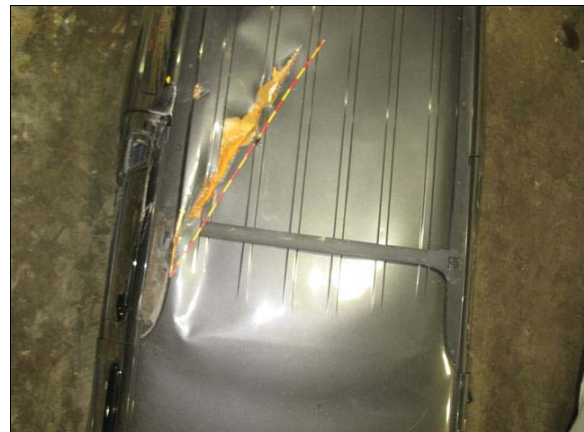
**Figure 4:** Damage from cable guardrail on roof of the Dodge

**Exterior Damage Event 3:** The Dodge sustained damage on the top plane from contact with the cable guardrail. Direct damage began at the front of the hood, 4 cm (1.6 in) inside the right front bumper corner and extended across the hood. Direct damage was also found on the roof (**Figure 4**), beginning 96 cm (37.8 in) forward of the right rear axle and extending 100 cm (39.4 in) rearward and toward the center.

**Damage Classification Event 3:** The CDC was 00TDDW2. The WinSMASH program could not be used to calculate Delta V for this event. The severity of the damage was minor based on the extent of the roof damage.

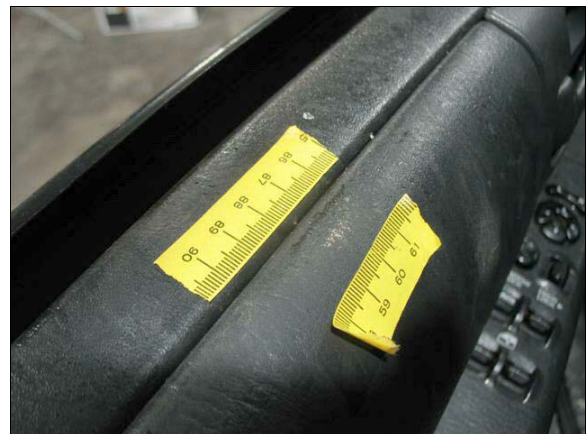
Inspection of the interior of the Dodge revealed a scuff on the top of the driver's door at the beltline (**Figure 5**), probably from contact by the left side of the driver. This scuff occurred as the driver was ejected from the vehicle through the disintegrated left front glazing. No other damage or occupant contacts were noted. There was no damage to the steering wheel or compression of the steering column.

**Figure 5:** Scuff on beltline of driver's door of the Dodge

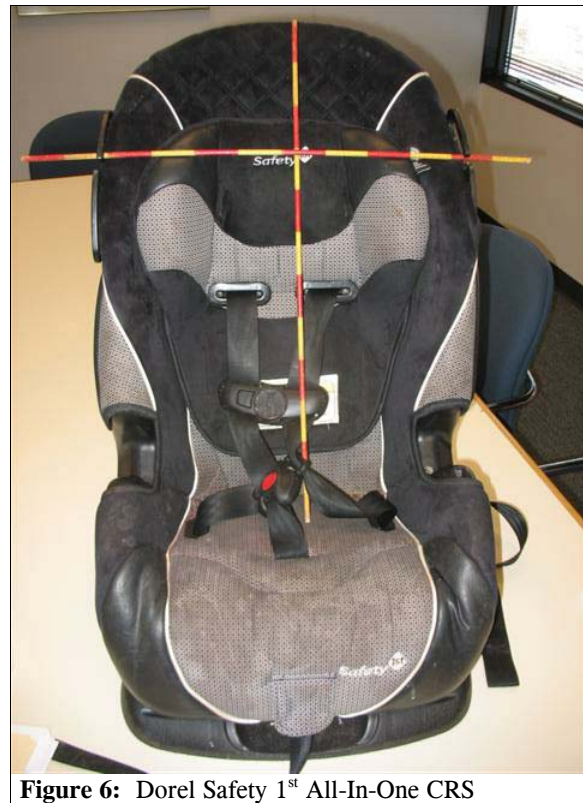
**Figure 6:** Dorel Safety 1<sup>st</sup> All-In-One CRS

Visual inspection of the CRS revealed no crash related damage to the plastic shell or base. Very light load abrasions were present on the forward-facing safety belt paths. This evidence suggests that the lap-and-shoulder belt was routed through the forward-facing belt path.
