ON-SITE SIDE IMPACT INFLATABLE OCCUPANT PROTECTION INVESTIGATION

CASE NUMBER - IN11008
LOCATION - TEXAS
VEHICLE - 2006 MERCEDES BENZ S500
CRASH DATE - December 2010

September 2, 2011

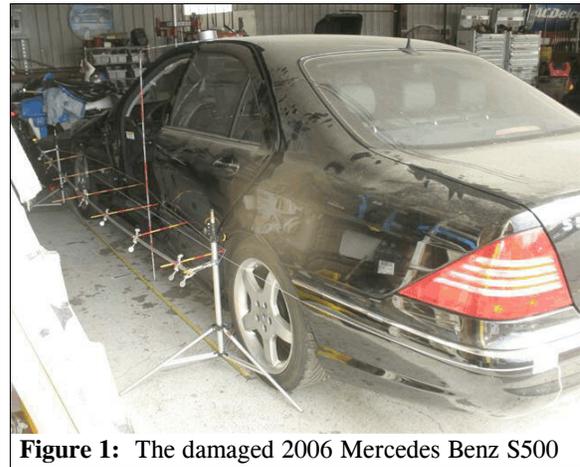
Figure 1: The damaged 2006 Mercedes Benz S500

The Mercedes sustained left side plane damage during the impact with the Dodge. The left fender, left front wheel, left front door, and left rear door were directly damaged. The direct damage began 288 cm (113.4 in) forward of the left rear axle and extended 264 cm (103.9 in) rearward along the left side plane. The crush measurements were taken at the lower door level and the maximum residual crush was 16 cm (6.3 in) occurring at C₄. The height of the maximum door crush was 57 cm (22.4 in) and the door sill differential was 4 cm (1.6 in). The height of the sill was 39 cm (15.4 in). The left side wheelbase was reduced 3 cm (1.2 in).

The Collision Deformation Classification (CDC) was 10LYEW2 (310 degrees). The Missing Vehicle algorithm of the WinSMASH program calculated the total Delta V as 13 km/h (8.1 mph). The longitudinal and lateral velocity changes were -8 km/h (-5 in) and 10 km/h (6.2 mph), respectively. Based on the damage, the results appeared reasonable.

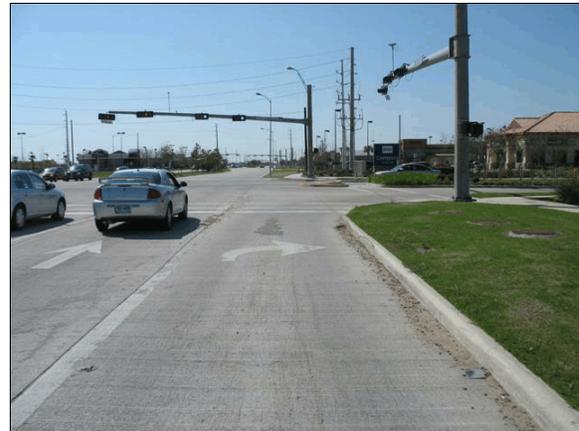
Pre-Crash: The Mercedes was traveling west in the first through lane from the right (**Figure 2**). The traffic signal was on the green phase and the driver intended to continue westbound through the intersection. As the Mercedes was approaching the intersection, the westbound traffic in the other two through lanes stopped and some vehicles stopped within the intersection. The Dodge was traveling north approaching the intersection in the first through lane from the right (**Figure 3**). The driver intended to continue northbound through the intersection. According to the police crash report, the Dodge traveled into the intersection and maneuvered around the stopped westbound vehicles and proceeded toward the north leg of the intersection.

Figure 2: Approach of the Mercedes westbound in the first through lane from the right

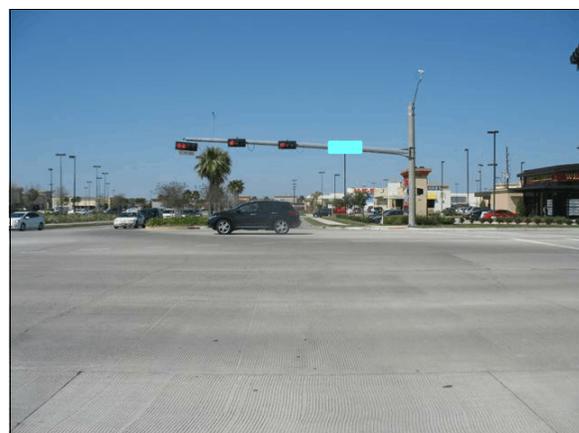
Figure 3: Approach of the Dodge northbound into the intersection

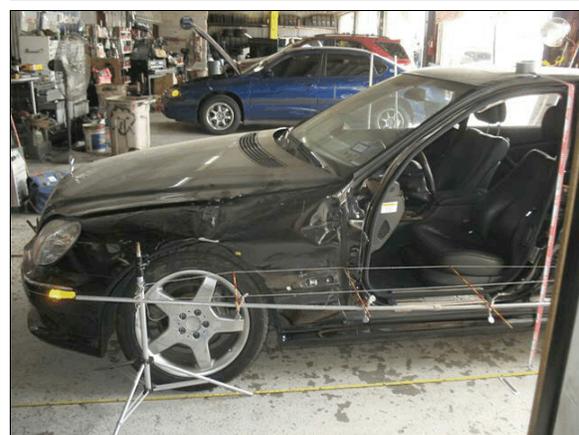
Crash: As the driver of the Mercedes proceeded through the intersection, the front plane of the Dodge impacted the left side plane of the Mercedes (**Figure 4**). The force direction on the Mercedes was within the 10 o'clock sector and the impact triggered a deployment of the left front and rear door-mounted side impact air bags and left IC air

Figure 4: Damage to the left side plane of the Mercedes from the front plane impact by the Dodge; the left front door of the Mercedes was removed by rescue personnel

bag. The calculated total Delta V for the Mercedes was 13 km/h (8 mph). The longitudinal and lateral velocity changes were -8 km/h (-5) and 10 km/h (6.2 mph), respectively. The calculated total Delta V for the Dodge was 10 km/h (6.2 mph). The longitudinal and lateral velocity changes were -8 km/h (-5 mph) and -6 km/h (-3.7), respectively. Following the impact, the Mercedes rotated counterclockwise and came to final rest near the northwest corner of the intersection heading southwest. The Dodge rotated counterclockwise and came to final rest within the intersection heading northwest.

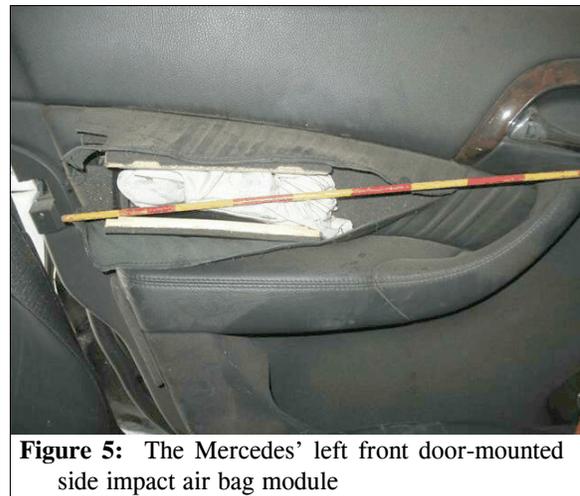
The left front door-mounted side impact air bag was located within the door panel above the arm rest and approximately 17 cm (6.7 in) forward of the back of the door (**Figure 5**). The module cover was a two-flap configuration constructed of pliable vinyl and had a soft plastic foam outer covering. Each cover flap was 19.5 cm (7.7 in) in width and 6 cm (2.4 in) in height. The cover flaps opened at the designated tear seams and were undamaged. The deployed side impact air bag (**Figure 6**) was 45 cm (17.7 in) in

Figure 5: The Mercedes' left front door-mounted side impact air bag module

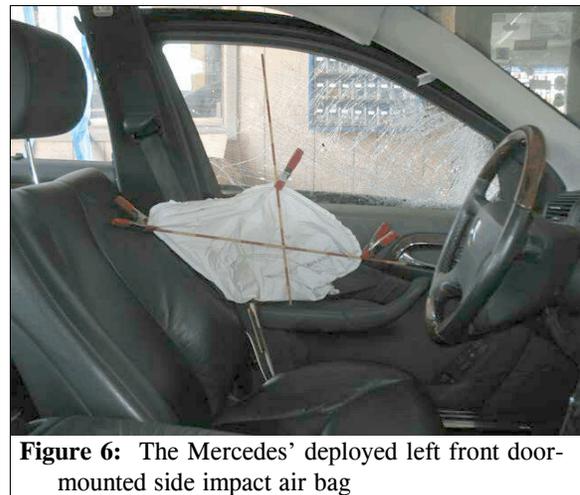
Figure 6: The Mercedes' deployed left front door-mounted side impact air bag

width and 25 cm (9.8 in) in height. There were no external vent ports. There was a seam 27 cm (10.6 in) in length where both sides of the air bag were sewn together. The seam was located 13 cm (5.1 in) above the bottom of the air bag. When the air bag was extended to its full height, it extended 4 cm (1.6 in) above the beltline. There was no discernable evidence of occupant contact and no damage to the air bag.
