ON-SITE SIDE IMPACT INFLATABLE OCCUPANT PROTECTION INVESTIGATION

CASE NUMBER - IN11009
LOCATION - OHIO
VEHICLE - 2009 HYUNDAI SONATA SE
CRASH DATE - February 2011

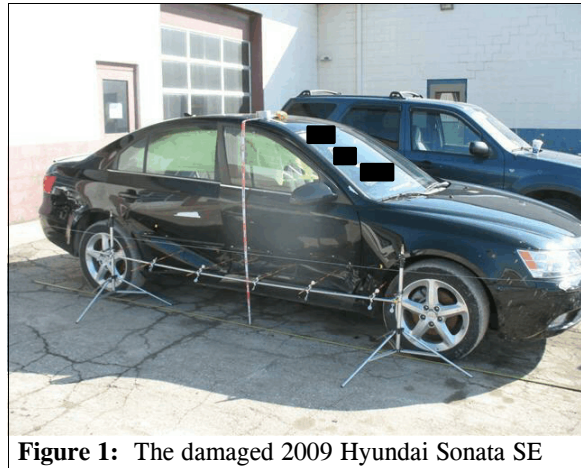
Figure 1: The damaged 2009 Hyundai Sonata SE

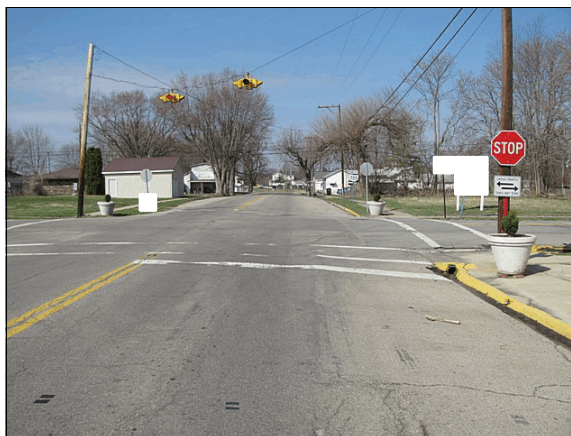
Figure 2: View west; the Hyundai was stopped at the intersection; the Ford was southbound approaching from the right

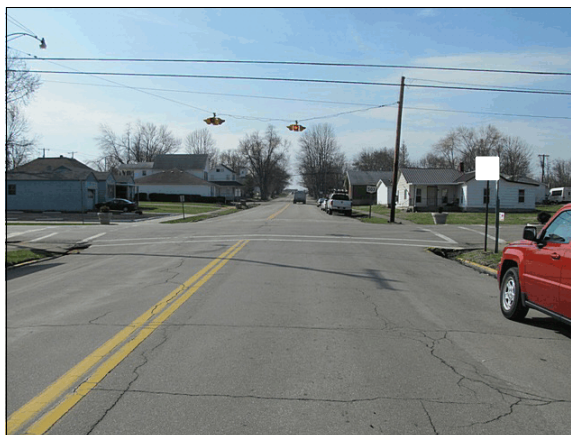
Figure 3: Southbound approach of the Ford to the intersection, the Hyundai was westbound approaching from the left

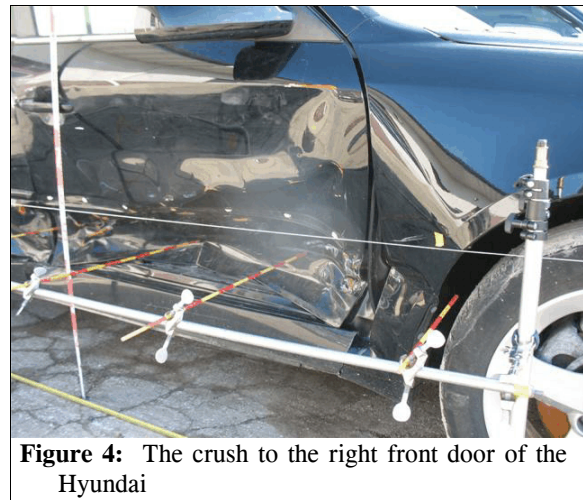
The Hyundai sustained right side plane damage during the impact with the Ford. The right side doors and fender were directly damaged. The direct damage began 31 cm (12.2 in) rear of the right front axle and extended 180 cm (70.9 in) rearward along the right side plane. The crush measurements were taken at the lower-door level and the maximum residual crush was 31 cm (12.2 in) occurring at C₄ (**Figure 4**). The height of the maximum door crush was 43 cm (16.9 in). The door sill differential was 18 cm (7.1 in). The height of the sill was 36 cm (14.2 in). The table below presents the right side crush profile.

Figure 4: The crush to the right front door of the Hyundai

The Collision Deformation Classification (CDC) was 03RYEW3 (80 degrees). The Missing Vehicle algorithm of the WinSMASH program calculated the total Delta V as 24 km/h (14.9 mph). The longitudinal and lateral velocity changes were -4 km/h (-2.5 in) and -24 km/h (-14.9 mph), respectively. Based on the damage, the results appeared reasonable.

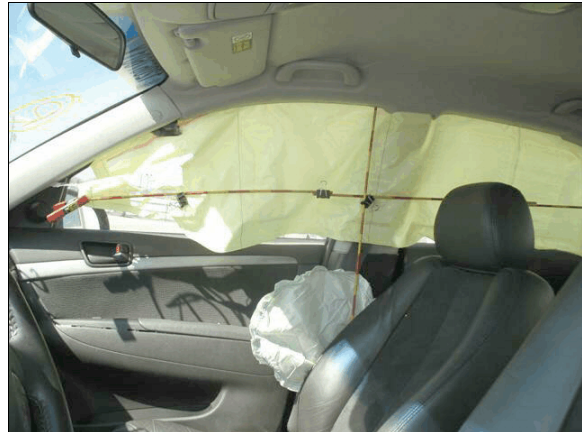
The deployed right IC air bag (**Figure 5**) extended from the A-pillar to the C-pillar. There were no external vent ports. The IC was 170 cm (55.1 in) in width and 32 cm (12.6 in) in height, and was attached to the A-pillar by an 8 cm (3.1 in) nylon tether. The IC did not extend below the beltline. Inspection of the deployed IC revealed no discernable evidence of occupant contact and no damage.

Figure 5: The Hyundai's deployed right IC air bag and seat-mounted side impact air bag

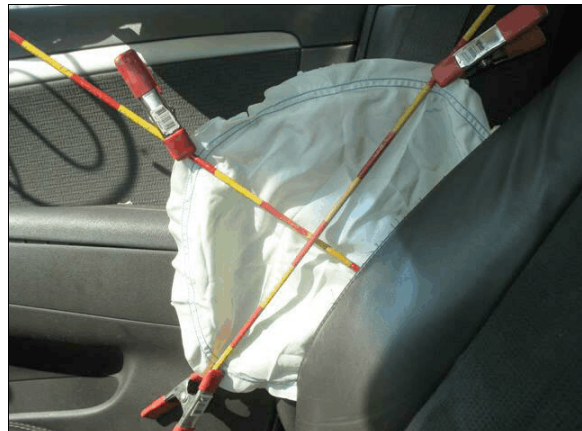
The deployed front right seat-mounted side impact air bag (**Figure 6**) was 22 cm (8.7 in) in width and 37 cm (14.6 in) in height. There were no external vent ports. There was no discernable evidence of occupant contacts and no damage to the air bag. The deploying air bag created scuff marks on the left B-pillar.

Figure 6: The Hyundai's deployed front right seat-mounted side impact air bag
