**CALSPAN ON-SITE IMPACT FIRE INVESTIGATION**

**SCI CASE NO.: CA11018**  
**OFFICE OF DEFECTS INVESTIGATION**

**VEHICLE: 2008 DODGE CHARGER POLICE VEHICLE**

**CRASH DATE: APRIL 2011**

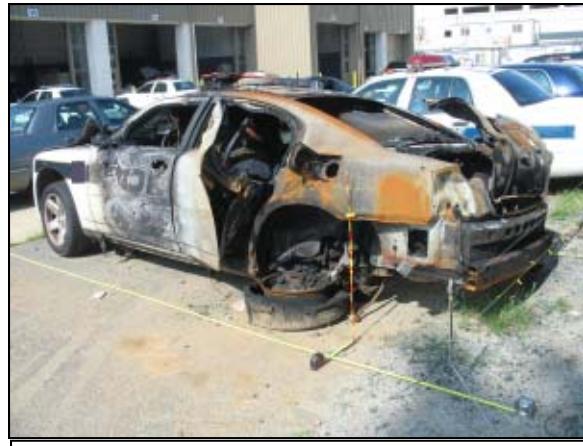
**Figure 1:** Left rear oblique view of the 2008 Dodge Charger Police Vehicle.

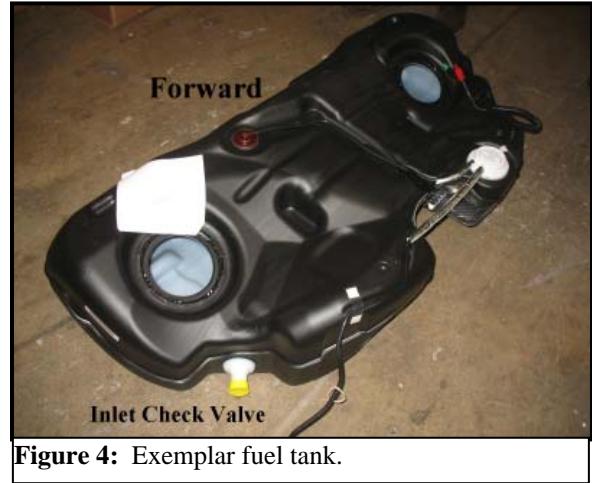
**Figure 4** is an image of an exemplar fuel tank for reference. The exemplar fuel tank was a new OEM replacement part inspected at a Dodge repair facility. The top aspect of the tank contained two 11 cm (4.5 in) diameter ports for the electric fuel pumps/sending units. These units were retained within the tank with metal back rings. The fuel was supplied to the engine from the right side of the tank. Two plastic valves were mounted to the top of the tank and secured with rubber grommets. The fill inlet port was located at the lower left rear corner of the tank. The white plastic inlet valve was fused to the tank. This plastic inlet contained a spring-loaded internal check valve and had a 5 cm (2 in) long neck for the attachment of the filler tube.

**Figure 4:** Exemplar fuel tank.

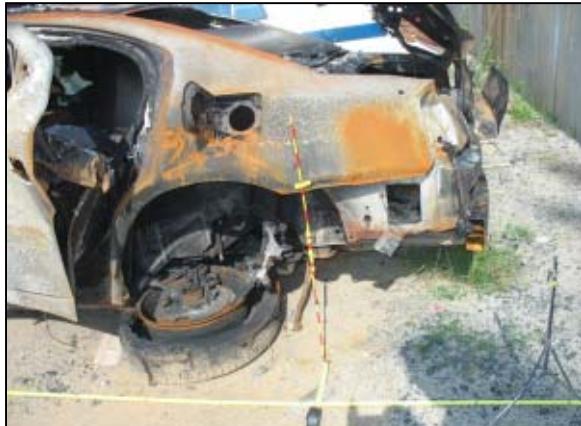
The Dodge Charger sustained minor exterior damage as a result of the impact (Event 1) and major fire damage (Event 2). The rear bumper fascia was consumed in the fire; therefore the precise location of the direct damage on the rear plane could not be determined. There was no discernable contact to the rear bumper reinforcement. Therefore, the direct vehicle-to-vehicle contact had to have occurred within the 10 cm (4 in) unsupported left rear corner area, outboard of the left end of the reinforcement. A crush profile was documented along the 134 cm (52.8 in) width of the reinforcement as follows: C1 = 1 cm (0.5 in), C2 = 0, C3 = 0, C4 = 0, C5 = 0, C6 = 0. The narrow engagement wrapped around the corner and extended 77 cm (30.3 in) forward along the body line of the quarterpanel (**Figure 7**). The vertical rod in the figure depicts the end of the direct body damage. The direct damage along the left plane was located at a height of 76 cm (30 in). This height was consistent with the general location of the damage on the Lexus. It was noted during the SCI inspection that there was no damage to the inner structure of the rear corner area below the body damage. An examination of an exemplar Dodge Charger determined that this area was concealed by a plastic body panel that was consumed in the fire. This plastic panel was also consumed on the right plane of the Dodge.

**Figure 7:** View of the left rear quarterpanel and impact damage to the Dodge.

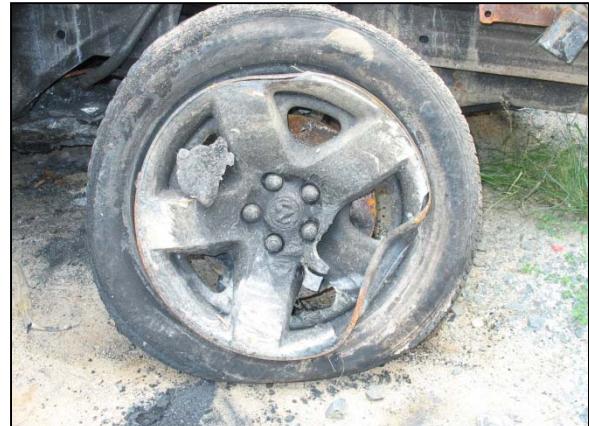
During the impact, as the vehicles' body structures deformed, the vehicle-to-vehicle engagement transitioned into direct wheel-to-wheel contact. **Figure 8** is a view of the outboard surface of left rear wheel. A 30 cm (12 in) section of the rim deformed and had folded over onto itself. The force of the wheel-to-wheel contact fractured the casting at the outer bearing, and the left rear

wheel separated from the arms of the five link suspension. The left rear drive shaft was missing at the time of the SCI inspection. An analysis of the vehicle's corner impact damage was beyond the scope of WinSMASH model. The Collision deformation Classification (CDC) assigned to this damage pattern was 06BLEE6.

**Figure 8:** View depicting the damage to the left rear wheel rim of the Dodge.

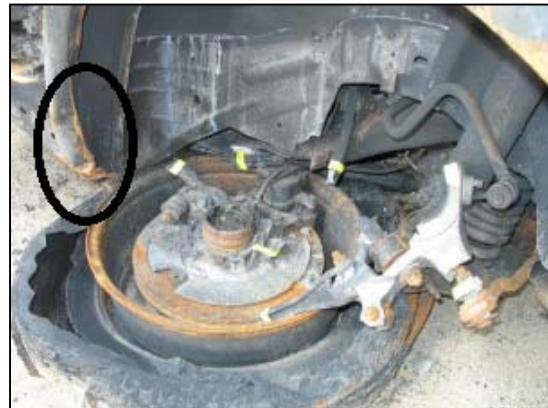
Analysis of the physical evidence and the dynamics of the impact indicated that direct wheel-to-wheel contact between the Lexus and Dodge caused the fracturing of the Dodge's 5-link suspension and the separation of the left rear wheel. **Figure 9** is an image of the fractured suspension arms, bearing casting and wheel. The separated left rear wheel assembly was then displaced forward by the Lexus. Subsequently, it came into contact with the forward lower aspect of the wheel opening and with the lower aspect of the filler neck, which was located within this region. The isolated damage is highlighted in **Figure 9**.

**Figure 9:** View of the Dodge's fractured rear suspension, bearing casting and separated left rear wheel.

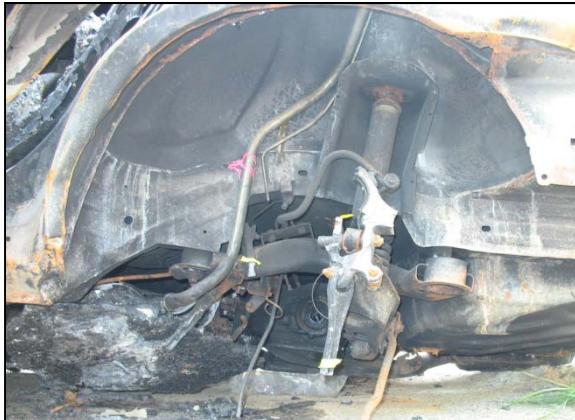
The wheel-to-filler neck contact placed the connection between the filler neck and the fuel tank in tension. It appeared that the inlet nozzle (and integral check valve) dislodged from overload and separated from the fuel tank. The separated nozzle/check valve allowed gasoline to flow freely from the tank and the vapors ignited in a fuel-fed fire. The fuel tank, neoprene hose section and nozzle/check valve were consumed in the fire. The rubber grommet at the filler door was also consumed and the filler neck separated from the quarterpanel. **Figure 10** is a close-up view into the left rear wheel well opening of the fractured suspension. The position of the filler neck was reconstructed for the purposes of the image.

**Figure 10:** View of the Dodge's left rear wheel well opening and reconstructed position of the filler neck.

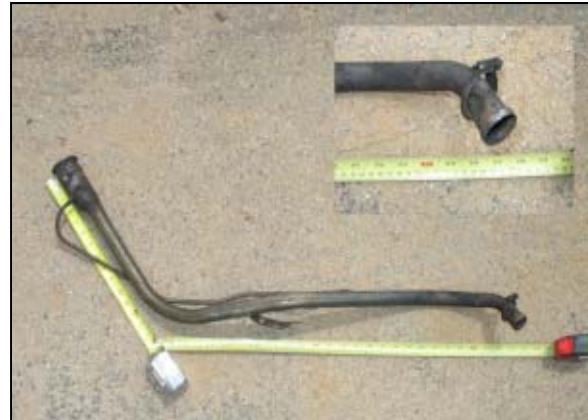
**Figure 11** is an image of the filler neck. This component was found within the trunk at the time of the SCI inspection. Only one of the clamps that were used to secure the neoprene hose at the tank connection was found with the filler neck. The 3 cm (1 in) diameter filler neck had primarily retained its shape. Impact damage was noted to the downstream end of the tube (toward the fuel tank). A 2 x 2 cm (0.8 x 0.8 in) flat spot was identified on the bottom side of the tube. This area was centered 5 cm (1.8 in) from the end of the tube. A corresponding flat spot was located on the top side of the tube. The flat spot was located 3 cm (1 in) from the end of the tube. The downstream end of the tube was oval as a result and measured 2 cm x 3 cm (0.8 in x 1.1 in). The recovered hose clamp was also oval and measured 3 cm x 4 cm (1 in x 1.5 in). The consistent shape of the tube and clamp indicated that this clamp may have been located at the outboard end of the neoprene hose section.

**Figure 11:** View of the filler neck from the Dodge.

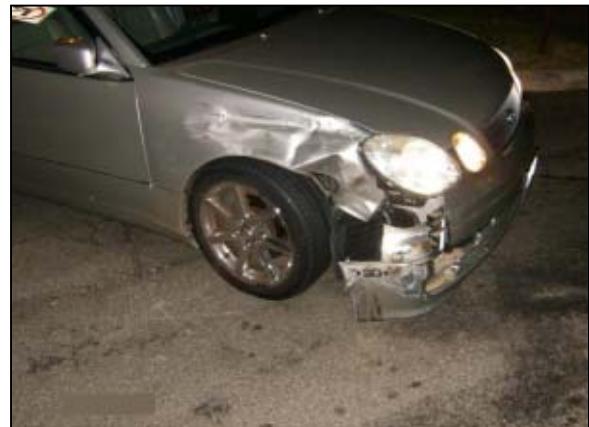
**Figure 12** is an on-scene police image of the damaged front right corner area. Analysis of the image indicated the direct contact damage began immediately outboard the right end of the front bumper reinforcement and wrapped around the corner onto the right fender. The width of the direct contact to the frontal plane was an estimated 15 cm (6 in). The longitudinal length of the direct contact along the fender was an estimated 102 cm (40 in). The direct contact ended at the aft edge of the wheel opening. The lead edge of the fender was crushed inboard exposing the face of the right front tire. The right wheelbase was reduced and estimated 5 to 8 cm (2 to 3 in). The tire was in contact with the aft portion of the wheel opening. The insurer's repair order indicated that all of the right front suspension components were replaced. The total cost of the repair was \$7,772.07 (\$4687.35 Parts + Labor and Tax). An analysis of this corner impact damage was beyond the scope of the WinSMASH program. The CDC assigned to this damage pattern was 12FREE5.

**Figure 12:** Front right oblique view of the Lexus.  
Image supplied by the police investigation.
