REMOTE COMBINED NASS/SCI DRIVER AIR BAG FATALITY INVESTIGATION

CALSPAN CASE NO. 1997-04-146A

VEHICLE - 1996 GEO METRO

CRASH DATE - OCTOBER, 1997

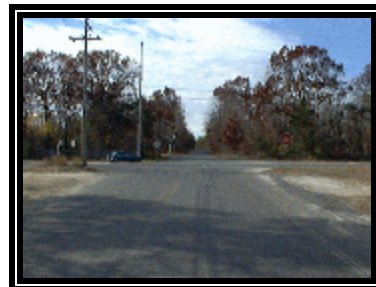
Figure 1: Southbound trajectory view of the intersection.

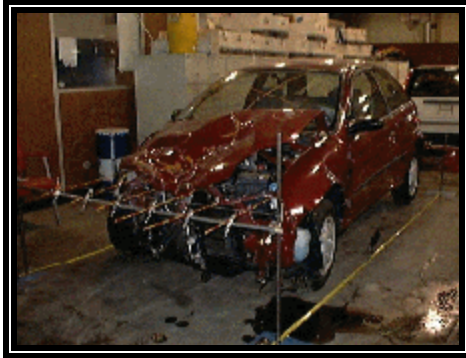
The crash involved a southbound 1996 Geo Metro and an eastbound 1985 Chevrolet S-10 pickup truck. The frontal plane of the Geo (**Figure 2**) struck the forward portion of the left side plane of the S-10 pickup in a 2/11 o'clock impact configuration. The Geo sustained a maximum crush value of approximately 38 cm (15 in) at C5, inboard of the right bumper corner. The direct contact damage was 94 cm (37 in) in width, began at the right front corner and extended to the left. The S-10 pickup sustained a maximum lateral crush of 46 cm (18 in) located 33 cm (13 in) forward of the left front axle (**Figure 3**). The width the of direct contact damage was 136 cm (54 in), which began at the left corner

of the front bumper and extended rearward. The field L was 164 cm (65 in). At impact, the right front structure of the Geo deformed and “locked” into the left front suspension of the S-10 pickup. This sequence displaced the front bumper structure from the Geo and foreshortened the left side wheelbase of the S-10 pickup approximately 15 cm (6 in). The Collision Deformation Classification (CDC) of the Geo was 02-FZEW-2 and the CDC of the S-10 pickup was 11-LFEW-3.

Figure 2: Left front view of the Geo Metro.

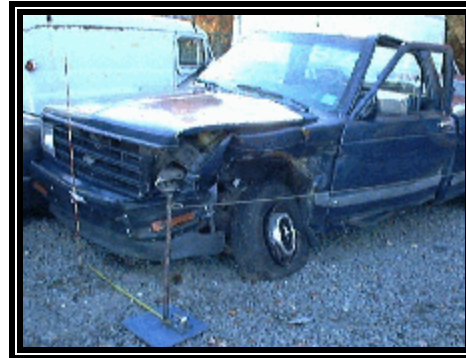
Figure 3: Left front view of the Chevrolet S-10 pick-up.

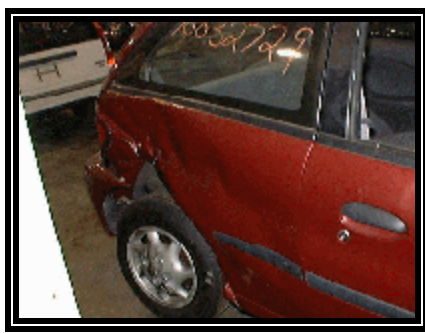
Due to the force of the impact, the Geo rotated counterclockwise and upon separation from the initial contact, the vehicles impacted again in a side-slap configuration. The right rear of the Geo struck the left side of the S-10 pickup box aft of the left rear axle (**Figures 4 and 5**). The CDC's of the side-slap impact were 03-RBEW-2 and 09-LBEW-3 for the Geo and S-10 pickup respectively. After the side-slap impact, the vehicles slid to their respective final rest locations in the southeast quadrant of the intersection.

Figure 4: Right side damage of the Geo Metro.

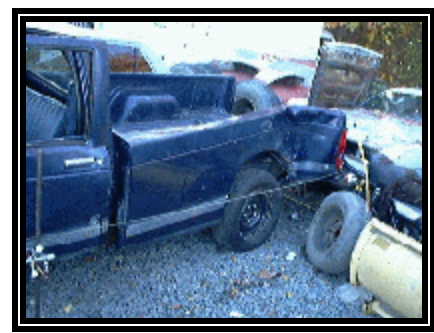
Figure 5: Left side damage of the Chevrolet S-10 pick-up.

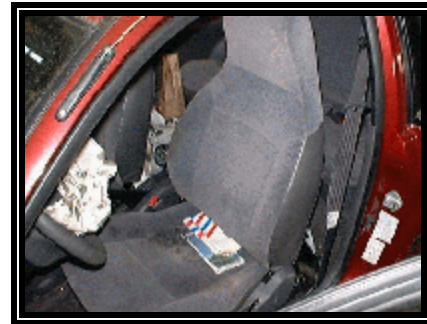
The front seating system in the Geo Metro consisted of bucket seats with reclining backs . The head restraints were integral. Inspection of the left front seat (**Figure 6**) found the seat to be in a mid to rear track position at the time of inspection. The seat back was slightly reclined and there was no seat performance failure. The horizontal distance between the center of the steering wheel hub and the left front seat back measured 61 cm (24 in). It was unknown if the seat track position had been altered from its at-crash position prior to the NASS inspection.

Figure 6: View of the left front seat.

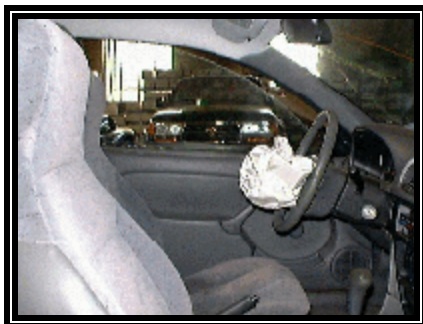
Figure 7: View of the left front interior.

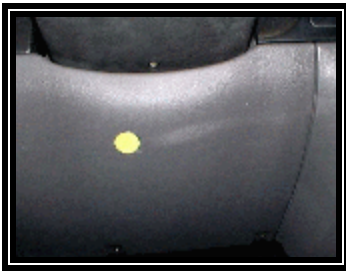
Figure 7 is a view of the left front interior. **Figures 8 - 10** are the occupant contacts identified during the inspection. The driver's knee bolster exhibited a scuff mark attributed to contact with the driver's right knee. The scuff was located directly below and to the right of the steering column centerline. A scuff mark was also identified on the center left aspect of the driver's sun visor. This scuff was attributed to probable contact with the driver's left hand. A rebound contact from the driver's head was noted on the leading aspect of the left B-pillar above the D-ring elevation. There was no deformation to the 4 spoke steering wheel rim, and there was no compression of the steering column's shear capsules.

Figure 8: View of the driver's knee bolster contact.

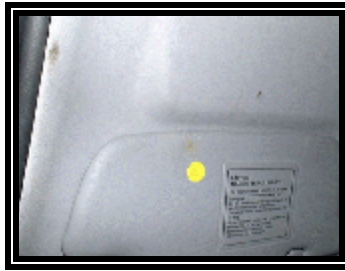
Figure 9: View of the contact to the driver's sunvisor.

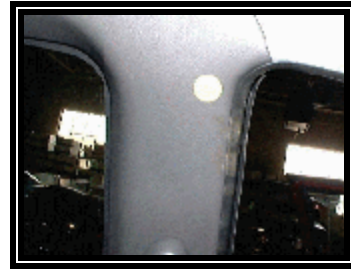
Figure 10: View of contact to the left B-pillar.

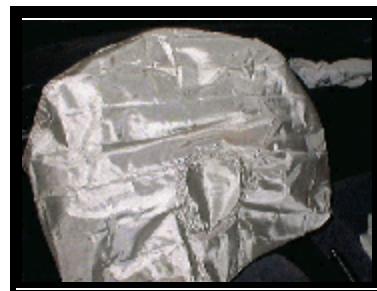
The air bag membrane measured 70.0 cm (27.5 in) in its deflated state (**Figure 11**). The air bag was tethered and had two vent ports in the 10/2 o'clock sector on the back side of the bag. The face of the air bag exhibited scattered blood spatters. The air bag fabric

Figure 11: Driver air bag.

also exhibited black transfers in the six o'clock sector on the back side of the bag and in the 12 o'clock sector and right lower quadrant on the front side of the bag. The black transfers on the air bag and scuffs on the interior surfaces of the module cover flaps were indicators of an altered air bag deployment path due to the forward position of the driver at the time of deployment.
