**TRANSPORTATION SCIENCES  
CRASH RESEARCH SECTION**

**CALSPAN REMOTE AIR BAG DEPLOYMENT/CHILD  
FATALITY INVESTIGATION  
CALSPAN CASE NO. 1997-41-049A  
CRASH LOCATION: STATE OF FLORIDA  
CRASH DATE: APRIL, 1997**

Contract No. DTNH22094-D-07058

U.S. Department of Transportation  
National Highway Traffic Safety Administration  
Washington, D.C. 20590

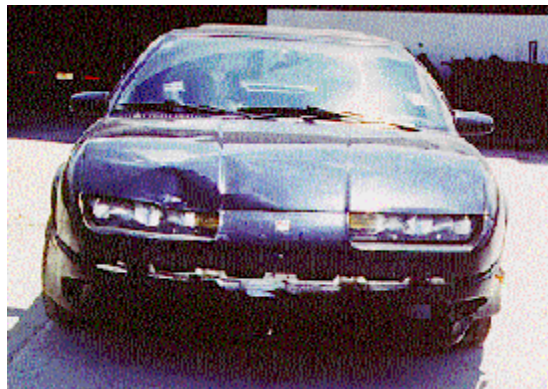
Figure 1. View of the damaged frontal plane  
of the Saturn.

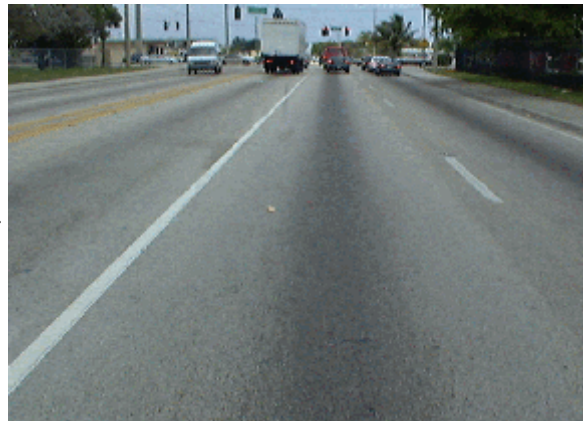
The Saturn was traveling eastbound in the second lane of the five lane undivided roadway approaching the four-leg intersection. The Oldsmobile was traveling ahead of the Saturn also in the second lane. The driver of the Oldsmobile began braking actions to slow for the overhead control signal in the red phase. The driver of the Saturn failed to detect the overhead light or the yielding Oldsmobile in sufficient time to successfully avoid the collision. He initiated avoidance actions by applying the brakes of the Saturn, however, he subsequently impacted the back plane of the Oldsmobile with the front plane of the Saturn. The PAR and scene photographs did not identify the presence of pre-crash braking skid marks. The front bumper fascia of the Saturn contacted and overrode the back bumper of the Oldsmobile which resulted in the deployment sequence of the front left and front right air bag system of the Saturn. The rear springs of the Oldsmobile had been modified and the rear of the vehicle subsequently rode low to the ground. The alteration of the rear springs resulted in the override-type damage to the rear of the Oldsmobile. The Saturn came to final rest in its respective travel lane. The Oldsmobile came to final rest in the left turn lane of the eastbound roadway.

Figure 2. View of the Saturn's approach to point of impact.

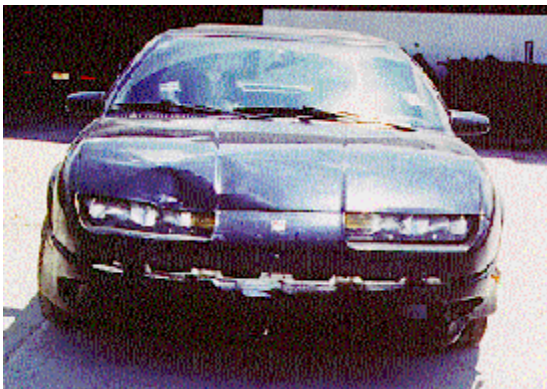
The Saturn SL-2 sustained minor frontal damage which extended across the entire width of the front bumper fascia. Direct contact damage began at the left front bumper corner and extended 114 cm (45 in) to the right corner. Crush was minimal and was reported at a maximum of 6.0 cm (2.4 in) located at the right front bumper corner. Table 1 identifies the crush sustained by the frontal plane of the Saturn. The damage resulted in a 12 o'clock direction of force with a resulting Collision Deformation Classification (CDC) of 12-FDEW-1. The SMASH program generated a total delta V of 22.9 km/h (14.2 mph). Calculated longitudinal and lateral delta V's were -22.9 km/h (-14.2 mph) and 0 km/h, respectively. A General Motors representative present at the vehicle inspection with the trauma center researcher ascertained a total delta V of 24.9 km/h (15.5 mph) from information retained in the Saturn's Systems Diagnostic Module (SDM). The Saturn's measured crush was probably under represented due to rebound of the front bumper's energy absorption system and the pliable material of the bumper cover which resulted in a lower calculated SMASH delta V then reported by the SDM. The interior of the Saturn lacked intrusion damage. Interior vehicle damage consisted of a fracture of the rear view mirror's glazing and its subsequent forward displacement which resulted in a fracture of the windshield.

Figure 3. View of the damaged frontal plane of the Saturn.

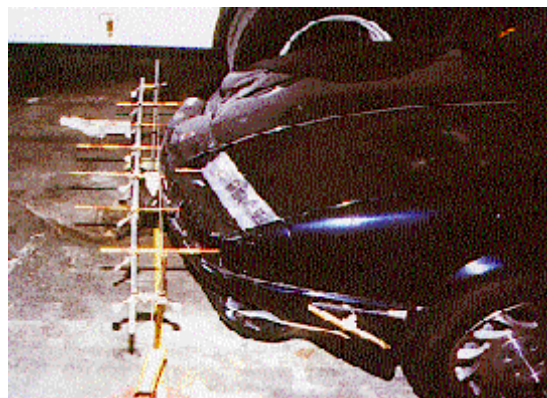
Figure 4. Left lateral view of the Saturn's damaged frontal plane.

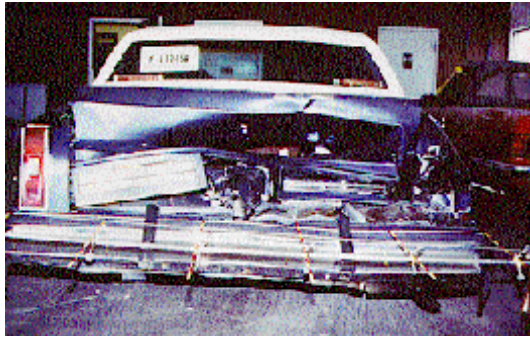
The Oldsmobile 98 Regency sustained induced and direct damage which extended across the width of the back plane. Direct contact damage began at the right rear bumper corner and extended 119 cm (47 in) left. Crush measurements were calculated at the bumper level and at the at the lower aspect of the tail lamps due to the overriding damage pattern sustained by the Oldsmobile. Maximum bumper crush was

reported at 23.0 cm (9.1 in) at the right rear bumper corner. Maximum crush at the tail lights was calculated at 42.0 cm ( 16.5 in). Maximum crush was 42.0 cm (16.5 in) located at the right rear bumper corner. Table 2 identifies the crush damage profile sustained by the Oldsmobile. The damage resulted in a 6 o'clock direction of force with a resulting CDC of 06-BDEW-2. The extent zone was revised following SCI reviewing the CDS case file. The SMASH program generated a total delta V of 14.0 km/h (8.7 mph). Calculated longitudinal and lateral delta V were 14.0 km/h (8.7 mph) and 0 km/h, respectively.

Figure 5. View of the damaged back plane of the Oldsmobile.

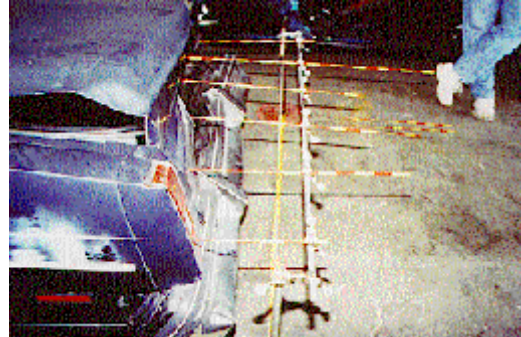
Figure 6. Left lateral view of the Oldsmobile's damaged back plane.

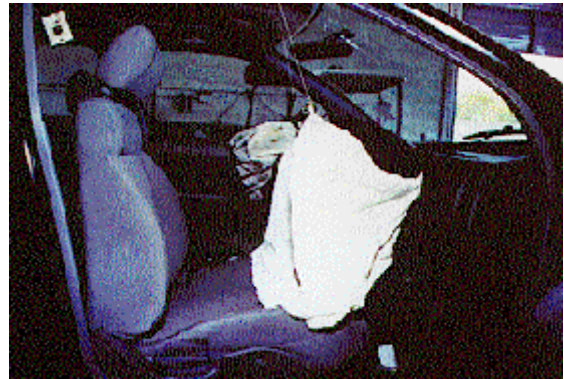
Figure 7. Right lateral view of the Saturn's passenger compartment area.

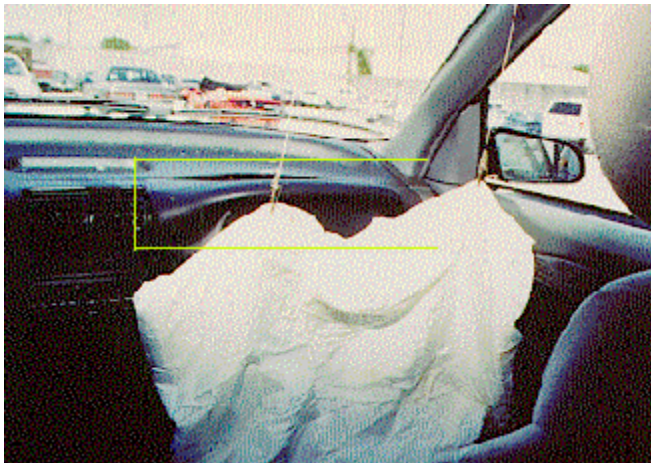
Figure 8. View of the deployed front right air bag and highlighted instrument panel brow.

The front right air bag deployed from a mid-mounted position in the right side instrument panel which was equipped with a brow (protruding curved upper panel) above the module cover flap designed to direct the deployment path of the air bag. The module cover flap had a measured maximum width of 30 cm (12 in) and a maximum height of 12.0 cm (4.7 in). Possible occupant contact was located inferior and adjacent to the top seam of the air bag which consisted of a brown transfer. The air bag was not equipped with tethers or vent ports and measured 69 cm (27 in) in width and 43 cm (17 in) in height. Contact damage to the air bag consisted of a "scuff", not further defined, at the top seam of the face of the air bag, centered.

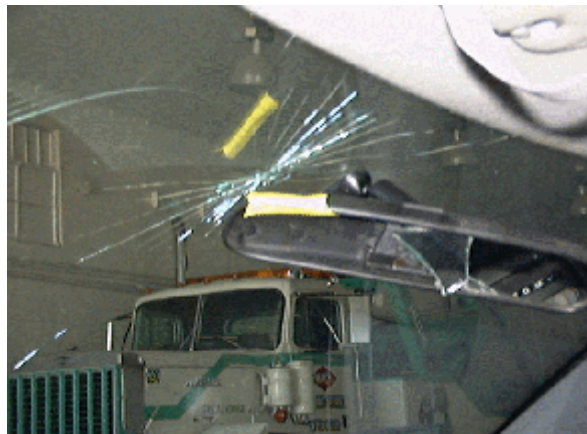
The driver of the Saturn was a 22 year old male with a reported height of 175 cm (69 in) and weight of 136 kgs (300 lbs). He was not restrained by the 3-point manual lap and shoulder belt system as indicated by SDM stored data, the PAR, and witness accounts of the crash events. Location of the seat track was reported at the rear most position by the trauma center researcher. The seat back was reportedly reclined and the tilt steering wheel was in the full upright position. At impact, the unrestrained driver responded to the 12 o'clock direction of force and was displaced in a forward direction as the air bag deployed. The driver presumably contacted his right forearm or hand with the displaced and fractured rearview mirror and windshield as his hand was displaced from the steering wheel when the air bag deployed. The mirror

was displaced down and to the left with respect to the vehicle and the windshield fracture was located to the left of the rearview mirror. The PAR indicated that the driver of the vehicle did not sustain injury as a result of the crash, however, medical reports for the child positioned on the lap of the right front seated occupant indicated that the driver sustained minor (not further specified) injuries. The driver did not receive treatment.

Figure 9. Displaced and damaged rear view mirror and fractured windshield.
