**REMOTE INVESTIGATION OF A DRIVER AIR BAG FATALITY**

**NASS CASE NO. 1997-45-042B**

**VEHICLE - 1992 BUICK LESABRE**

**CRASH DATE - APRIL, 1997**

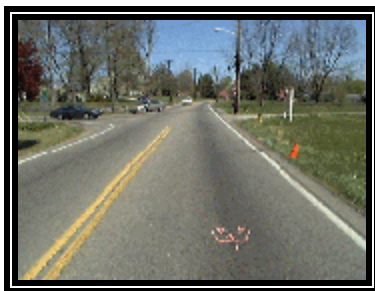
**Figure 1:** Eastbound trajectory view.

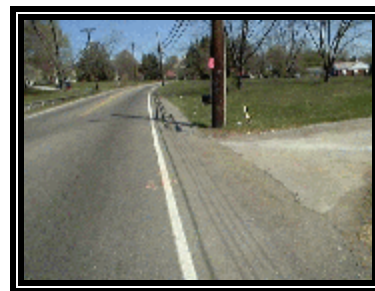
**Figure 2:** View of the utility pole.

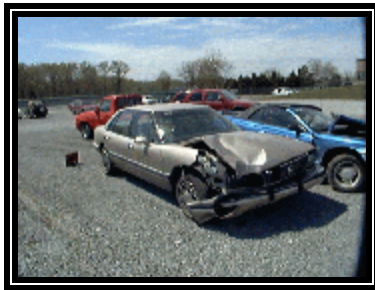
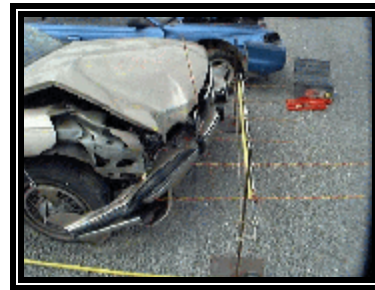
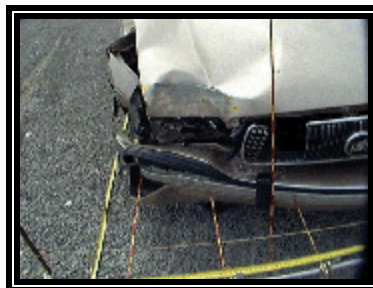
The Collision Deformation Classification (CDC) of the Buick was coded 12-FREN-2, with a measured crush of 47.0 cm (18.5 in) at the right corner of the front bumper. The direct contact damage width was 32.0 cm (12.6 in), located 40.0 to 72.0 cm (15.7 to 28.3 in) right of the vehicle centerline. The deformation was localized to the vehicle's right frontal area. The bumper, right front fender, hood and the unitized structure forward of the right front axle were damaged. There was no measurable change in the right side wheelbase dimension. The crush profile measured across the full 162 cm (64 in) width of the front bumper was as follows: C1 = 6.0 cm (2.4 in), C2 = 7.0 cm (2.8 in), C3 = 11 cm (4.3 in), C4 = 20 cm (7.9 in), C5 = 32 cm (12.6 in), C6 = 47.0 cm (18.5 in). Figures 3 through 5 are views of the Buick's frontal damage.

**Figure 3:** Right front view of the Buick.

**Figure 4:** Right lateral view across the frontal plane.

**Figure 5:** Close-up view of the right front corner.

The Buick struck the utility pole with the structures of the right front corner, outboard of the unitized frame rail. The vehicle's structures outboard of the frame rail are less stiff than structures that incorporate the frame rail. Because the impact occurred in an area of reduced stiffness, the triggering of the air bag deployment was delayed to a time late in the collision sequence when the driver was out-of-position over the top of the module. The Barrier model of the SMASH algorithm (with pole impact parameters) calculated the delta V of the Buick to be 33.5 km/h (20.8 mph). The longitudinal delta V of -33.5 km/h (-20.8 mph) was above the threshold required to deploy the vehicle's air bag system.

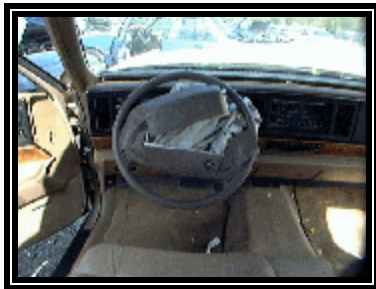
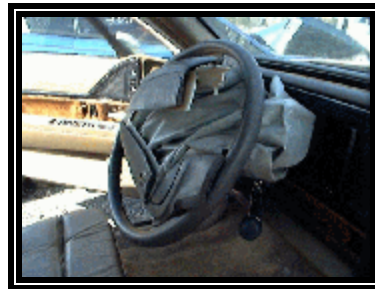
The driver's forward position restricted the proper opening of the cover flaps upon initiation of the deployment sequence. This impeded the air bag's normal egress from the module. The air bag remained captured within the air bag module during its initial expansion, which caused pressure to build within the module. The increased pressure caused the module cover to eventually deform, Figures 6 and 7. This allowed the air bag to deploy through the module's 1 to 5 o'clock sectors. The failure of the air bag to properly unfold, during the expansion, allowed the air bag fabric to come in contact with the hot inflator. This contact caused the fabric to fuse/melt onto itself. (Refer to the Supplemental Inflatable Restraint section, page 4 for further detail.)

**Figure 6:** Deformed driver air bag module.

**Figure 7:** Lateral view of the driver air bag module.

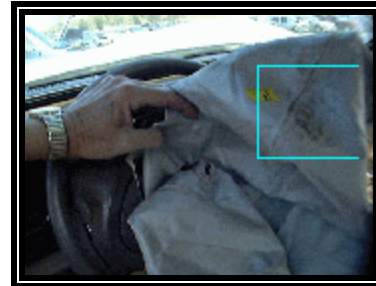
and 5.0 cm (2.0 in), respectively. The air bag measured 62 cm (24 in) in diameter in its deflated state and was not tethered. The bag was vented by two ports located on the back side in the 2 and 10 o'clock sectors. The driver air bag deployment was triggered by the impact. However, due to the forward position of the driver, the cover flaps failed to properly open at the tear seams. A heavy black smudge located in the 11 o'clock sector on the front side of the air bag was identified by the researcher, Figure 8. This smudge was caused by the friction heating between the expanding air bag's and the interior surface of the module cover during the altered deployment sequence.

**Figure 8:** View of the smudge to the face of the air bag.

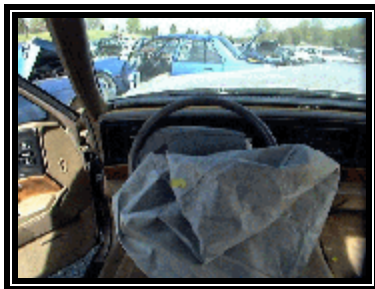
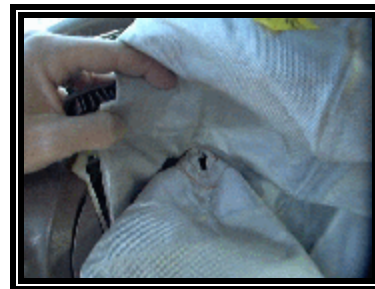
The air bag remained captured within the air bag module during its initial expansion, which caused pressure to build within the module. The right side of the upper cover flap was torn from the inflator module. The air bag did not unfold properly and was not able to fully expand toward the driver. The NASS researcher initially indicated a problem with the stitching around the vent port as the cause of the air bag's improper expansion. It is more probable that the failure of the air bag to properly unfold, during the expansion, allowed the air bag fabric to come in contact with the hot inflator. This contact caused the fabric to fuse/melt onto itself, (Figures 9 and 10).

**Figure 9:** Driver air bag.

**Figure 10:** Close-up view of the fused fabric.
