SCI/NASS COMBINATION CASE REPORT

CASE NUMBER - NASS-1997-49-182E

VEHICLE - 1998 FORD ESCORT

CRASH DATE - October 1997

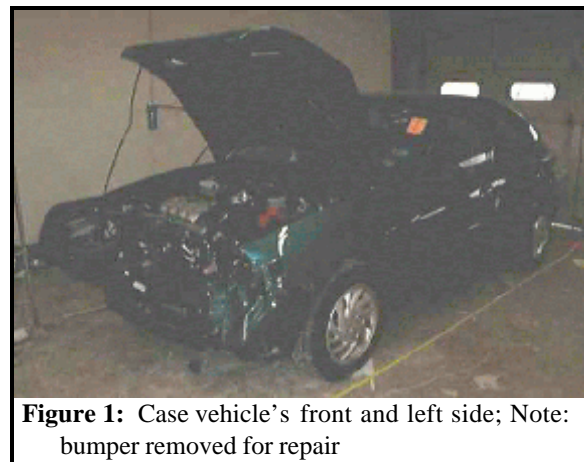
Figure 1: Case vehicle's front and left side; Note: bumper removed for repair

disabling damage. Damage to the case vehicle (**Figure 1**) consisted of direct contact across the left half of the front, including the bumper, grille, the front edge of the left fender and the leading edge of the hood, with induced damage across the entire front. In addition, there was an area of spider web cracking on the right side of the windshield immediately above the front right air bag module. The CDC for the case vehicle is: **11-FYEW-2**, with principal direction of force 340 [-20] degrees. The WinSMASH reconstruction program, damage only algorithm, was used on the case vehicle's highest severity impact. The Total, Longitudinal, and Lateral Delta Vs are, respectively: 19 km.p.h. (12 m.p.h.), -19 km.p.h. (-12 m.p.h) and +3 km.p.h. (+2 m.p.h.).

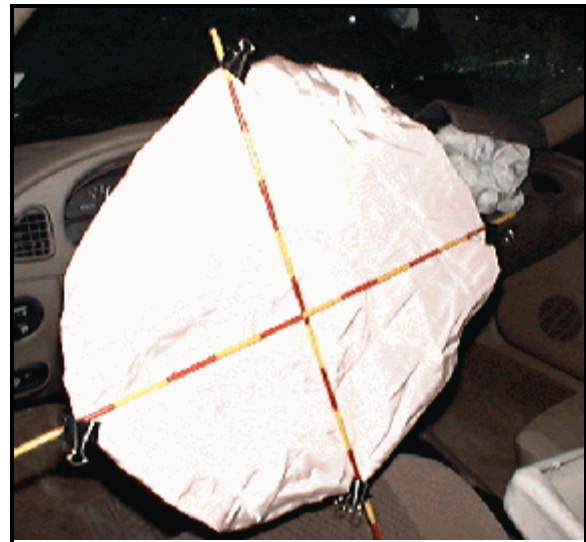
The case vehicle's driver air bag was located in the steering wheel hub. An inspection of the air bag module's cover flaps revealed that the flaps opened along the perforations, with no evidence of damage to the flaps. The driver air bag was round, with a diameter of approximately 54 centimeters [21.3 inches]. Vent ports were located at the 10 and 2 o'clock positions, and the air bag had no tethers. A smudge of pink makeup, probably lipstick, was found near the center of the air bag (**Figure 2**). The driver air bag was otherwise unremarkable. The interior inspection also revealed that the steering wheel rim was bent forward, approximately 1 centimeter (0.4 inches), in the upper quadrant. There was no evidence of steering column movement.

Figure 2: Case vehicle's driver air bag

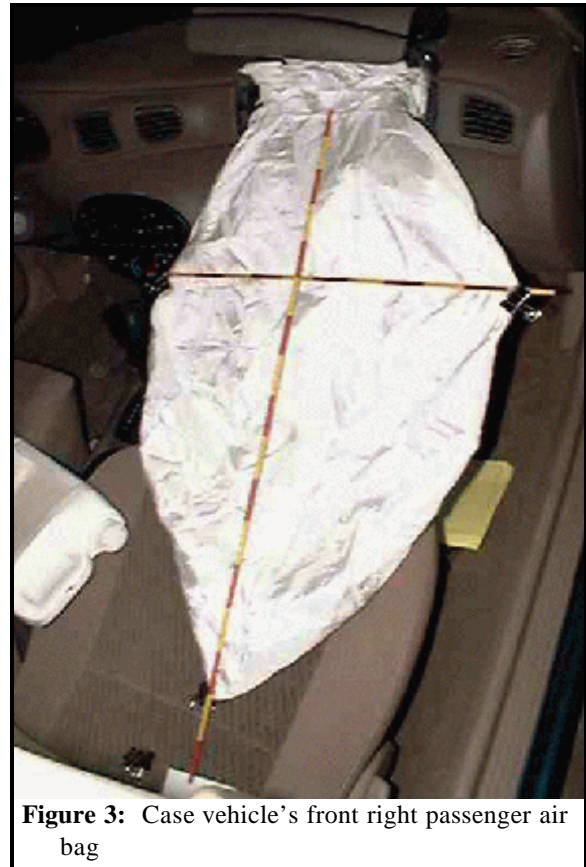
The front right passenger air bag module was located in the middle instrument panel and had a single cover flap. The vehicle inspection indicates that the air bag module's cover flap opened along the perforations with no evidence of damage to the cover flap or the surrounding areas of the instrument panel. The windshield, however, had an area of spider web cracking directly above the air bag module's cover flap. The front right passenger air bag was a vertical rectangle approximately 53 centimeters [21 inches] wide and 82 centimeters [32 inches] tall. There were two vent ports in the air bag's side panels, located approximately at the 10 and 2 o'clock positions, and no tether straps. There was no contact evidence on the air bag and no evidence of damage to the air bag (**Figure 3**).

Figure 3: Case vehicle's front right passenger air bag
