**VERIDIAN ON-SITE AIR BAG RELATED/ADULT PASSENGER  
FATALITY INVESTIGATION**

**VERIDIAN CASE NO. CA97-007  
VEHICLE: 1995 CHRYSLER NEW YORKER  
LOCATION: PENNSYLVANIA  
CRASH DATE: FEBRUARY 1997**

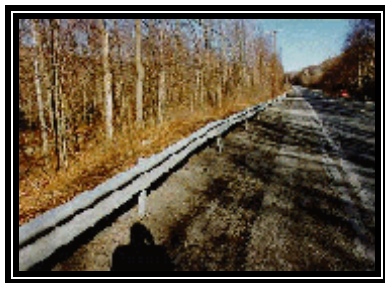
The front left corner area of the New Yorker impacted the W-beam guardrail resulting in minor damage to the vehicle. The 12 o'clock impact force redirected the vehicle in a clockwise (CW) direction which allowed the left rear area of the New Yorker to engage with the guardrail. The W-beam guardrail system consisted of a single rail with weak post I-beam supports spaced on 3.7 m (12.0') centers. The contact damage on the guardrail system was continuous with a maximum lateral displacement of 27.9 cm (11.0") to the corrugated beam (**Figure 3**).

**Figure 3. Deflection of the W-beam guardrail.**

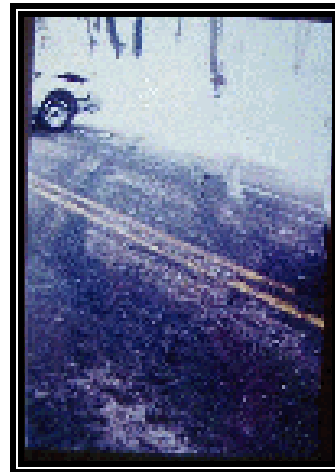
**Figure 4. On-scene police photograph of the vehicle's CW yaw skid pattern.**

The Chrysler separated from the guardrail and traversed the travel lanes of the roadway, initiating a slight CW yaw estimated at 8-10 degrees. This yaw pattern was evident by the vehicle's tire marks depicted in the on-scene police photographs (**Figure 4**). The vehicle departed the right (north) stone shoulder and mounted the base of an earth embankment with the front tires. The center frontal area of the New Yorker impacted a 30.4 cm (12.0") diameter tree that was located 3.2 m (10.5') outboard of the north edge line. The damage and trajectory algorithm of the WinSMASH program computed an impact speed of 22.4 km/h (13.9 mph). The 12 o'clock direction of force impact crushed the frontal structure of the vehicle, inclusive of the energy absorbing bumper system, radiator support panel, and the hood. The vehicle underwent a velocity change of 16.7 km/h (10.4 mph) with a longitudinal component of -16.6 km/h (-10.3 mph) and a lateral component of 2.3 km/h (1.4 mph). As a result of the tree impact, the frontal air bag system deployed. The vehicle rotated approximately 40 degrees CW as it rebounded from the tree impact and came to rest straddling the eastbound travel lane perpendicular to the roadway.

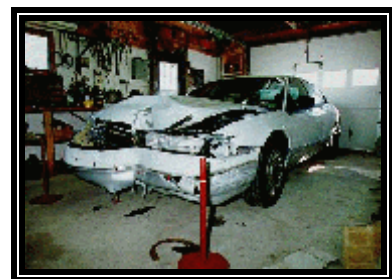
The initial contact damage with the W-beam guardrail system involved the front left corner area of the Chrysler New Yorker. The direct contact damage began on the corner of the bumper fascia and extended 26.0 cm (10.25") inboard. The contact abraded the bumper fascia and displaced the corner area of the fascia with no residual crush to the bumper structure (**Figure 5**). As the contact deflected the guardrail, the leading edge of the left front fender engaged against the rail. The contact displaced the left headlamp assembly, abraded the side aspect of the wrap-around bumper fascia, and fractured the composite left front fender. The damage extended 71.1 cm (28.0") longitudinally onto the left front fender and side aspect of the fascia.

**Figure 5. Front left bumper damage from the initial guardrail impact.**

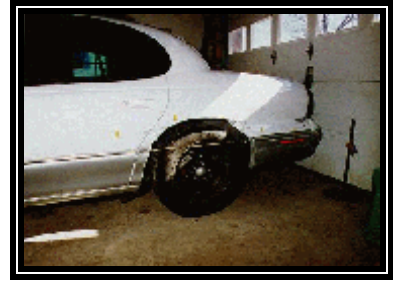
The guardrail system redirected the vehicle in a clockwise (CW) direction as it separated from the barrier. Due to this CW deflection, the left rear quarter panel subsequently impacted the W-beam in a sideswipe configuration, resulting in an impact force within the 12 o'clock sector. The direct contact damage began on the left rear door (21.4") forward of the left rear axle and extended 108.6 cm (42.75") rearward onto the left quarter panel, terminating at the rear bumper corner (**Figure 6**). A crush profile was documented for this impact and was as follows: C1 = 0.6 cm (0.25"), C2 = 3.2 cm (1.25"), C3 = 3.8 cm (1.5"), C4 = 1.0 cm (0.4"), C5 = 0.2 cm (0.1"), C6 = 0 cm.

**Figure 6. Secondary guardrail impact damage to the left rear quarter panel.**

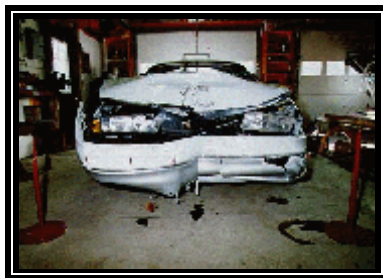
The center frontal area of the Chrysler subsequently impacted a 30.5 cm (12.0") diameter tree resulting in a 12 o'clock direction of force. Maximum bumper crush was 39.1 cm (15.375"), located on the bumper reinforcement bar immediately left of the vehicle's centerline. The direct contact damage began 5.1 cm (2.0") right of center and extended 19.1 cm (7.5") to the left. The narrow impact deformed the full frontal width of the vehicle resulting in a combined induced and direct damage width of 134.6 cm (53.0"). The impact crushed the bumper fascia, the styro-foam filler panel, and the bumper reinforcement bar. A crush profile was documented at the level of the reinforcement bar and was as follows: C1 = 5.7 cm (2.25"), C2 = 17.8 cm (7.0"), C3 = 32.4 cm (32.4"), C4 = 24.8 cm (9.75"), C5 = 6.4 cm (2.5"), C6 = 0 cm [-12.1 cm (-4.75")].

**Figure 7. Frontal damage resulting from the tree impact.**

Components damaged by the frontal impact included the bumper system, grille, hood, radiator support panel, radiator, and the air conditioning condenser.

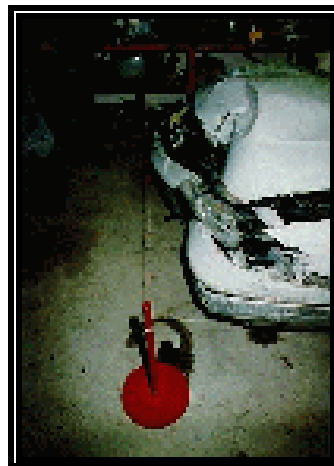
**Figure 8. Profile view documenting the depth of frontal crush.**

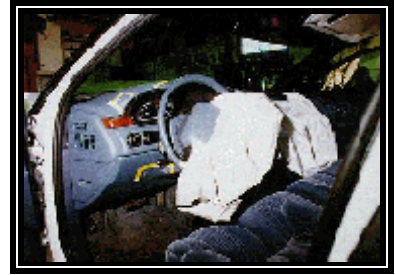
The 1995 Chrysler New Yorker was equipped with a frontal air bag system for the driver and right passenger positions (**Figure 9**). The system consisted of two radiator support mounted electro-mechanical crash sensors, the console mounted control module, and the conventionally mounted driver air bag module within the two-spoke steering wheel rim, and the top mounted passenger air bag module assembly. The system deployed as a result of the tree impact with no failures or defects noted.

**Figure 9. Deployed frontal air bags.**

The top panel of the passenger air bag yielded evidence of a restricted deployment based on transfers to the membrane. These black vinyl transfers extended 31.1 cm (12.25") laterally across the width of the bag at the inflator and extended 27.9 cm (11.0") rearward on the top panel, radiating to a width of 31.8 cm (12.5"). Within this transfer pattern was a faint make-up transfer that was located 6.4-10.8 cm (2.5-4.25")

inboard of the right seam and 11.4-19.1 cm (4.5-7.5") below the leading edge of the cover flap. There was no additional contact evidence or damage to the passenger side air bag.

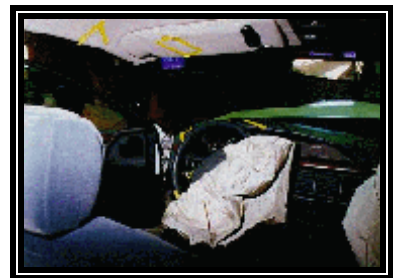
The driver's torso loaded the deployed front left air bag and compressed the expanded bag against the steering column. As a result of the thoracic loading, the energy absorbing steering column compressed approximately 2.5 cm (1.0"). There was no deformation of the steering wheel. The air bag provided the driver with a sufficient ride down of the crash forces and mitigated potential thoracic injury. His scalp contacted and scuffed the left sun visor 34.3-38.7 cm (13.5-15.25") left of center. There was no deformation to the visor and the integral vanity mirror remained intact. A scuff mark was noted to the side rail 27.9-32.4 cm (11.0-12.75") rearward of the windshield header. The driver's head probably impacted the left roof side rail as he rebounded from his initial trajectory during the post-crash spin-out of the vehicle. **Figure 11** is an overall view of the driver's trajectory and contact points.

**Figure 11. Driver's trajectory and contact points.**

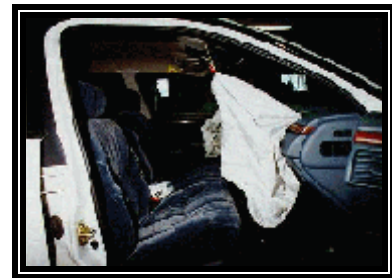
The right front passenger of the Chrysler New Yorker was a 66 year old female. The passenger was wearing a blue pullover-type sweater, denim jeans, and a leather-type jacket that was opened across the front of her body. In addition, the passenger was wearing a white knit scarf draped around her neck. She was not wearing the manual 3-point lap and shoulder belt system. Belt non-usage was confirmed by the lack of loading evidence on the system and the lack of routine usage indicators. Additionally, the first responders to the crash scene observed the passenger slumped in the center front position of the vehicle with the front right belt system stowed against the B-pillar. The upper D-ring was adjusted to the full-down position. The manually adjusted right front seat was positioned to a full rear track position with the seat back set to an angle of 18 degrees (**Figure 12**).

**Figure 12. Adjusted seat track position with respect to the front right air bag.**

The expanding air bag hyper-extended her neck which resulted in a C-spine fracture and complete transection of the cervical spinal cord. She was subsequently displaced upward and rearward by the bag toward the center front seated position.
