### ON-SITE ALLEGED INADVERTENT AIR BAG DEPLOYMENT INVESTIGATION

CASE NUMBER - IN97-010  
LOCATION - TEXAS  
VEHICLE - 1995 DODGE NEON  
CRASH DATE - February, 1997

December 3, 2002

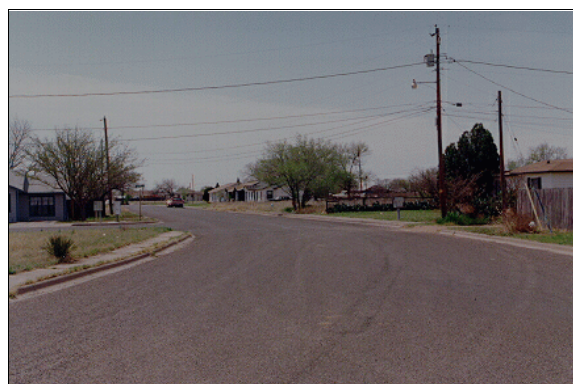
According to the Police Crash Report and the driver's interview, the case vehicle was traveling south in the southbound lane of a two-lane city street, negotiating a left curve and approaching a Tee intersection with another city street (**Figure 1**). The driver intended to turn left at the intersection and travel east. It was snowing and there was no other traffic present. As the driver was executing the left turn maneuver, the driver and right front passenger air bags deployed for no apparent reason. The driver claims that she lost control of the vehicle following the inadvertent air bag deployment and impacted the curb on the north side of the east-west street. The diagram on the Police Crash Report depicts the case vehicle at rest, headed east with its left front wheel against the curb (**Figure 2**).

**Figure 1:** Case vehicle's southerly travel path prior to first impact with west curb (case photo #01)

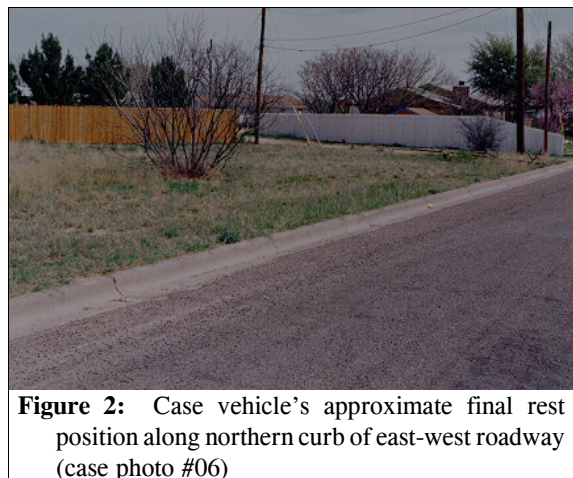
**Figure 2:** Case vehicle's approximate final rest position along northern curb of east-west roadway (case photo #06)

Our investigation indicates that as the case vehicle's driver attempted to negotiate the left curve in the snow, the case vehicle skidded essentially straight through the curve, with the wheels turned slightly to the left because the driver was attempting to steer leftward, and impacted the west curb with the right front wheel/undercarriage (**Figure 1** above). The sliding trajectory in combination with the leftward orientation of the front wheels and the slight negative crown of the roadway combined for added loading on the right front wheel assembly that enabled the right front undercarriage area to impact the curb, causing the air bags to deploy. The case vehicle's driver most likely over steered the case vehicle back onto the roadway, causing the case vehicle's right rear tire to scuff the curb (**Figure 3**) and the case vehicle to rotate counterclockwise. The case vehicle skidded through the intersection, entered the east-west roadway, and slid across the east-west roadway—while rotating counterclockwise. The case vehicle's left front wheel (**Figure 2** above) scraped along the north curb before the case vehicle came to rest heading east.

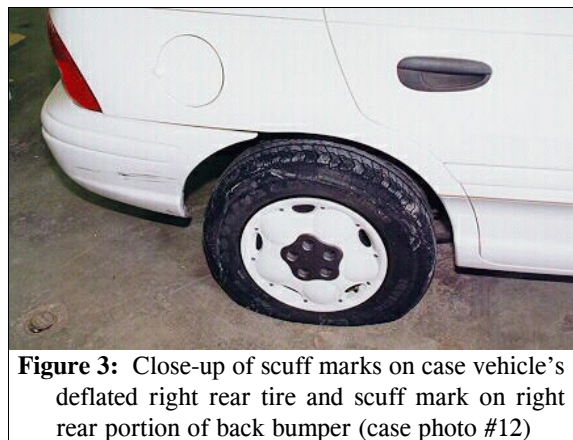
right front wheel and steering mechanism that was, in this contractor's opinion, sufficient to deploy the air bags. In addition, there were fresh scrub marks on the right front, left front, and right rear tires (**Figure 3**), and the right rear tire was deflated.

**Figure 3:** Close-up of scuff marks on case vehicle's deflated right rear tire and scuff mark on right rear portion of back bumper (case photo #12)

The right rear tire was deflated and had fresh abrasions on the sidewall (**Figure 3** above). Both front wheels were angled inward, approximately +10 degrees for the left front tire (**Figure 4**) and -20 degrees for the right front tire (**Figure 5**). The steering components on the right were embedded with soil and grass and the right tie rod was broken (**Figure 6**). There were light

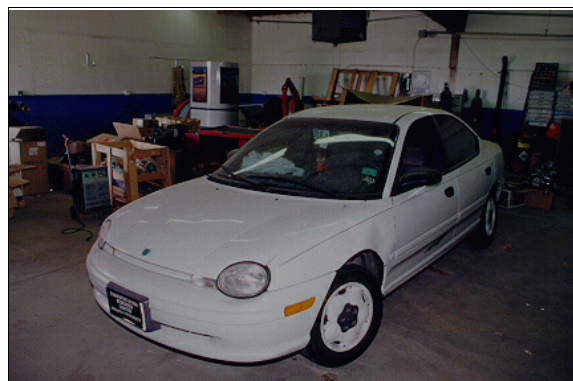
**Figure 4:** Case vehicle's front and left side showing no obvious contact damage and inward rotation of left front tire (case photo #08)

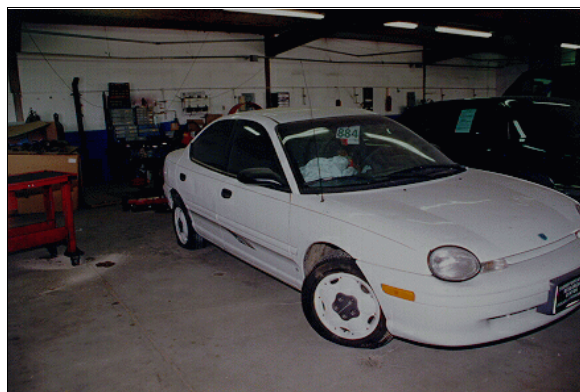
**Figure 5:** Case vehicle's front and right side showing no obvious contact damage inward rotation of right front tire (case photo #11)

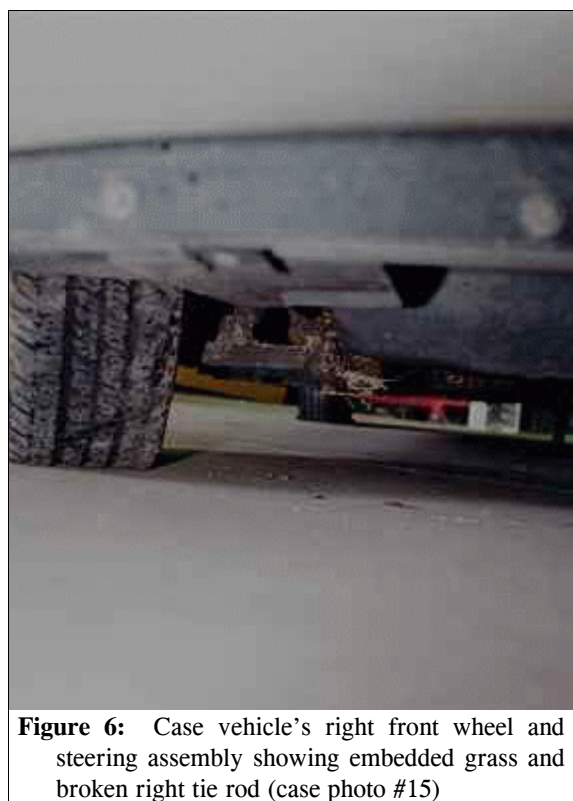
**Figure 6:** Case vehicle's right front wheel and steering assembly showing embedded grass and broken right tie rod (case photo #15)

The CDC for the first curb impact that deployed the air bags and caused the damage to the right front steering assembly is estimated as **00-UFRW-2**. This was an impact of low severity, approximately 14 - 22 km.p.h. (9 - 14 m.p.h.). The CDC for the second curb impact, with the right rear tire, is estimated as **03-RBWN-1**. The third curb impact, with the left front tire and wheel cover, is estimated as **11-LFWS-1**. The second and third impacts were very minor, leaving only scuffs and minor abrasions with impact three being a swiping-type impact as the vehicle came to rest against the north curb of the east-west roadway.

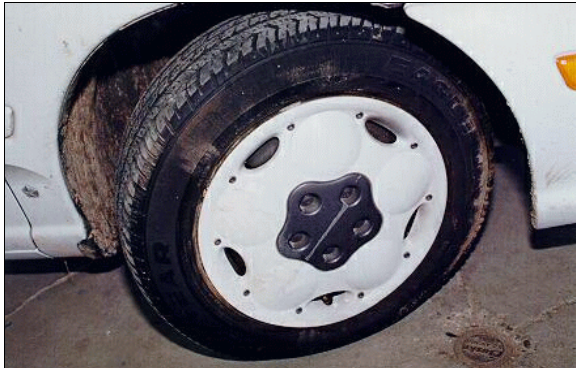
scuffs and soil on both front tires (**Figures 7 and 8**) and light scratches along the rim of the left front wheel cover (**Figure 8**). There were numerous light scratches on the underside of the front bumper cover, extending across the right two-thirds of the bumper. The left front door window glazing was broken out.

**Figure 7:** Close-up of scuff marks on case vehicle's inward rotated right front tire (case photo #14)

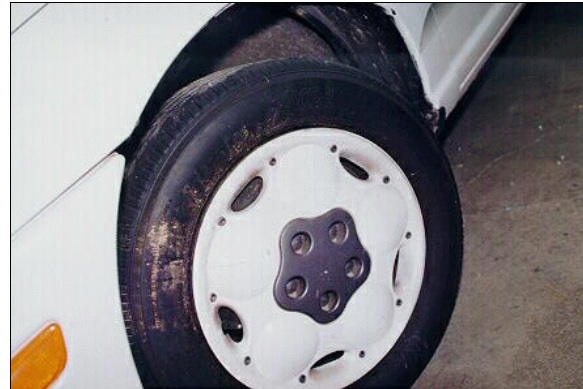
**Figure 8:** Close-up of scuffs and scrapes on case vehicle's inward rotated left front wheel from north curb impact (case photo #16)

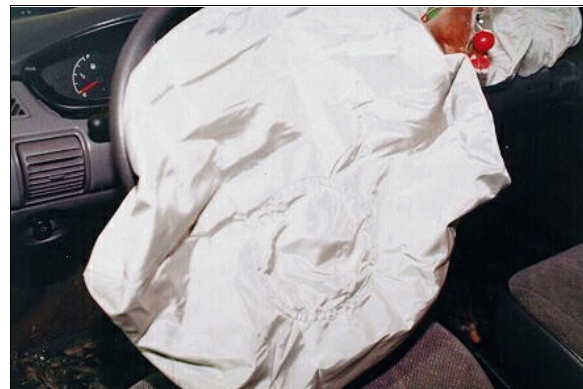
The case vehicle was equipped with a Supplemental Restraint System (SRS) that contained frontal air bags at the driver and front right passenger positions. Both frontal air bags deployed as a result of the front right undercarriage impact with the south curb. The driver's air bag was in the hub of the steering wheel and the front right air bag was in the mid-instrument panel location. For both air bags, the cover flaps opened at the designated tear points, and there was no evidence of damage to the air bags or the cover flaps. Both air bags were designed with two tethers. The driver air bag had one vent port, approximately 3 centimeters (1.2 inches) in diameter, located at the 12 o'clock position. The front right air bag also had one vent port, approximately 6 centimeters (2.4 inches) in diameter, located at the 12 o'clock position. There was no contact evidence readily apparent on the driver's air bag (**Figure 9**). There was an area of oil/skin transfer on the front right air bag, just above the top seam at the middle of the bag (**Figure 10** below). There was no other evidence of occupant contact on the interior surfaces of the

**Figure 9:** Case vehicle's deployed driver air bag showing no obvious evidence of occupant contact (case photo #19)

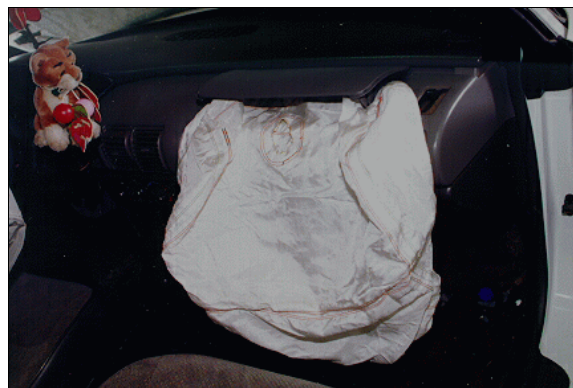
**Figure 10:** Case vehicle's deployed front right passenger air bag (case photo #22)
