**CALSPAN ON-SITE AIR BAG/DRIVER FATALITY INVESTIGATION
CALSPAN CASE NO. CA97-013
VEHICLE: 1994 FORD PROBE
LOCATION: MAINE
CRASH DATE: MARCH, 1997**

<p>14. <i>Sponsoring Agency Code</i></p>	
<p>15. <i>Supplementary Notes</i> On-site investigation of a single vehicle crash that resulted in air bag deployment and the death of the 51 year old male driver.</p>			
<p>16. <i>Abstract</i></p> <p>This on-site investigation focused on the injury mechanisms that resulted in the death of a 51 year old male driver of a 1994 Ford Probe. The Probe was equipped with frontal air bags which deployed during the crash for the driver and right passenger position. The driver lost control of the Probe as he was traveling on a snow-covered state route with a left curve and negative grade during a heavy wet snowfall that resulted in several inches on snow accumulation on the asphalt road surface. The vehicle yawed slightly in a clockwise direction and impacted a W-beam guardrail system that bordered a quadrant of an intersection. The impact involved the front bumper fascia of the Probe which crushed the bumper structure to a residual depth of 1.5 cm (0.6") at the centerline of the vehicle. The Probe unde

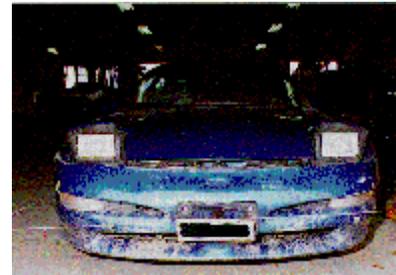
Figure 1. Frontal damage to the 1994 Ford Probe.

The 1994 Ford Probe sustained minor frontal damage as a result of the impact sequence with the struck W-beam guardrail. The direct contact damage consisted of abrasions across the full width of the bumper fascia. The overall length of the contact damage was 127.6 cm (50.25"). Measurement stands were positioned at the corners of the vehicle which reflected the overall length and width of the Ford Probe. A crush profile was subsequently documented for the frontal damage. Based on the placement of the stands, the vehicle sustained a maximum crush depth of 1.5 cm (0.6") that was located 14.0 cm (5.5") right of center. The mid aspect of the compressible bumper fascia sustained minimal residual crush while the outboard aspects of the bumper rebounded to its original length. The residual crush profile was at bumper level as follows: C1 = 0 cm, C2 = 0 cm, C3 = 1.3 cm (0.5"), C4 = 1.5 cm (0.6"), C5 = 0 cm, and C6 = 0 cm. The Collision Deformation Classification (CDC) for this impact event was 12-FDEW-1.

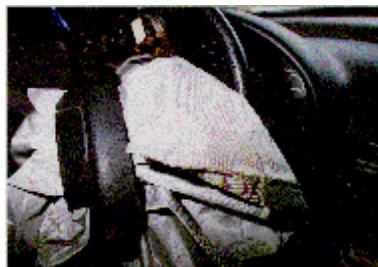
Figure 2. Altered deployment path of the driver air bag.

The front driver air bag's deployment path was impeded by the forward position of the driver. As a result, the lower half of the air bag membrane deployed from the H-configuration module cover flaps while the upper half of the bag deployed between the module/spoke cover and the steering wheel rim. As a result, the cover separated from the mounting bracket. Fabric transfers from the driver's sport coat were present on the back side of the upper half of the bag. These are further discussed in the *Automatic Restraint System* section of this summary report.

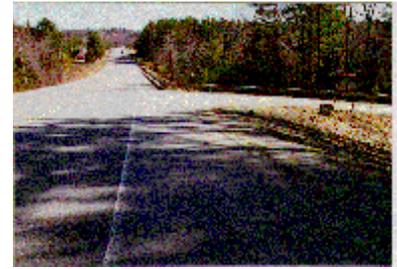
Figure 3. Overview of the crash scene.

The crash occurred during nighttime hours on a rural two-lane state route at the mouth of a 3-leg T intersection with a private road (**Figure 3**). The roadway was snow covered due to a heavy, wet snowfall with temperatures in the 0 degree C (30 degree F) range. Visibility was rated by the investigating officer as poor at the time of the crash. On the approach to the crash scene, the roadway was curved to the left with a negative grade of 5 degrees. Both travel lanes were bordered by wide asphalt shoulders. A W-beam guardrail paralleled both roadways at the northeast quadrant of the intersection which protected traffic from a steep negative embankment. The posted speed limit was 89 km/h (55 mph).

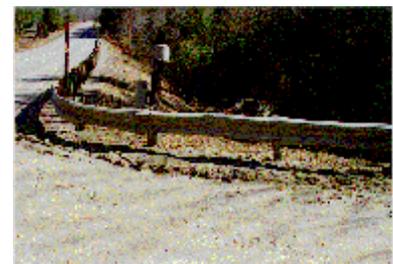
The Ford Probe impacted the continuous W-beam guardrail system that bordered the southeast quadrant of the intersection (**Figure 4**). The front bumper fascia of the Probe contacted the W-beam rail between two strong post guardrail posts, crushing the beam to a depth of 21.3 cm (8.0"). The direct contact damage on the fascia began 58.4 cm (23.0") right of center and extended 127.6 cm (50.25") to the left front bumper corner. Residual crush at bumper level was 1.5 cm (0.6") located at the mid point of the fascia. There was crush at the locations of C1-C2 and C5-C6. Vehicle damage was limited to the bumper fascia and the reinforcement bar. The resultant direction of force was within the 12 o'clock sector with an estimated velocity change of 13-16 km/h (8-10 mph). This threshold level impact induced deceleration was sufficient to deploy the Ford Probe's driver and passenger side air bag system. In addition, the guardrail impact involved an elongated time frame (delta T) which resulted in air bag deployment late in the crash sequence.

Figure 4. Struck guardrail.

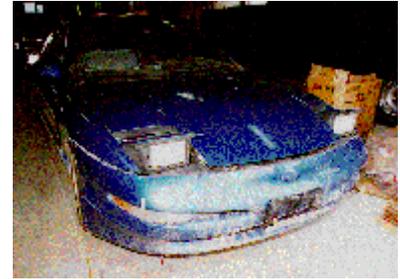
Figure 5. Overall view of the Ford Probe.

The involved vehicle was a 1994 Ford Probe SE, two-door hatchback (**Figure 5**). The Probe was identified by vehicle identification number (VIN) 1ZVLT20A8R5 (production number deleted) and was manufactured on 2/21/94. The odometer reading at the time of our inspection was 96,280 km (59,827 miles). The vehicle was equipped with P205/55R15 all-season radial tires. The rear tires were recently replaced and had a tread depth of 7.9 mm (10/32"). The front drive tires were in worn condition with a measured depth of 1.6 mm (2/32") for the left front and 2.4 mm (3/32") for the right front. The drive train consisted of a transverse mounted 4-cylinder, 2.0 liter engine and a 4-speed automatic overdrive transmission with a console mounted transmission selector lever. In addition to the frontal air bags for the driver and right passenger positions, the Probe was equipped with front bucket seats with manual adjusters, power windows and door locks, and a tilt steering wheel.

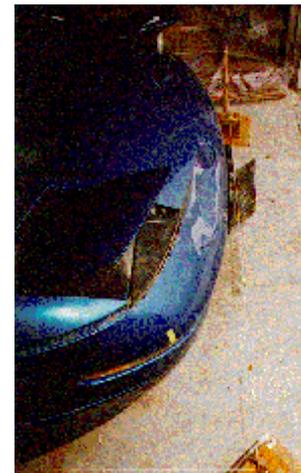
Figure 6. Profile view of the crush profile.

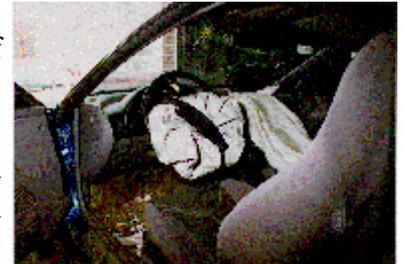
The interior of the Ford Probe sustained minor damage that was associated with air bag deployment and driver contact (**Figure 7**). There was no deformation that resulted from the exterior damage or intrusion of the passenger compartment.

Figure 7. Overall view of the deployed frontal air bags and the driver contact points.

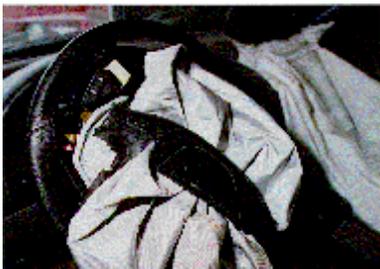
The front driver air bag was concealed within a module cover that consisted of symmetrical cover flaps in terms over overall height and width. The vertically oriented hinge points of the flaps varied in width due to the taper of the flaps. As a result of the forward positioned driver at deployment, the normal deployment path of the cover flaps and air bag membrane was impeded. Although the cover flaps opened at the designated tear points, the expansion of the bag was restricted by the position of the driver. Therefore, the lower half of the air bag membrane deployed through the module cover flaps and the upper half expanded between the module cover assembly, separating the cover from the steering wheel mount (**Figure 8 and 9**).

Figure 8. View of the deployed driver air bag through the top of the separated module cover.

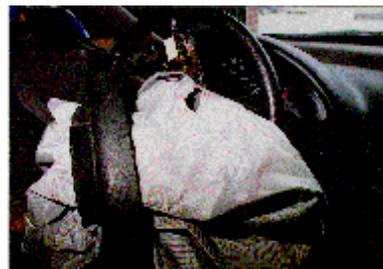
Figure 9. Additional view of the upper air bag membrane and red fabric transfer.

A second fabric transfer was located on the bag in the vicinity of the left vent port. This transfer extended 8.3 cm (3.25") on the back of the bag and wrapped 7.6 cm (3.0") onto the face of the bag, originating at the 11 o'clock sector (**Figure 9**). This transfer resulted from expansion against the red sport coat that was visible in the autopsy photographs of the driver's body. The driver bag was not damaged as a result of the impeded deployment path of the bag.

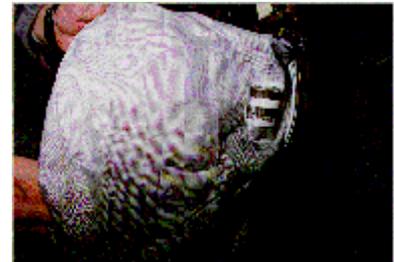
The back panel of the driver air bag (panel exposed toward front of vehicle opposite of driver) contained a blue/gray fabric transfer that extended from the inflator area of the bag toward the peripheral seam (**Figure 10**). The transfer originated near the above mentioned label with a width of 5.1 cm (2.0") and extended 16.5 cm (6.5") in length toward the seam. The transfer flared to a maximum depth of 19.7 cm (7.75"). This transfer resulted from bag membrane expansion against the lining of the driver's red sport coat.

The front right passenger air bag deployed from a mid mount module assembly in the right instrument panel. The single cover flap opened at the lower and side aspects of the flap and was hinged at the top surface to the upper instrument panel. The overall dimensions of the flap were **Figure 10. Blue/gray fabric transfer to driver air bag.**

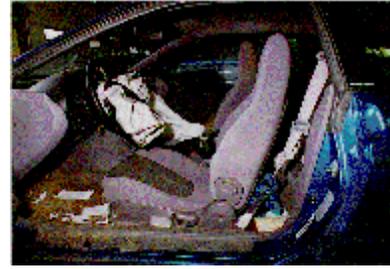
inspection, the seat track was positioned 13.7 cm (5.4") rearward of the full forward position and 8.6 cm (3.4") forward of the full rear position (**Figure 11**). The seat back with the integral head restraint was reclined several positions rearward of the vertical. The driver was wearing gray slacks, a white long sleeve shirt with a black tie, and a red sport coat with a bluish/gray synthetic lining.

Figure 11. Overall view of the driver's seated position.
