On-Scene / Vehicle to Vehicle to Vehicle
Dynamic Science, Inc. / Case Number: DS97013
1995 Hyundai Accent
Utah
June/1997

1. Report No. DS97013		2. Government Accession No.		3. Recipient Catalog No.	
4. Title and Subtitle In-Depth Accident Investigation				5. Report Date June, 1997

Description:	This case was initiated in response to a report of an air bag related fatal injury to a child. The 3 month-old-child was restrained in a rearward facing child restraint in the right front seat.
Investigation Type:	On-Scene
Crash Location:	Utah
Crash Date:	June, 1997
Notification Date:	June, 1997
Field Work Completed:	June, 1997

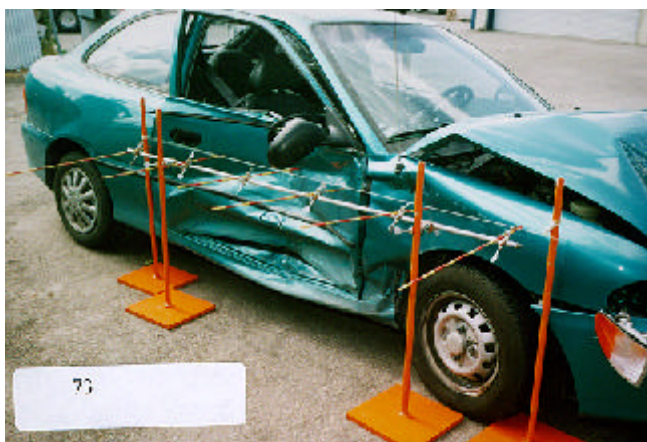
Description: 1995 Hyundai Accent 3-door hatchback
 VIN: KMHVD14N9SU01XXXX
 Odometer: 122,875 km (76,353 miles)
 Engine: 1495 cc OHC L4
 Reported Defects: None
 Cargo: None visible
 Damage Description: Major damage to the right side. Minor damage to the right rear, and moderate damage to the front bumper, primarily on the left side with an override of the hood.
 CDC Impact # 1 Vehicle 1 vs Vehicle 2: 02RYEW3

Delta V ³ :	Total	23.0 km/h (14.3 MPH)
	Longitudinal	-7.9 km/h (-4.9 MPH)
	Latitudinal	-21.6 km/h (-13.4 MPH)
	Energy	14,676 joules (10,834 ft-lbs)

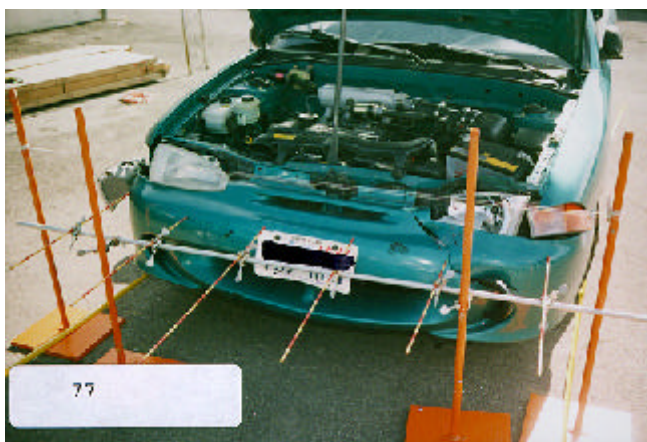
CDC Impact # 3 Vehicle 1 vs Vehicle 3: 12FYEW1

Impact Speed:	Unknown	
Delta V ⁴ :	Total	19.5 km/h (12.1 MPH)
	Longitudinal	-19.2 km/h (-11.9 MPH)
	Latitudinal	3.4 km/h (2.1 MPH)
	Energy	12,099 joules (8,927 ft-lbs)

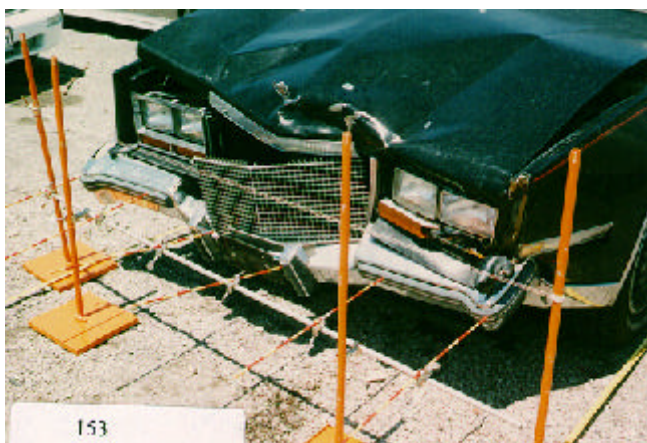
CDC: 11FYEW1

Damage Description: Major damage across the front bumper. Minor damage to the left side. Vehicle was driveable and impounded by the police.

Impact Speed:	Unknown	
Delta V ⁵ :	Total	12.6 km/h (7.8 MPH)
	Longitudinal	-11.8 km/h (-7.3 MPH)
	Latitudinal	4.3 km/h (2.7 MPH)
	Energy	21,186 joules (15,632 ft-lbs)

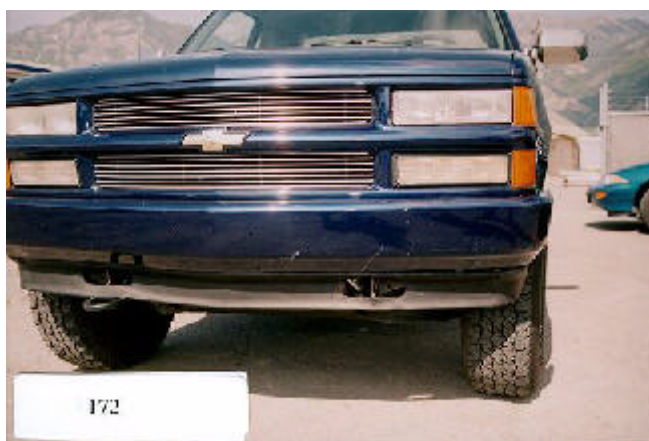
CDC: 11FYLW1

Damage Description: Minor damage to the front bumper, primarily on the left corner. The chain hook had been torn off and embedded in the bumper of Vehicle 1.

Impact Speed: 0.0 km/h (0.0 MPH), stopped waiting at the stop sign

Total	9.1 km/h (5.7 MPH)
Longitudinal	-8.6 km/h (-5.3 MPH)
Latitudinal	3.1 km/h (1.9 MPH)
Energy	10,368 joules (7,651 ft-lbs)

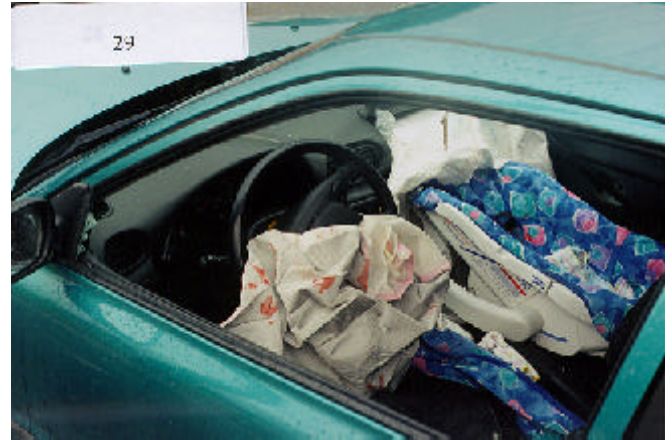
Figure 7. Position of child restraint at the scene.

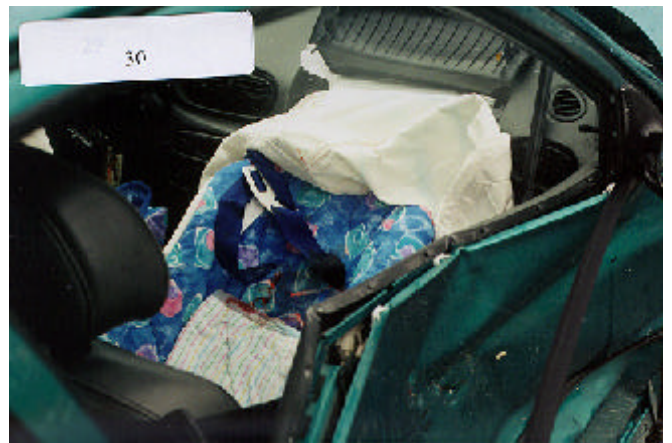
Figure 8. Position of child restraint at the scene.
