**CALSPAN REMOTE CHILD PASSENGER/AIR BAG FATALITY INVESTIGATION
CALSPAN CASE NO. CA97-016
LOCATION: PUERTO RICO
VEHICLE: 1996 HYUNDAI ACCENT
CRASH DATE: APRIL, 1997**

1. <i>Report No.</i> CA97-016	2. <i>Government Accession No.</i>	3. <i>Recipient's Catalog No.</i>	
4. <i>Title and Subtitle</i> Calspan Remote Child Passenger/Air Bag Fatality Investigation Vehicle: 1996 Hyundai Accent Location: Puerto Rico		5. <i>Report Date:</i> July, 1999

14. <i>Sponsoring Agency Code</i>	
15. <i>Supplementary Notes</i> Remote investigation of a child passenger fatality that resulted from the deployment of the frontal air bag system in a 1996 Hyundai Accent.

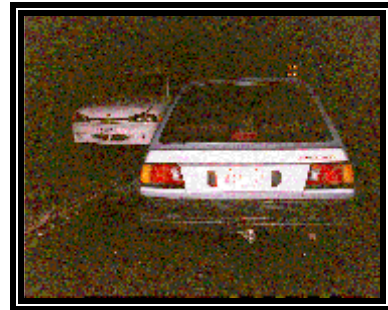
Figure 1. Involved Hyundai and Toyota Tercel.

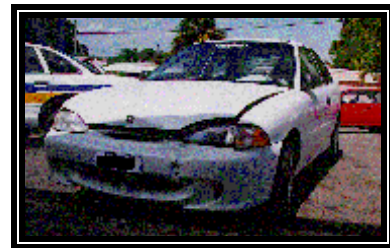
The frontal area of the Hyundai Accent impacted the rear of the Toyota Tercel in a slightly off-set configuration involving the left two-thirds of the frontal plane of the Hyundai (**Figure 2**) against the right two-thirds of the Tercel. The pre-crash braking action by the driver of the Hyundai compressed the front suspension of the vehicle. This allowed the front bumper fascia of the Hyundai to impact the Tercel's Class I trailer hitch and the exhaust tailpipe. Both of these components extended below the level of the Tercel's bumper. The trailer hitch deformed the Hyundai's bumper fascia left of center below the inboard aspect of the left headlight assembly. The tailpipe of the Tercel produced a semi-circular gouge to the plate that was affixed to the front license plate mounts (front license plate was not required). The impact crushed the energy absorbing front bumper of the Hyundai which allowed the hood face to engage against the bumper of the Tercel. Minor damage resulted to the involved vehicles. Resultant directions of force were 12 o'clock for the Hyundai and 06 o'clock for the struck Toyota. The Hyundai underwent a longitudinal deceleration that was sufficient to deploy the vehicle's frontal air bag system. Velocity changes were estimated at 13-16 km/h (8-10 mph) for both vehicles. The

Figure 2. Frontal damage to the Hyundai Accent.

The Hyundai sustained minor frontal damage as a result of its impact with the rear of the Toyota Tercel. The front bumper of the Hyundai partially underrode the rear bumper of the Tercel. Residual crush was minimal as the energy absorbing bumper system appeared to have rebounded following the impact. The direct contact damage began approximately 25 cm (10") right of center and extended to the left bumper

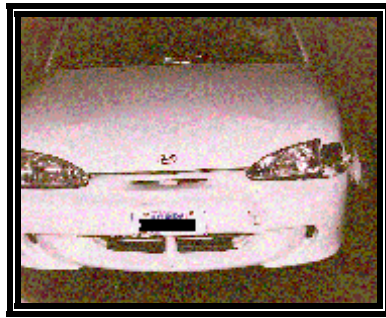
corner. Superficial transfers were evident across the left two-thirds of the frontal plane. The tailpipe of the Tercel penetrated the front dealer plate that was fastened to the center license plate mounting system. The trailer hitch of the Tercel deformed the Hyundai's front bumper fascia directly below the inboard aspect of the left headlamp assembly (**Figure 3**). The hood face of the Hyundai engaged against the rear bumper of the Tercel which buckled the forward aspect of the hood. In addition, the left turn signal assembly was displaced from its fender mount. The Collision Deformation Classification (CDC) for this impact was 12-FYEW-1.

Figure 3. Contact damage to the front bumper fascia.

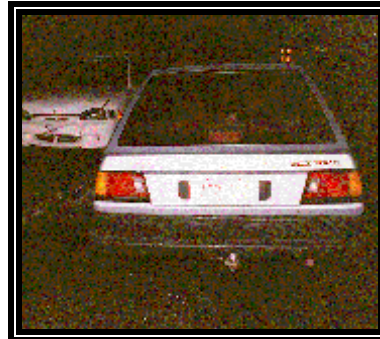
Figure 4. Rear impact damage to the Toyota.

The Toyota Tercel sustained minor damage to the rear of the vehicle. Although the available photographs failed to document a crush depth, minimal displacement of the bumper probably occurred. The tongue of the center mounted trailer hitch was deformed in a downward direction (**Figure 4**) from contact with the Hyundai. The tailpipe, however, did not appear to be displaced. The CDC for this damage pattern was 06-BZLW-1.

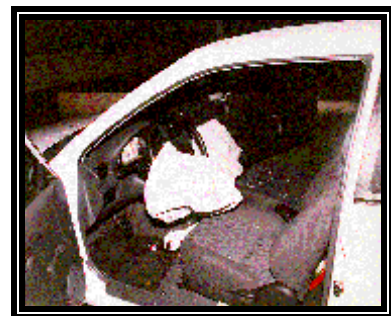
The driver air bag deployed from an H-configuration module assembly. Base on previous investigations, the upper cover flap was 12.1 cm (4.75") in width at the tear seam and 7.6 cm (3.0") in height. The lower cover flap maintained the same width, however, the height was 5.7 cm (2.25"). The driver bag was approximately 66.0 cm (26.0") in diameter in its deflated state and was vented by two 2.5 cm (1.0") diameter ports located at the 10 and 2 o'clock positions. The bag was tethered by two wide band internal straps. The deployed driver air bag is shown in **Figure 5**.

Figure 5. Deployed driver air bag and adjusted seat track position.

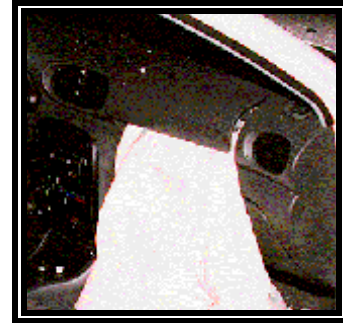
The passenger air bag in the Hyundai Accent was mounted in a mid mount configuration in the right instrument panel. The single cover flap was hinged at the top surface and opened at the designated side and bottom tear seams. Again, based on previous investigations, the vinyl cover flap was 15.2 cm (6.0") in height and 35.3 cm (13.9") in width. The on-scene police photographs documented a faint horizontal transfer to the leading edge of the cover flap that appeared to be tissue. The transfer extended across the right two-thirds of the leading edge (**Figure 6**). This transfer resulted from contact against the chin and right arm of the child passenger. Additional faint vertically oriented scuffs were present of the mid aspect of the cover flap at the apex of the contour. These scuff marks were related to the extended arms of the child passenger.

Figure 6. Deployed front right air bag with tissue transfer on the leading edge of the cover flap.

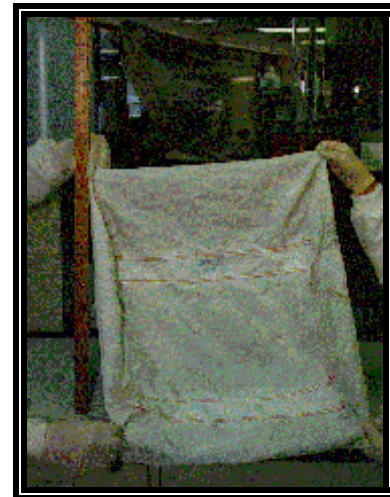
Figure 7. Removed front passenger air bag.

The passenger air bag module of the Hyundai involved in this crash was removed from the vehicle and photographed by the medical examiner's staff (**Figure 7**). No distinct occupant contacts (i.e., tissue transfers) were visible on the bag membrane. Two vertically oriented transfers (probable vinyl) were noted to the face of the bag centered at the horizontal mid point and over the top tether stitching. These transfers probably resulted from bag expansion against the inside surface of the module cover flap as the child passenger restricted the deployment path of the flap. The ME's staff used a yardstick as a point of reference which indicated the height of the bag was approximately 50.8 cm (20.0"). In a previous investigation, the overall dimensions of the passenger bag were 54.0 cm (21.25") vertically and 45.7 cm (18.0") in width. There was no damage (i.e., tears) to the deployed passenger air bag membrane.

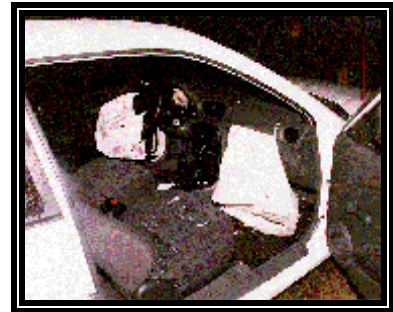
The 18 month old child passenger was positioned in the front right of the Hyundai Accent. It was unknown if the child was in a seated position pre-crash or in another position, either on the seat or standing in front of the front passenger air bag module assembly. Base on the on-scene police photographs, the front right seat was positioned in a mid track position with the seat back support set to a slight recline position (**Figure 8**). The child passenger was not wearing the manual 3-point lap and shoulder belt system. It should be noted that this child passenger should have been restrained in a forward facing child restraint in the rear seat of the vehicle.

Figure 8. Adjusted seat track position and the deployed passenger air bag.
