INDIANA UNIVERSITY

TRANSPORTATION RESEARCH CENTER

ON-SITE AIR BAG NON-DEPLOYMENT INVESTIGATION

CASE NUMBER - IN97-016
LOCATION - KENTUCKY
VEHICLE - 1995 CHEVROLET ASTRO CS
CRASH DATE - January, 1997

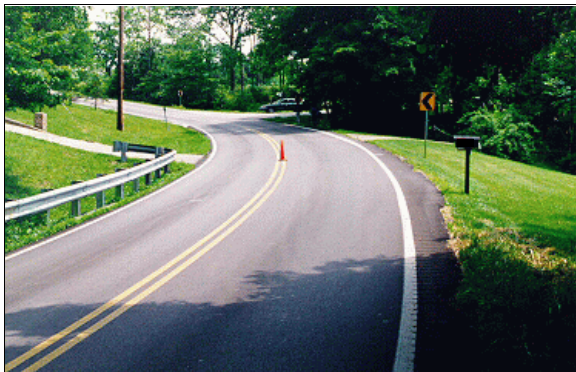
Figure 1: Case vehicle's southeastward travel path in left-hand curve just prior to impact in southeast-bound lane (i.e., orange cone on centerline marks approximate impact area); Note: case vehicle had moved toward right (southwest) shoulder attempting to avoid Mack truck which was in a clockwise yaw (case photo #02)

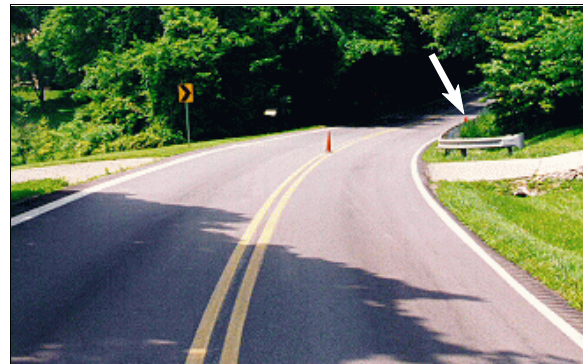
Figure 2: Mack truck's northwestward travel path after re-entering roadway from right (northeast) shoulder; Note: Mack went into a clockwise yaw, crossed the centerline, and struck the case vehicle in the opposing lane (near orange cone on the centerline) before sliding into the guardrail off the right-hand side of the road near the high-lighted (arrow) orange cone (case photo #10)

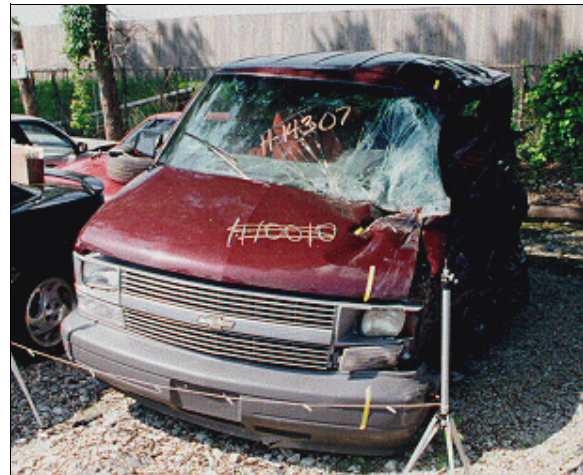
Figure 3: Case vehicle's very narrow front left corner impact; Note: yellow tape on bumper indicates direct damage width from contact with Mack truck's rear tandem wheels and yellow tape on hood shows direct damage width from impact with Mack's dump truck bed (case photo #20)

The case vehicle's front left corner impacted the left rear tandem wheels of the Mack truck. The front left corner sustained a narrow end engagement with 17 centimeters (6.7 inches) of direct damage width to the front bumper. The maximum crush to the front left bumper corner was 9 centimeters (3.5 inches); however, direct damage extended along the entire left side of the case vehicle for a total distance of 433 centimeters (170.5 inches) and involved the case vehicle's hood, "A"-pillar, "B"-pillar, "C"-pillar, and "D"-pillar. There was approximately 10 to 15 centimeters (3.9 to 5.9 inches) of outside intrusion along the entire left side (sill level and above) of the greenhouse area. The left fender and left front door were impacted by the Mack truck's rearmost, left dual wheel while the hood and upper portions of the pillars were impacted by the left rear corner of the Mack truck's dump truck bed (**Figure 12**). The case vehicle's left front wheel was pushed rearward 12 centimeters (4.7 inches), shortening the wheelbase.

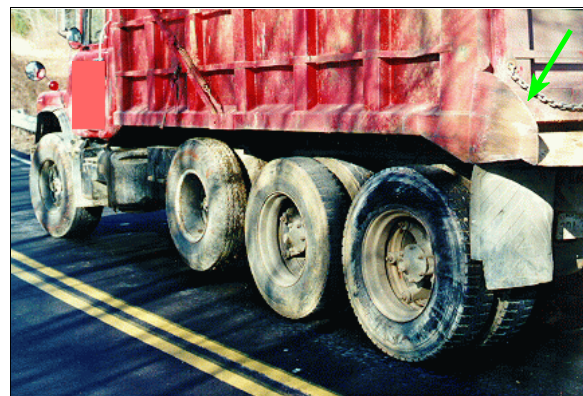
Figure 4: Mack's left side viewed from left of back showing minimal damage (i.e., scuffing) to left rear tandem wheels and scrapes on the rearward protrusion of the left back corner of the dump truck's bed (case photo #52)

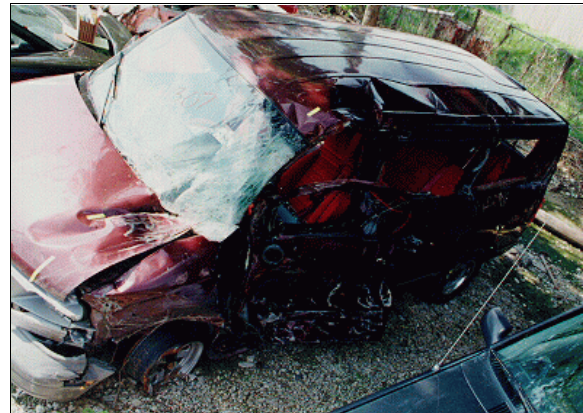
intrusion along the whole left side greenhouse area (Figure 5).

Figure 5: Overhead left view of case vehicle's left side damage from impact with Mack truck's left rear tandem wheels and left back corner of the bed of the dump truck; Note: absence of left front tire and "A"- through "D"-pillar damage (case photo #25)

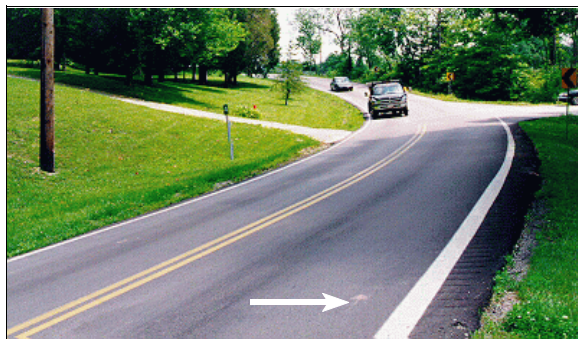
Figure 6: Case vehicle's southeastward path of travel, straddling right edge line, near point of impact; Note: gouge mark on pavement indicates approximate point of impact and case vehicle begins eastward post-impact path of travel across roadway toward mile marker post and gravel driveway (case photo #04)

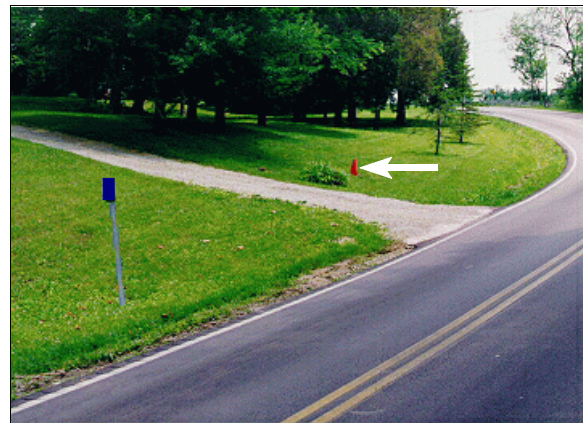
Figure 7: Case vehicle's eastward, post-impact, path of travel across roadway, right of mile marker post, across gravel driveway, and into a tree before rebounding and coming to rest heading south-southeast near orange cone (case photo #05)

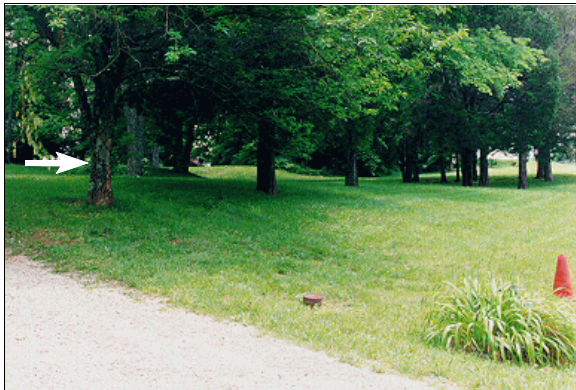
Figure 8: Case vehicle's eastward travel path across gravel driveway where its front left struck a tree before being redirected and coming to rest heading south-southeast near orange cone (case photo #07)

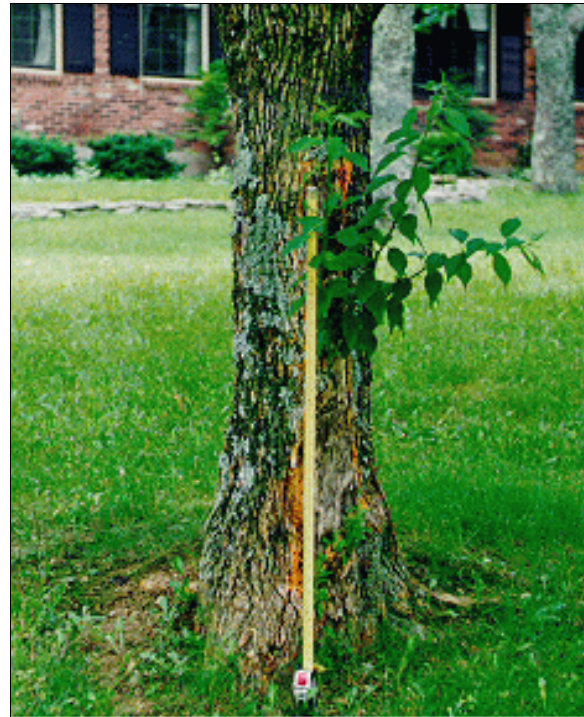
Figure 9: Close-up of yard tree impacted by front left of case vehicle prior to its being redirected south-southeastward to final rest (case photo #08)

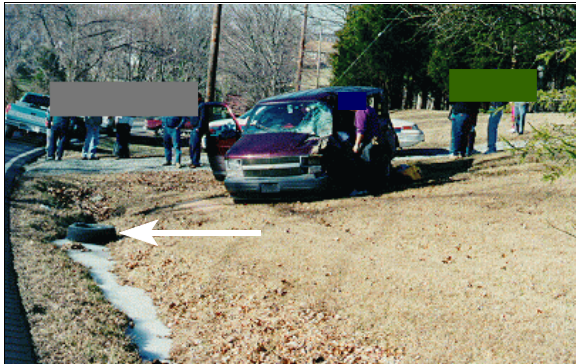
Figure 10: On-scene northwestward view of case vehicle's final rest position, heading south-southeastward, after striking and being redirected from tree; Note: case vehicle's left front tire in ditch (case photo #18)

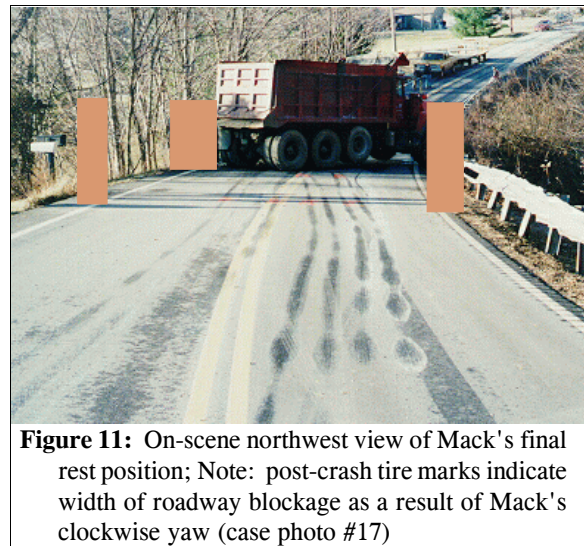
Figure 11: On-scene northwest view of Mack's final rest position; Note: post-crash tire marks indicate width of roadway blockage as a result of Mack's clockwise yaw (case photo #17)

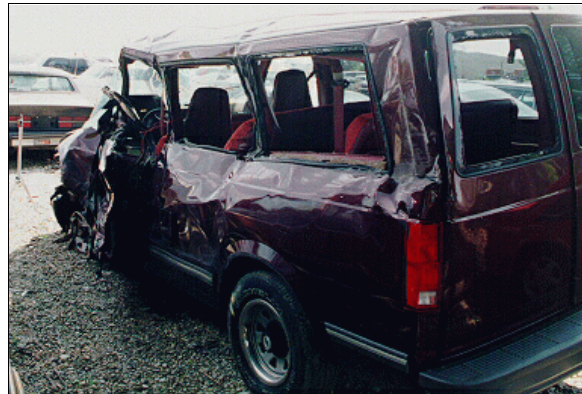
Figure 12: Case vehicle's left side viewed from left of back showing contact damage to all four pillars from impact with rearward protruding corner of Mack's dump truck bed (case photo #26)

window glazing. All of these components were damaged during the vehicle-to-vehicle impact. During the case vehicle's impact with the Mack truck, the Mack truck's left, rearmost, outside wheel rim sliced the case vehicle's left front tire, from the bead to the tread, on the outside sidewall deflating it. That tire separated from the wheel and came to rest in the trafficway's northeast drainage ditch, some 2.4 meters (8 feet) in front of the case vehicle's final rest position (**Figure 10** above). The impact with the tree (**Figures 8 and 9** above) was also to the front left corner of the case vehicle, partially masking the damage caused by contact with the Mack truck. There was lateral intrusion to the case vehicle's driver position, the second seat left position, and the third seat left position from the side panel, "A" through "D" pillars, and the roof side rail.

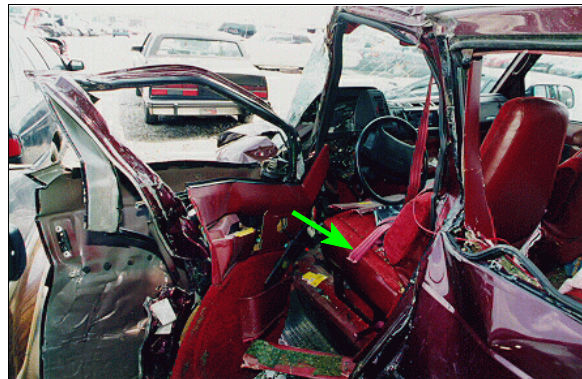
Figure 13: Closer-up view of direct damage to case vehicle's driver door and "A"- and "B"-pillars; Note: intrusion into driver seating area, cut seat belt, and non-deployment of driver's air bag (case photo #38)

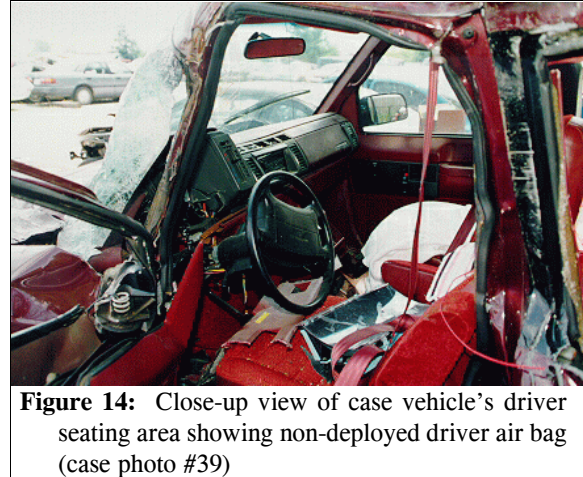
Figure 14: Close-up view of case vehicle's driver seating area showing non-deployed driver air bag (case photo #39)

The driver's air bag was located in the steering wheel rim and the module's cover flaps were in the symmetrical "H"-configuration. The cover flap dimensions were not measured. With no deployment, the air bag's dimensions and the existence and size of tethers and vent ports are unknown. An inspection of the case vehicle's steering wheel rim showed no visible evidence of deformation; however, post-crash the steering column's shear capsule was completely disengaged from the dash and, according to a police officer at the scene, had pinned the case vehicle's driver against her seat back.

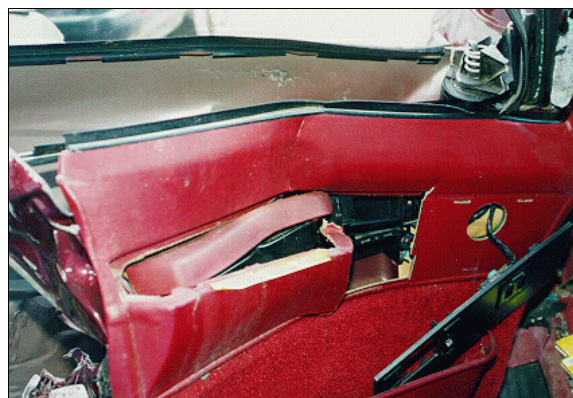
Figure 15: Close-up of interior surface of case vehicle's left front door panel; Note: evidence of driver contact (case photo #42)

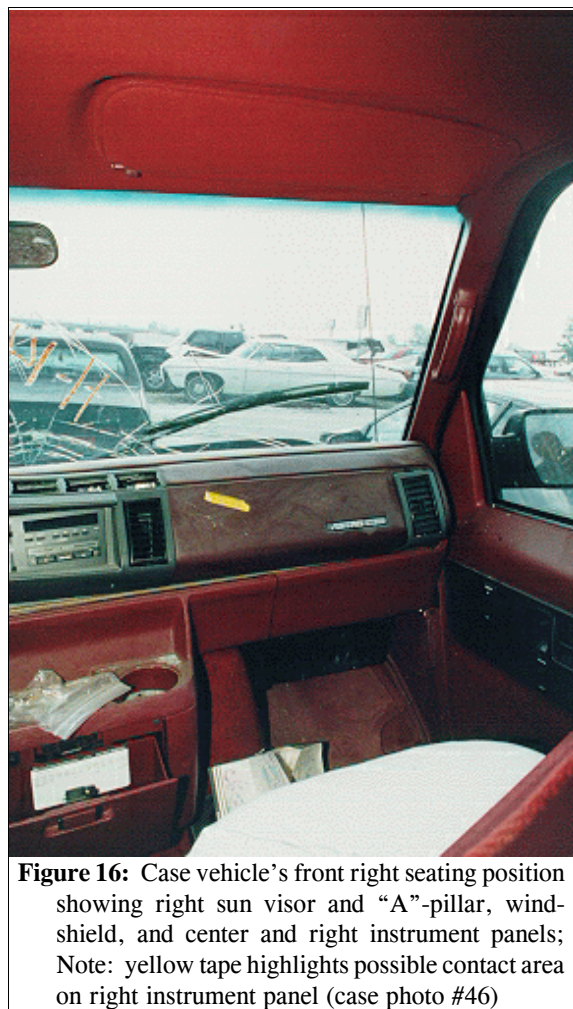
Figure 16: Case vehicle's front right seating position showing right sun visor and "A"-pillar, windshield, and center and right instrument panels; Note: yellow tape highlights possible contact area on right instrument panel (case photo #46)

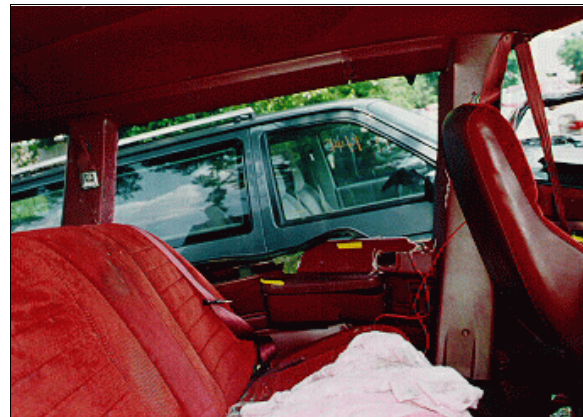
Figure 17: Case vehicle's second seating area showing occupant contact evidence to left side panel and intrusion into second row bench seat, causing serious injuries to second seated left passenger (case photo #47)
