On-Scene / Vehicle to Vehicle
Dynamic Science, Inc. / Case Number: DS97017
1997 Mercury Tracer LS
Arizona
July/1997

1. Report No. DS97017		2. Government Accession No.		3. Recipient Catalog No.	
4. Title and Subtitle In-Depth Accident Investigation				5. Report Date November/1997

Dynamic Science, Inc.
Accident Investigation
Case Number: DS97017

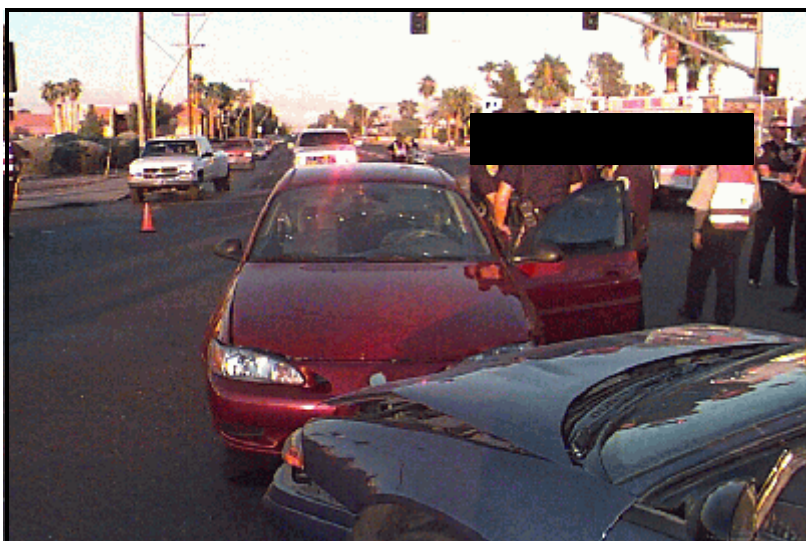
Figure 1. Final rest, looking east.

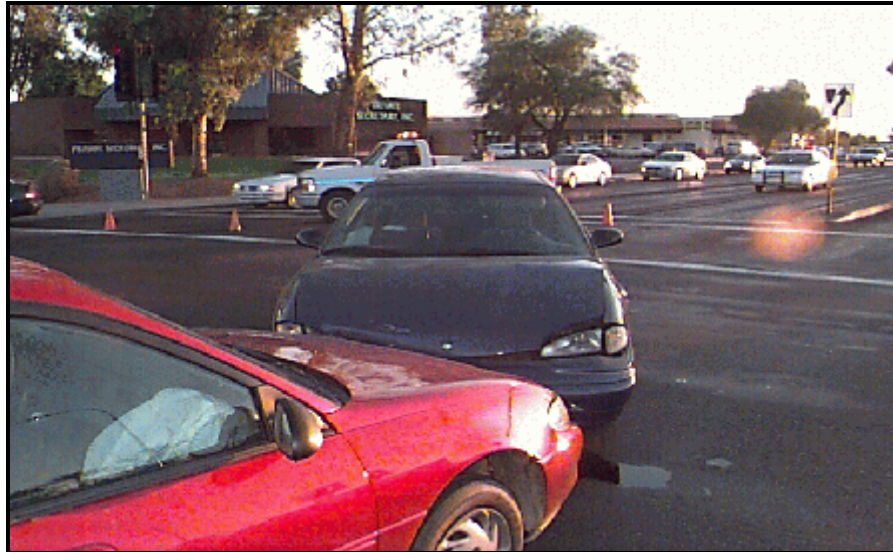
Figure 2. Final rest, facing southwest.

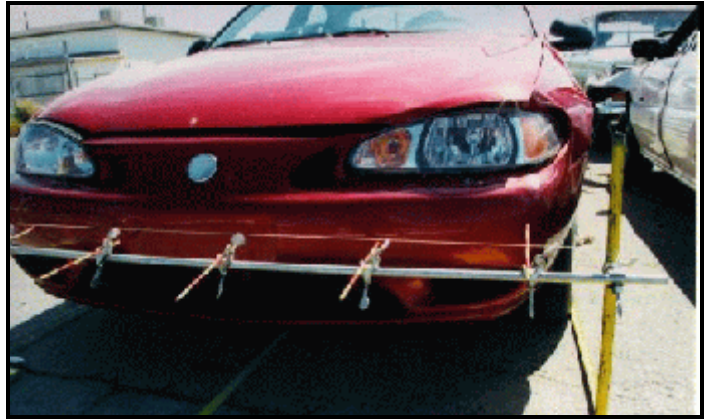
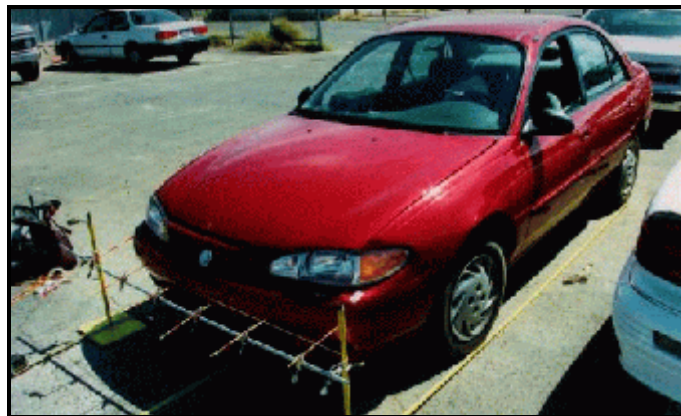
Description:	1997 Mercury Tracer LS	
VIN:	1MELM13P2VWxxxxxx	
Odometer:	34,869 km (21,667 miles)	
Engine:	2.0 L I 4	
Reported Defects:	None	
Cargo:	None	
Damage Description:	Light scratches to left front bumper corner, slight rearward deformation. Near complete restitution.	
CDC:	12FLLW1	
Minimum Travel Speed ¹ :	23 km/h (14 MPH)	
Delta V ² :	Total	10.3 km/h (5.5 MPH)
	Longitudinal	-10.3 km/h (-5.5 MPH)
	Latitudinal	00 km/h (00 MPH)
	Energy	6082 joules (4486 ft-lbs)

Figure 4. Exterior, Vehicle 1.

Figure 5. Exterior, Vehicle 1.

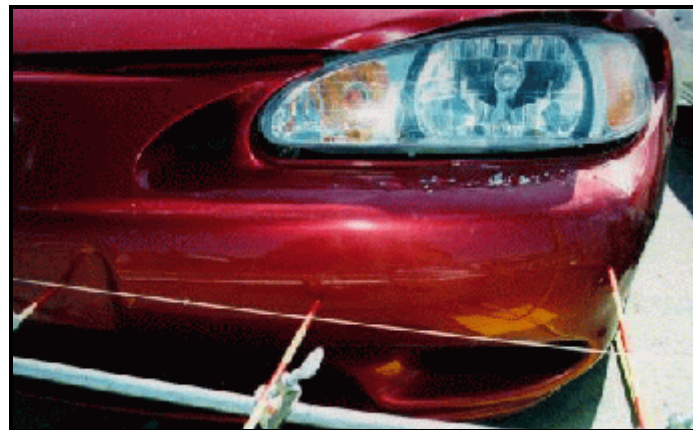
²Calculated using WinSmash program. Results are low. Bumper had restituted almost completely.

Figure 6. Exterior, Vehicle 1. Closeup of bumper.

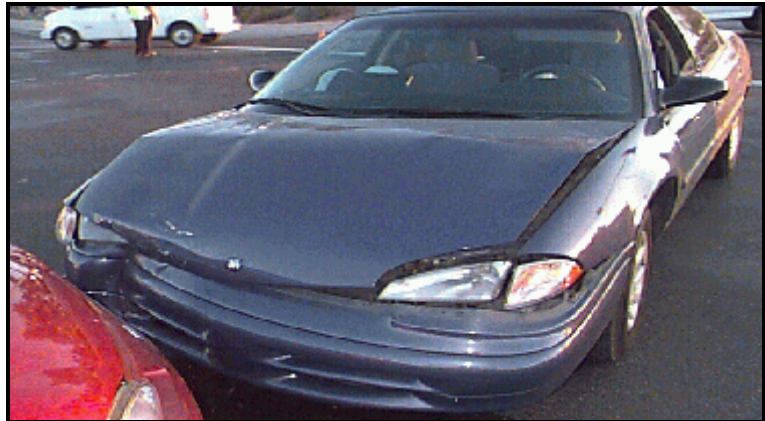
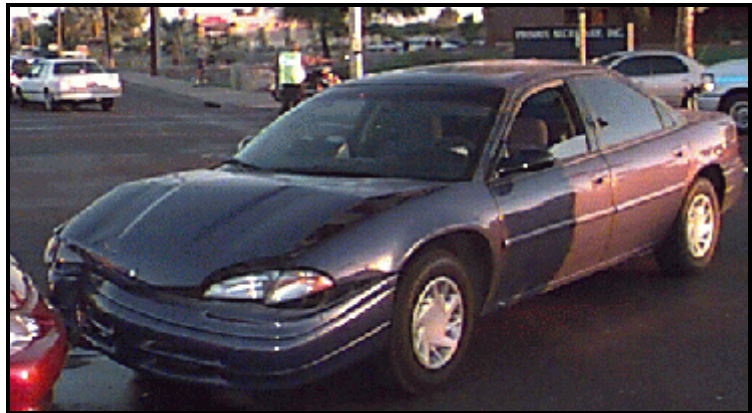
Description:	1994 Dodge Intrepid 4-door	
VIN:	1B3HD46T8RFxxxxxx	
Odometer:	Unknown	
Engine:	3.6 L V-6	
Reported Defects:	None	
Cargo:	None	
Damage Description:	Minor scrapes to right front bumper, slight rearward displacement of bumper, hood slightly buckled.	
CDC:	01FRLW1	
Minimum Travel Speed:	Stopped	
Delta V:	Total	7.2 km/h (3.8 MPH)
	Longitudinal	-6.6 km/h (-3.5 MPH)
	Latitudinal	-3.1 km/h (-1.6 MPH)
	Energy	4335 joules (3199 ft-lbs)

Figure 7. Exterior, Vehicle 2.

Figure 8. Exterior, Vehicle 2.

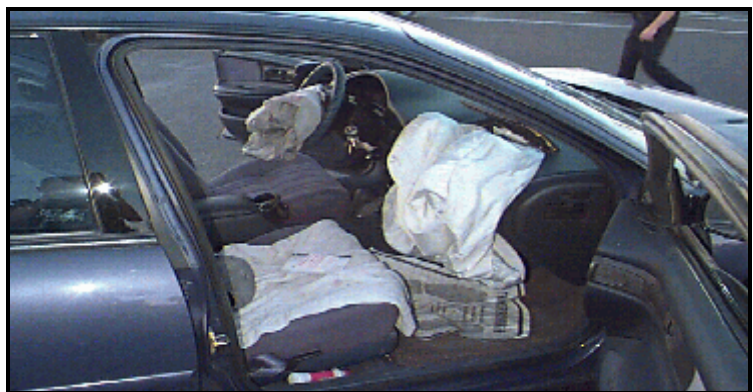
This vehicle is equipped with bucket seats in the front and a bench seat in the rear. Both seats were slightly reclined. The driver's side airbag was mounted in the steering wheel. The passenger side airbag was enclosed in a top-mount module. Neither airbag appears to have sustained any damage. There was no intrusion nor any integrity loss to the interior of the vehicle.

Figure 9. Interior, Vehicle 2

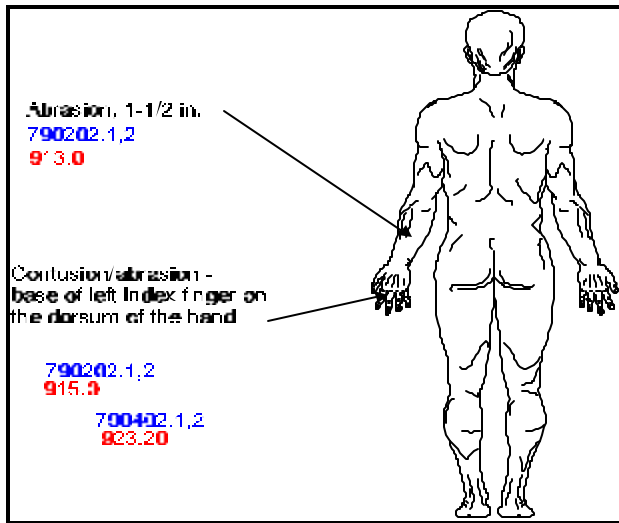
Figure 10. Occupant 2, Vehicle 1, extremity injuries

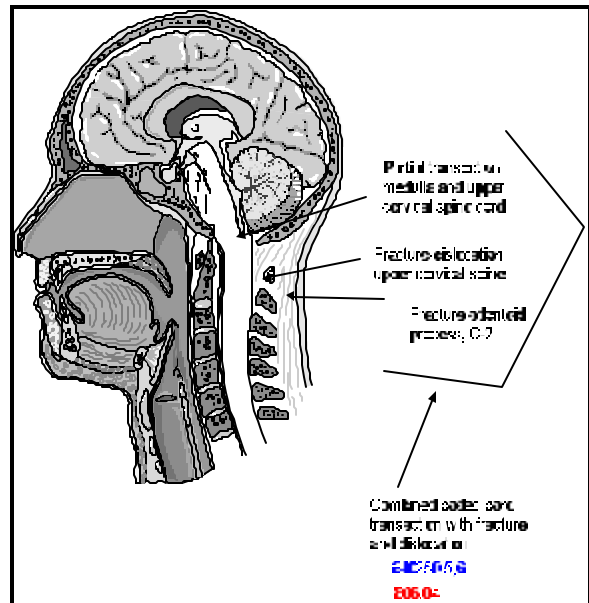
Figure 11. Occupant 2, Vehicle 1, spinal injury

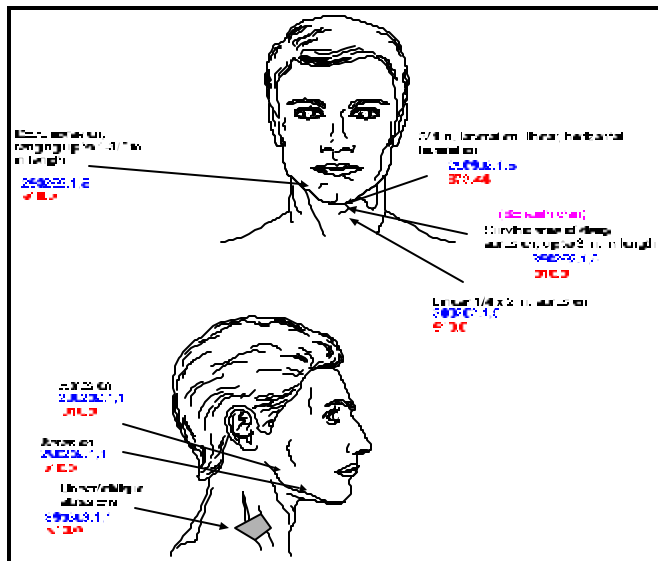
Figure 12. Occupant 2, Vehicle 1, facial abrasions/lacerations

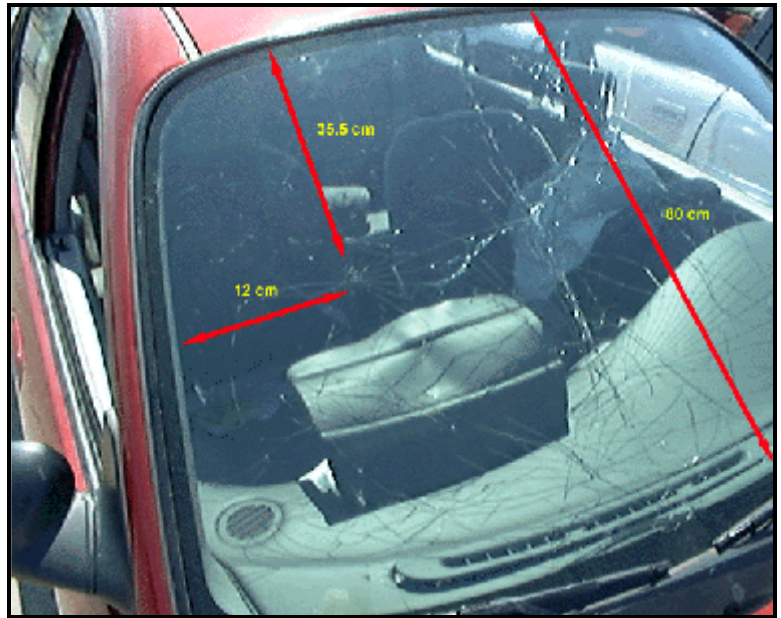
It appears that as the driver of Vehicle 1 braked, the child was pitched forward so that his head was between the module cover and the windshield. At deployment the module cover struck the underside of his chin and he was lifted upwards and pushed into the windshield, fracturing his neck while cracking the windshield and deforming the module cover. According to the autopsy report, he sustained a fracture-dislocation of the

Figure 13. Windshield contact, exterior view

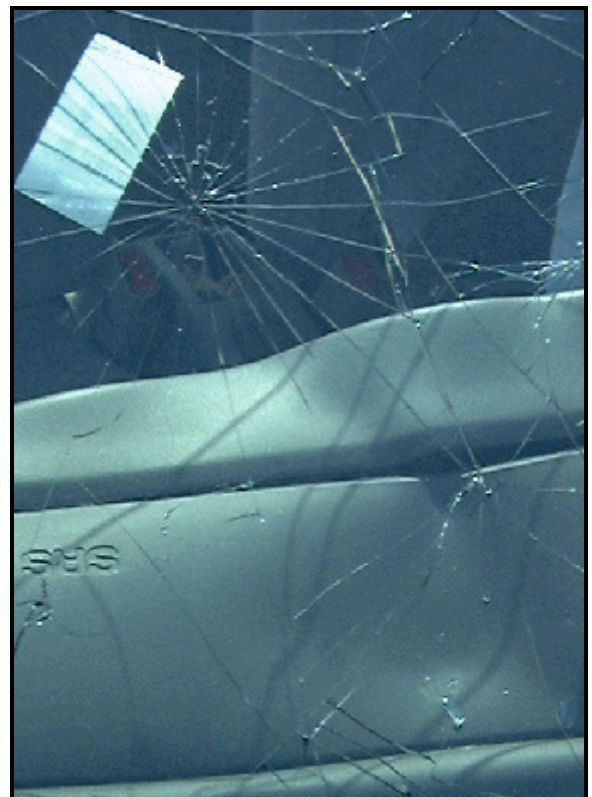
Figure 14. Windshield contact, exterior view, close-up

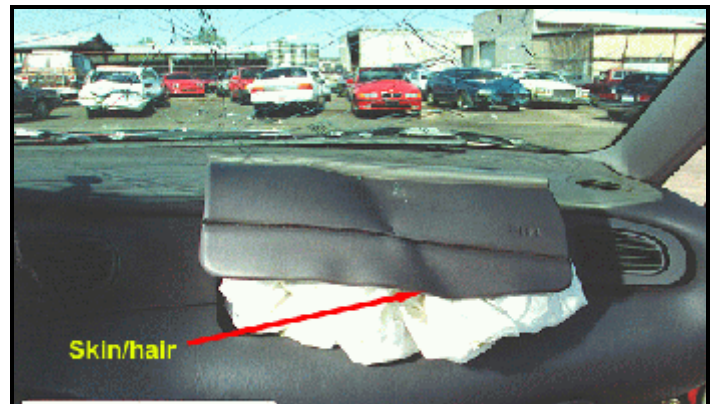
Figure 15. Module cover

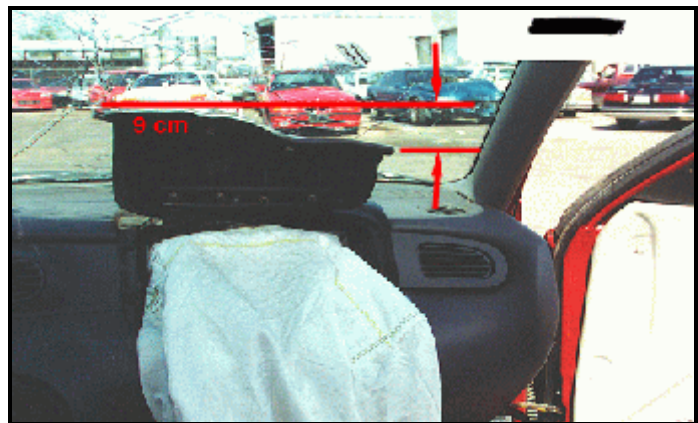
Figure 16. Deformed module cover

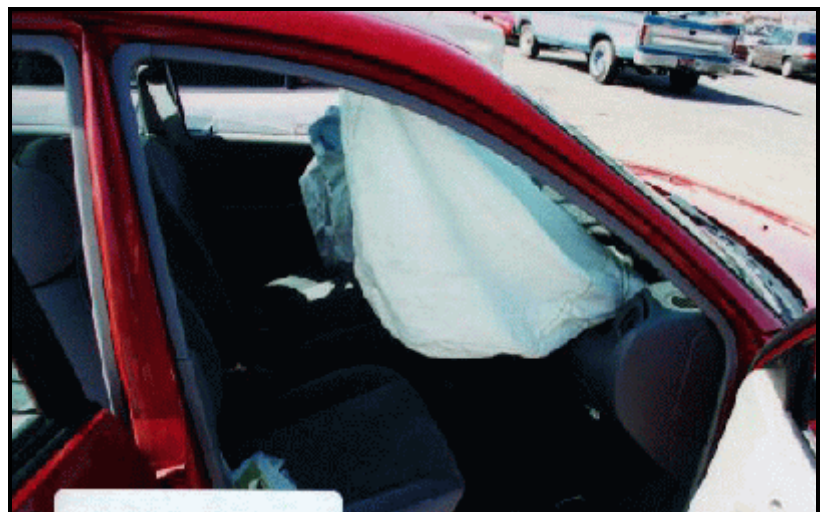
Figure 17. Vehicle Interior
