On-Scene / Vehicle to vehicle  
Dynamic Science, Inc. / Case Number:DS97018  
1995 Hyundai Accent  
New Mexico  
August/1997

1. Report No. DS97018		2. Government Accession No.		3. Recipient Catalog No.	
4. Title and Subtitle In-Depth Accident Investigation				5. Report Date December, 1997

**Dynamic Science, Inc.**  
**Accident Investigation**  
**Case Number:DS97018**

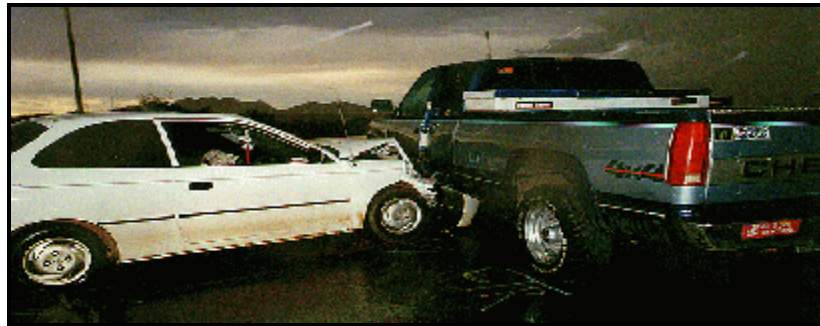
**Figure 1.** Final rest for both vehicles

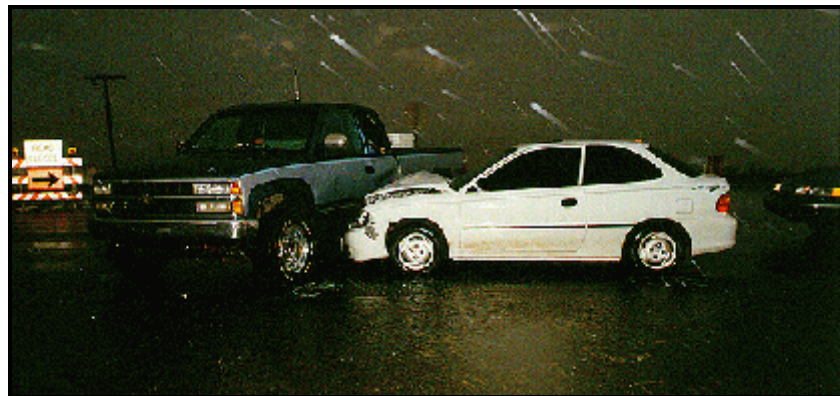
**Figure 2.** Final rest

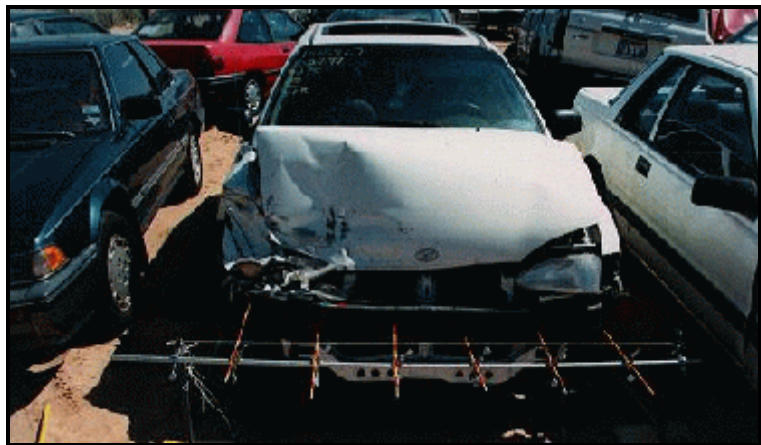
Description:	1995 Hyundai Accent three-door hatchback	
VIN:	KMHVD14N0SUXXXXXXX	
Odometer:	56,002 km (34,799 miles)	
Engine:	1495 cc OHC L4	
Reported Defects:	None	
Cargo:	Speaker equipment in trunk, behind rear seat	
Damage Description:	Moderate direct contact to front bumper, primarily on the right. Some hood buckling.	
CDC:	12FZEW1	
Impact Speed: <sup>1</sup>	34.0 km/h (21.2 MPH)	
Delta V:	Total	22.3 km/h (13.8 MPH)
	Longitudinal	-22.3 km/h (-13.8 MPH)
	Latitudinal	0 km/h (0 MPH)
	Energy	17,709 joules (13,069 ft-lbs)

**Figure 4.** Exterior, case vehicle

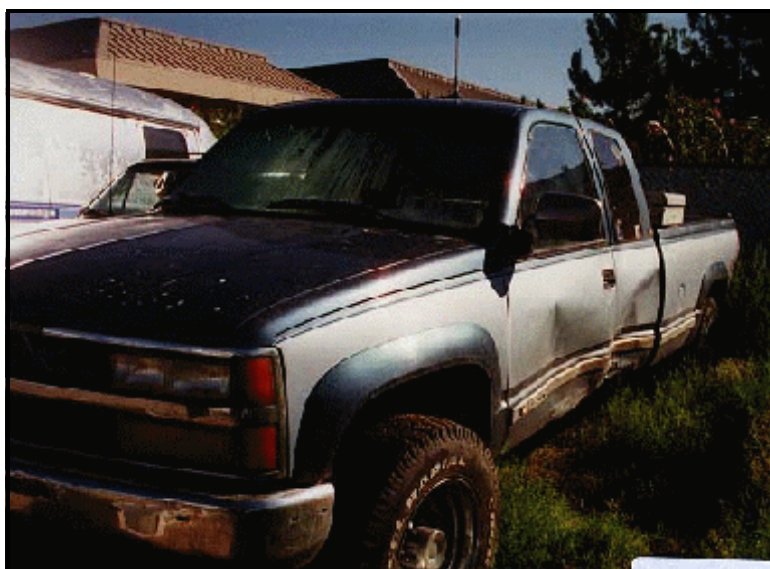
Description:	1990 Chevrolet K1500 pickup truck	
VIN:	2GCGK29K1Lxxxxxx	
Odometer:	Unknown	
Engine:	5.7 V8	
Reported Defects:	None noted	
Cargo:	Unknown	
Damage Description:	Moderate lateral crush to the sill area on the left side.	
CDC:	09LPLW2	
Impact Speed:	2.3 km/h (1.4 MPH)	
Delta V:	Total	11.2 km/h (7.0 MPH)
	Longitudinal	1.0 km/h (0.6 MPH)
	Latitudinal	11.2 km/h (6.9 MPH)
	Energy	11,120 joules (8,208 ft-lbs)

**Figure 5.** Exterior, Vehicle 2

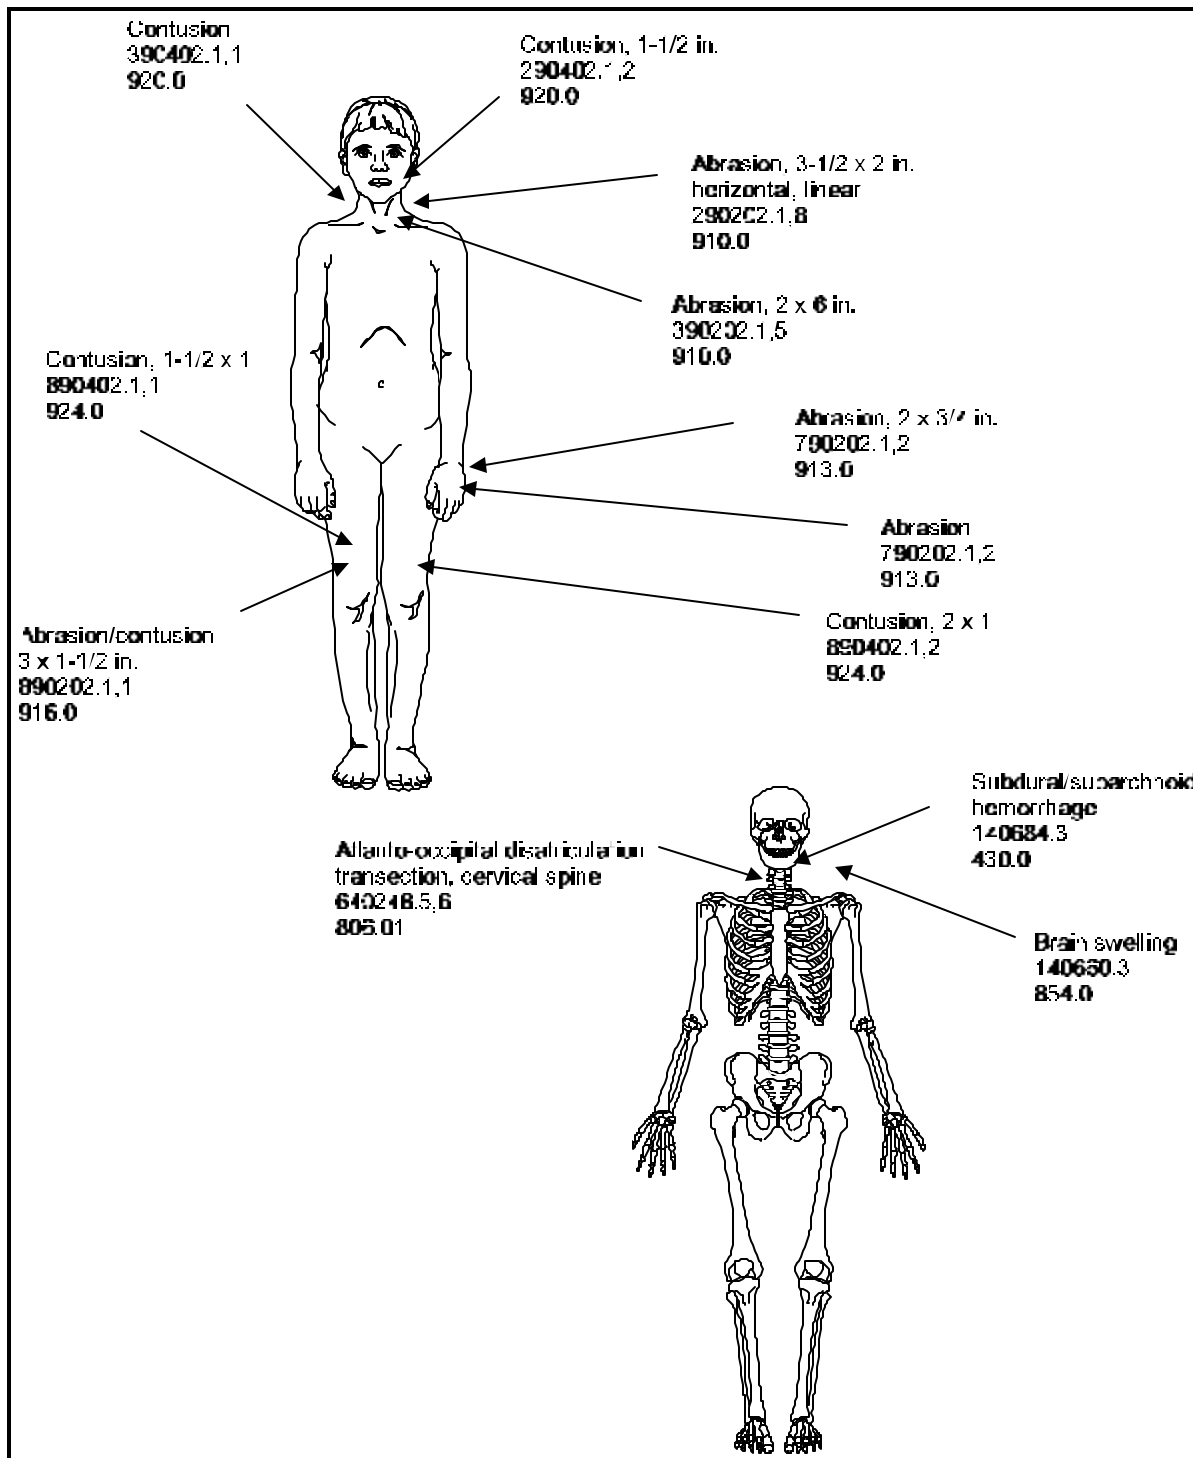
<u>INJURY</u>	<u>OIC CODE</u>	<u>ICD-9</u>	<u>SOURCE</u>
Driver:	No visible injuries			
RF Occupant	Atlanto-occipital disarticulation Transection, cervical spine	640248.5	806.01	Air bag
	Subdural/subarachnoid hemorrhage	140684.3	430.0	Air bag
	Brain swelling	140660.3	854.0	Air bag
	Abrasions, lower part of the face, lateral to both sides of mouth, 3-1/2 x 2 in.	290202.1	910.0	Air bag
	Contusion, left cheek, 1-1/2 in.	290402.1	920.0	Air bag
	Abrasion, anterior neck, just below chin, 2 x 6 in.	390202.1	920.0	Air bag
	Contusion, on neck, below left ear	390402.1	920.0	Air bag
	Contusion, on neck, below right ear	390402.1	920.0	Air bag
	Abrasion, back of left wrist, 2 x 3/4 in.	790202.1	913.0	Module cover
	Abrasion, back of left thumb and left forefinger	790202.1	913.0	Module cover
	Contusion, right thigh, 1-1/2 x 1 in.	890402.1	924.0	Lap belt
	Abrasion/contusion, right thigh 3 x 1-1/2 in.	890202.1	916.0	Lap belt

Contusion, left thigh, 2 x 1 in.	890402.1	924.0	Lap belt

Figure 6. Injury manikin, right front occupant

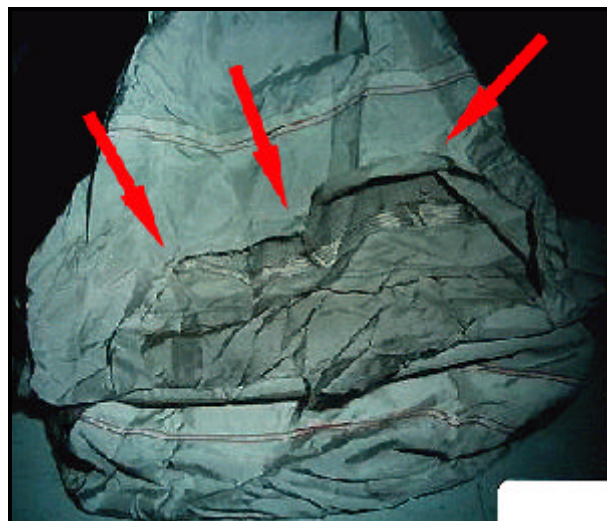
upward as the air bag began deploying. The top of the left hand of this occupant was struck by the module cover causing an abrasion/laceration to the hand and wrist and pushing her hand into the windshield. As the air bag deployed, it caught her beneath the chin and lifted her head upward and rearward while the lower portion of her body was being held in place by the lap belt. She sustained an atlanto-occipital disarticulation with a transection of the cervical spine and a subdural/subarachnoid hemorrhage due to the movement of the air bag against her neck and chin. There was skin evidence from her neck found on the air bag. As she was being lifted upward she loaded the lap belt causing the contusions/abrasions to her thighs.

**Figure 7.** Deployed air bag, arrows mark area where skin tissue was found

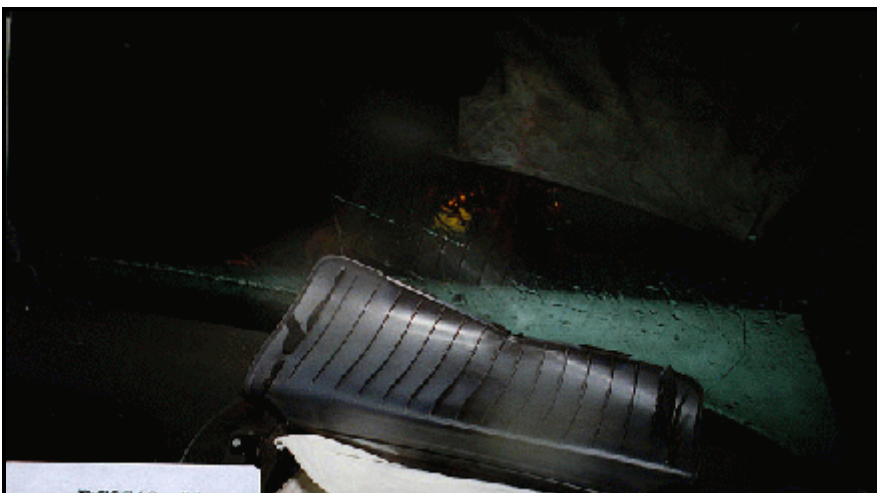
Prior to impact, the driver braked. This pitched the right front occupant forward toward the instrument panel. It appears likely that the occupant had her hands out in front of her. Her left hand was at a point between the module cover and the windshield. At impact, the air bag module cover rotated

**Figure 8.** Passenger air bag module cover
