Remote Investigation / Vehicle to vehicle
Dynamic Science, Inc. / Case Number: DS97022
1998 Pontiac Sunfire
Washington
October/1997

1. Report No. DS97022		2. Government Accession No.		3. Recipient Catalog No.	
4. Title and Subtitle In-Depth Accident Investigation				5. Report Date January 1998

Description: This case was initiated in response to a report of de-powered air bag deployment in a 1998 Pontiac Sunfire.

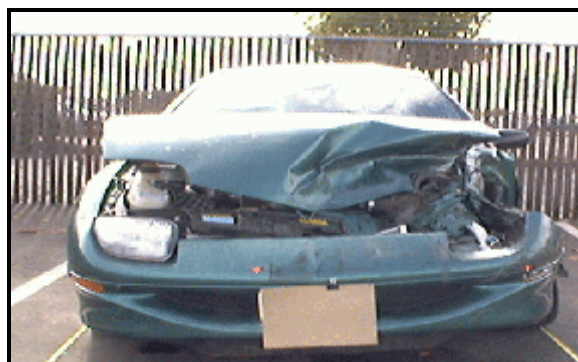
Figure 1. Exterior Vehicle 1, front view

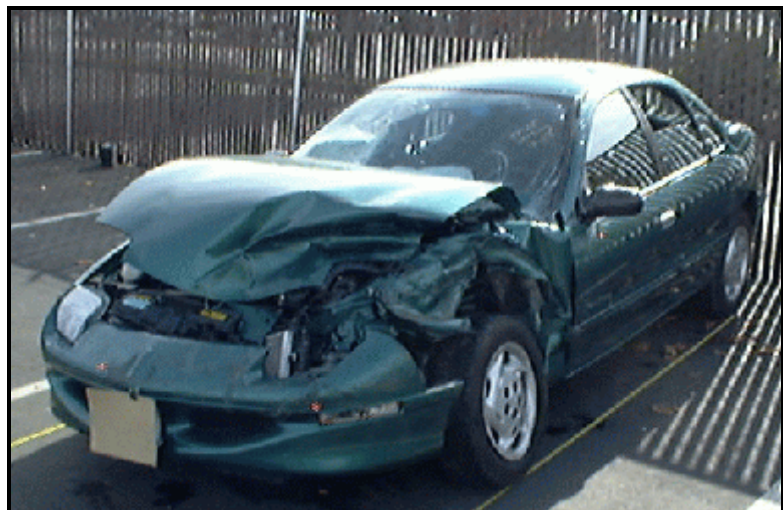
Description:	1998 Pontiac Sunfire four-door sedan	
VIN:	1G2JB52T5W7xxxxxx	
Odometer:	3537 km (2198 miles)	
Engine:	2.4 L L4	
Reported Defects:	None	
Cargo:	None	
Damage Description:	Moderate contact to left front bumper, extending down left fender. Hood bent backwards and to the right.	
CDC:	11FYEW2	
Delta V:	Total	14.5 km/h (9.4 MPH)
	Longitudinal	-12.5 km/h (-8.1 MPH)
	Latitudinal	7.2 km/h (4.7 MPH)
	Energy	16,293 joules (12,022 ft-lbs)

Figure 3. Exterior of Vehicle 1, left side view

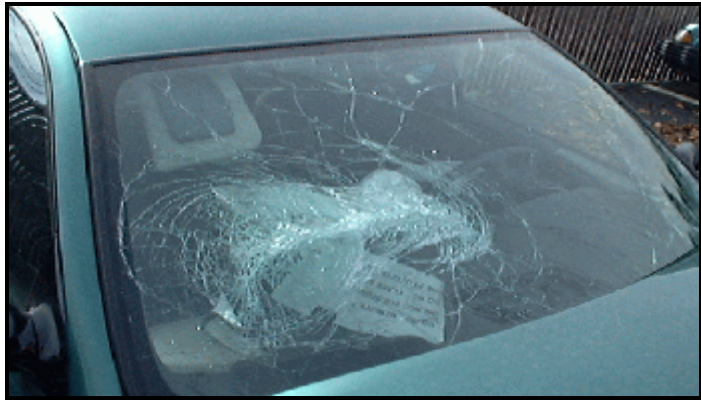
Figure 4. Vehicle exterior, damage to windshield from passenger side air bag

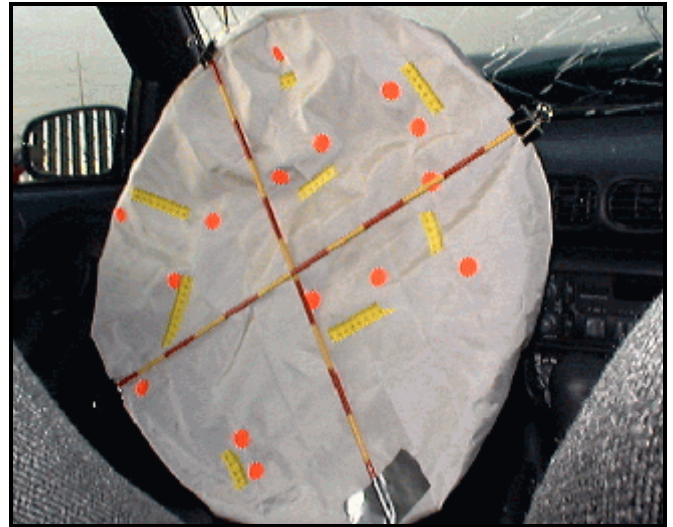
Figure 5. Driver's side air bag

The driver of Vehicle 1 sustained a large contusion to her right knee due to contact with the instrument panel; she also sustained a neck strain which she attributes to contact and the rearward motion from the deploying air bag. The driver was wearing wire-framed sunglasses at impact. These were bent and knocked off her face by the deploying driver's side air bag. No injuries resulted from this activity. She was wearing a shortsleeve T-shirt and long sweat pants. She had no injuries to her arms and hands, however the knee of her sweat pants had been torn due to contact with the lower instrument panel.

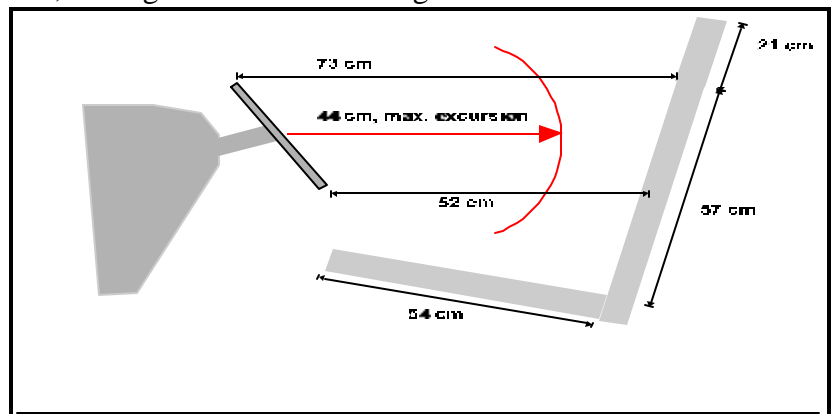
This vehicle is equipped with bucket seats in the front and a bench seat in the rear. Both front seats were in the rear most position at the time of vehicle inspection. Both seats were slightly reclined. The steering wheel mounted driver's side airbag was 60 cm (23.6 in.) in diameter and had a maximum excursion of 44 cm (17.3 in.). It had no tethers and two vents. The passenger side airbag measures 52 cm (20.4 in.) wide by 46 cm (18.1 in.) high and was

Figure 6. Driver's seat position
