**TRANSPORTATION SCIENCES  
CRASH RESEARCH SECTION**

**CALSPAN REMOTE DRIVER AIR BAG FATALITY INVESTIGATION  
CALSPAN CASE NO. CA97-22  
VEHICLE: 1991 CHEVROLET CAPRICE  
LOCATION: FLORIDA  
CRASH DATE: JUNE, 1991**

Contract No. DTNH22-94-D-07058

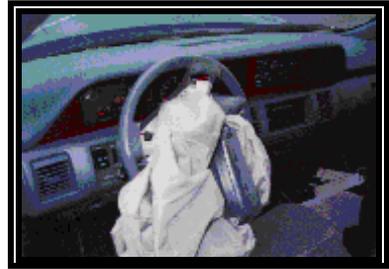
**Figure 1. Altered deployment of the driver air bag and separated module cover.**

Vehicle interior damage was limited to deployment of the SIR and driver loading of the steering assembly and the instrument panel. At deployment, the driver was positioned against the driver air bag module cover assembly which restricted the deployment path of the air bag. The air bag membrane initially deployed from the H-configuration module cover flaps, however, as the bag continued to inflate against the driver, the bag was redirected and expanded between the module cover and the steering wheel assembly, separating the module cover from the module assembly. Therefore, the bag was restricted by the module cover and was not able to inflate in a typical round configuration.

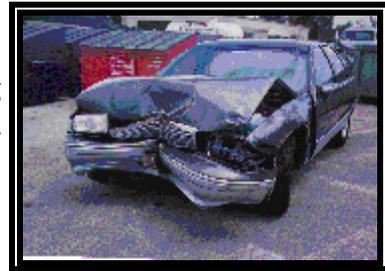
**Figure 2. Frontal view of the pole impact damage.**

The front left area of the 1991 Caprice (**Figure 2**) impacted the back right corner area of the 1984 Nissan Sentra resulting in a probable 12/6 o'clock impact configuration. The impact redirected the Nissan to its left as it traversed the two left turn lanes, the median, and the eastbound travel lanes before coming to a controlled stop in a parking lot adjacent to the east curbline. Based on the insurance company photographs, the Caprice sustained moderate damage, however, the severity of the crash did not warrant deployment of the driver air bag system.

The Caprice was redirected to its right as it crossed the outboard travel lane, mounted a barrier curb, traversed a concrete sidewalk and impacted a utility pole with the front center area of the vehicle (**Figure 2**). The pole impact crushed the front center bumper to an estimated depth of 35-40 cm (14-16"). As a result of the impact, the Caprice underwent a longitudinal velocity change of 24-29 km/h (15-18 mph) which deployed the driver air bag system. The Caprice came to rest engaged against the struck pole. The driver of the Caprice was found slumped across the front seat with her head adjacent to the right front door. The investigating police officer noted in his report that the driver was not restrained by the manual 3-point lap and shoulder belt system and that the driver's side air bag had deployed. He further noted that the steering wheel was damaged from driver contact.

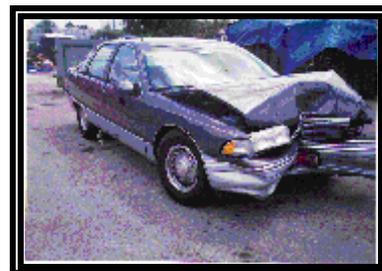
The second crash event involved a front center impact sequence with a wooden utility pole. The investigating officer noted in his report that the pole was not fractured, however, the pole was displaced and was leaning at a 15-20 degree angle. The direct damage to the vehicle occurred at the centerline and involved the front bumper, grille, radiator support panel, and the hood. Maximum crush was estimated at 35-40 cm (14-16") with a total velocity change of 24-29 kph (15-18 mph). The 12 o'clock direction of force impact was sufficient to deploy the Caprice's supplemental driver air bag system. The CDC for this impact was 12-FCEN-2 (**Figure 3**).

**Figure 3. Center frontal pole damage.**

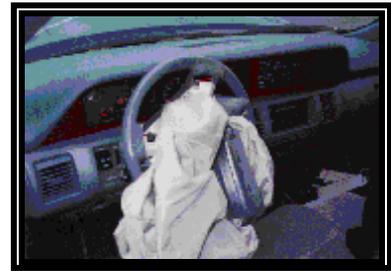
Due to the driver's forward position against the air bag module assembly at deployment, she impeded the opening of the H-configuration module cover flaps and the subsequent expansion of the air bag membrane. As a result, the expanding air bag membrane partially deployed from the module cover flaps, however, was restricted by the driver's torso. The continued expansion of the bag membrane within the module separated the module cover from the module mounting bracket (**Figure 4**). The upper portion of the air bag subsequently expanded through the top of the module assembly, between the cover and the steering wheel. The upper center area of the air bag membrane was restricted by the vinyl module cover, therefore the bag could not fully inflate in a typical round configuration.

**Figure 4. Separated module cover and restricted air bag.**

The driver's loading of the air bag and steering wheel rim resulted in forward bending of the steering wheel rim and spokes as evidenced by the photograph provided by the insurance carrier. In addition, the investigating officer noted steering wheel damage due to driver loading during the post-crash inspection of the vehicle.
