ON-SITE AIR BAG INVESTIGATION

CASE NUMBER - IN97-023
LOCATION - OKLAHOMA
VEHICLE - 1996 GMC SAFARI CARGO VAN
CRASH DATE - August, 1997

1. <i>Report No.</i> IN97-023		2. <i>Government Accession No.</i>		3. <i>Recipient's Catalog No.</i>	
4. <i>Title and Subtitle</i> On-Site Air Bag Fatality Investigation Vehicle - GMC Safari Cargo Van Location - Oklahoma			5. <i>Report Date:</i> 10/02/2000; 1/15/2001; 4/22/2002

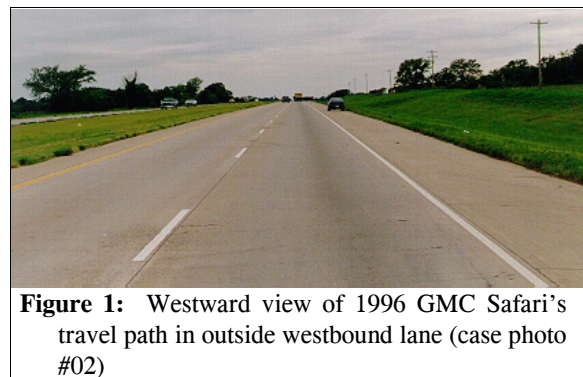
Figure 1: Westward view of 1996 GMC Safari's travel path in outside westbound lane (case photo #02)

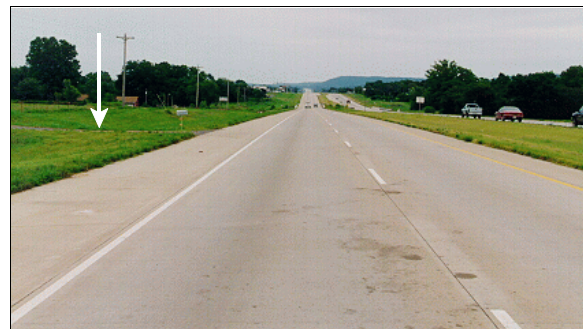
The U.S. highway was straight and level at the area of impact (i.e., actual slope was 1.5%, positive to the west). The pavement was concrete, and the width of the both westbound travel lanes was 3.7 meters (12 feet). The shoulders were improved (i.e., bituminous). The north side of the westbound road had a 3.2 meters (10.5 feet) paved shoulder and the south side had a 1.3 meters (4.3 feet) paved shoulder, prior to the 10 meter (33 feet) wide unprotected grassy median. Pavement markings consisted of a single solid yellow edge line on the south side of the roadway, a single solid white edge line on the north side of the roadway, and the two westbound lanes were divided by a dashed white line. The estimated coefficient of friction was 0.75 when dry. There were no visible traffic controls. The posted speed limit was 105 km.p.h. (65 m.p.h.). At the time of the crash the light condition was dark, the atmospheric condition was clear and the road pavement was dry. Traffic density was light, and the site of the crash was primarily of rural undeveloped farm land with periodic industrial/commercial buildings. In addition, there was a residential/farm driveway within approximately 30 meters (100 feet) of the crash site (**Figure 2**).

Figure 2: 1996 GMC Safari's westward travel path in outside westbound lane looking eastward from just west of point of impact; Note: divided trafficway, minimal upgrade toward west, and driveway intersecting from north (case photo #04)

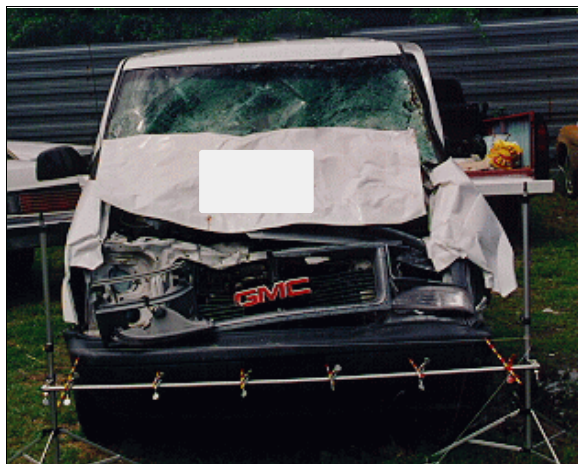
Figure 3: 1996 GMC Safari's frontal damage viewed from front with contour gauge present and showing bumper level crush (case photo #06)

The front of the 1996 GMC Safari (**Figures 3 and 4** above, and **Figures 5 and 6**) struck two horses (**Figure 7**), causing the 1996 GMC Safari's driver and front right passenger supplemental restraints (air bags) to deploy. The available evidence indicates that the two horses were traveling side-by-side, with one horse ahead of the other. The 1996 GMC Safari continued slightly to its right, traveling in a west-northwesterly direction before coming to rest heading essentially west-northwestward, straddling the edge line that separated the north roadside from the outside westbound lane, 24.7 meters (81 feet) west of the point of impact. The two horses were knocked westward. One horse came to rest in the outside westbound lane 41.1 meters (135 feet) west of impact, and the other horse came to rest on the north roadside 48.5 meters (159 feet) west of impact.

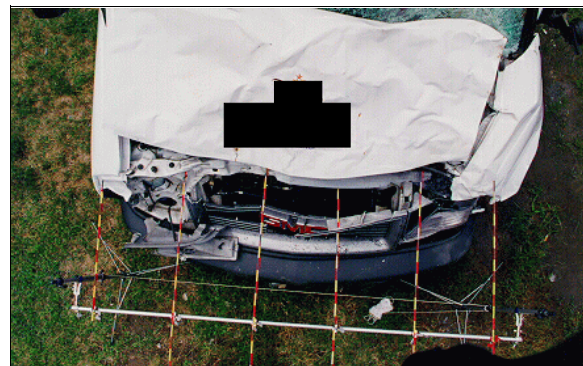
Figure 4: Overhead view of 1996 GMC Safari's frontal damage with contour gauge present showing above bumper crush and uneven crush profile (case photo #11)

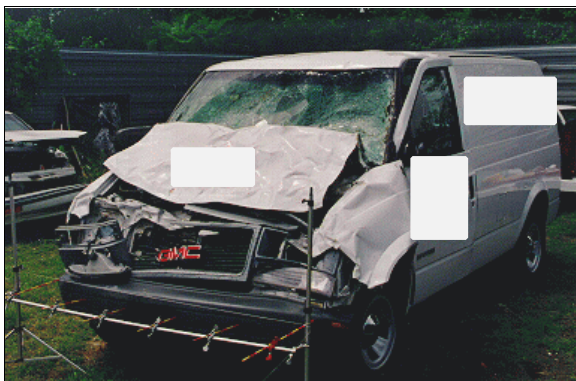
Figure 5: 1996 GMC Safari's frontal, uneven, crush profile from impacting two horses, viewed from left of front, with contour gauge set at bumper level (case photo #07)

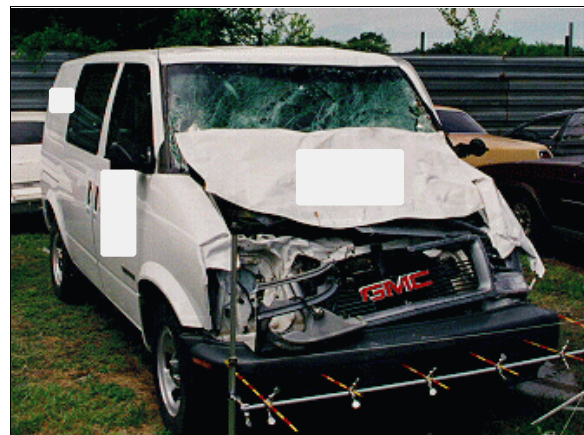
Figure 6: 1996 GMC Safari's frontal, uneven, crush profile from impacting two horses, viewed from right of front, with contour gauge set at bumper level (case photo #17)

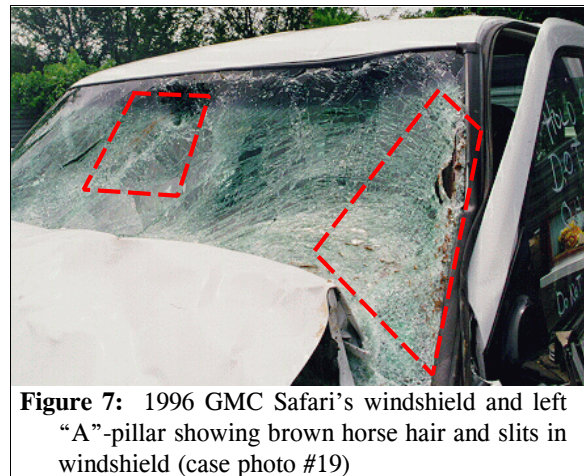
Figure 7: 1996 GMC Safari's windshield and left "A"-pillar showing brown horse hair and slits in windshield (case photo #19)

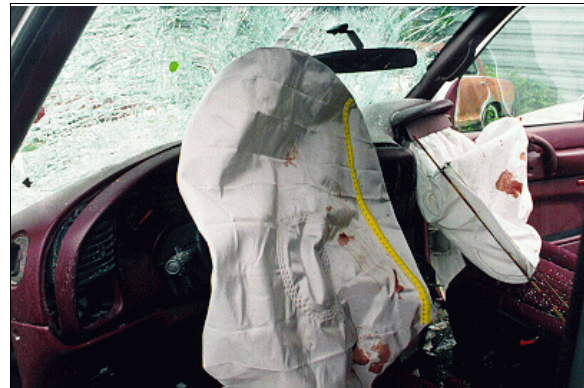
had 4.825 cubic meters (170.4 cubic feet) of space. The front seat belt systems were equipped with manually operated height adjusters for the “D”-rings. The vehicle was equipped with knee bolsters for both the driver and front right passenger, both of which had evidence of knee contact (i.e., scuffing but no deformation). Automatic restraint was provided by a Supplemental Restraint System (SRS) that consisted of a frontal air bag for the driver and front right passenger seating positions. Both front seat air bags deployed as a result of the 1996 GMC Safari’s frontal impact with the two horses (**Figure 8**).

Figure 8: 1996 GMC Safari’s deployed driver and front right passenger air bags; Note: blood on both air bags, contact evidence on windshield, and distorted rearview mirror (case photo #26)

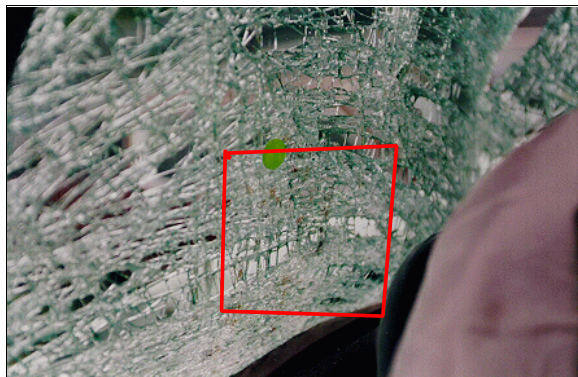
Figure 9: Close-up of interior surface of 1996 GMC Safari’s left windshield showing black plastic transfer from steering wheel rim contact and possible skin transfer from driver’s hand contact (case photo #30)

The inspection of the 1996 GMC Safari’s interior revealed a black plastic transfer to the lower left windshield (**Figure 9**) from the upper half of the steering wheel rim, which had been bent forward approximately 3 centimeters (1.2 inches) towards the intruding windshield (**Figure 10**). This interaction resulted from two forces. First, the steering wheel rim was bent backwards as a result of the driver loading the deploying driver’s air bag causing the air bag to expand backwards bending the steering wheel rim. Second, at least one of the two horses struck the left and center portions of the windshield causing the windshield’s glazing to intrude longitudinally inward toward the steering wheel rim. The interior inspection also revealed skin and hair on the armrest of the driver’s door, most likely from the driver’s left arm; scuffs to both the driver and

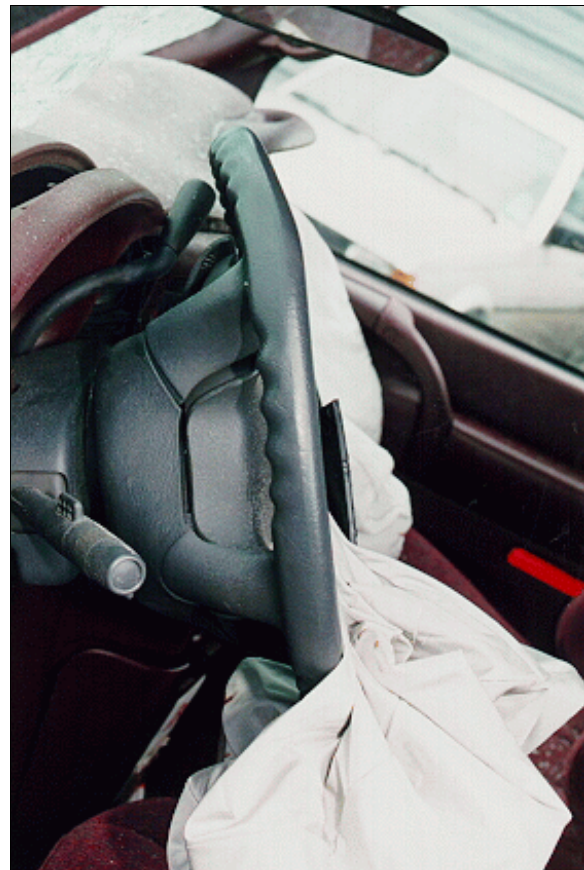
Figure 10: Vertical lateral view of 1996 GMC Safari’s steering wheel rim from left showing deformation to top of rim from loading (case photo #25)

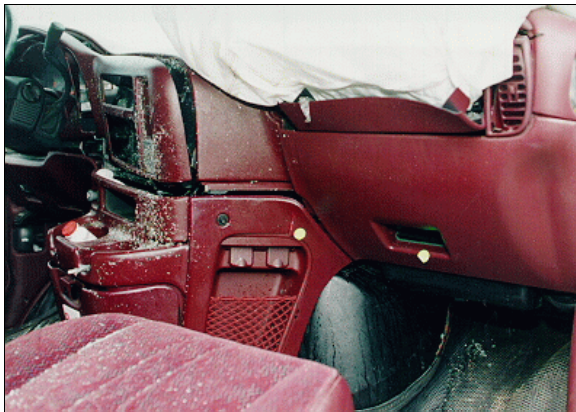
front right passenger knee bolsters, one from the driver's right knee and the other from the front right passenger's right knee (**Figure 11**); a scuff to the right side of the center instrument panel, most likely from the front right passenger's left knee (**Figure 11**); a skin and blood transfer to the windshield on the driver's side from the driver's left hand contact at impact (**Figure 9** above); and the rearview mirror was askew. The shear capsules on the steering column were most likely moved, but the exact amount was not documented during the inspection. Finally, there was an area of contact on the back side of the driver's seat, presumably from contact by the rear passenger seated (i.e., on a milk carton crate) on the left side of the cargo area (**Figures 12 and 13**).

Figure 11: Contact evidence on 1996 GMC Safari's right knee bolster and right side of center instrument panel (case photo #34)

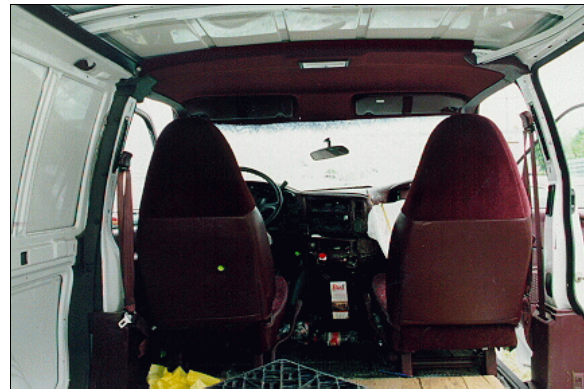
Figure 12: 1996 GMC Safari's rear cargo area showing one of the milk crates used as seats by the two cargo area passengers; Note: contact to back of driver's seat back (case photo #45)

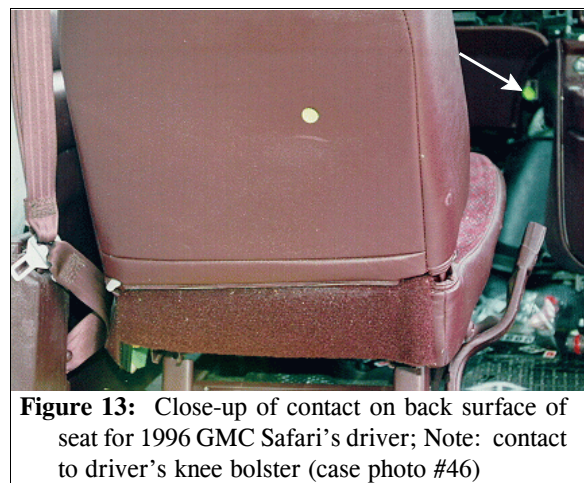
Figure 13: Close-up of contact on back surface of seat for 1996 GMC Safari's driver; Note: contact to driver's knee bolster (case photo #46)

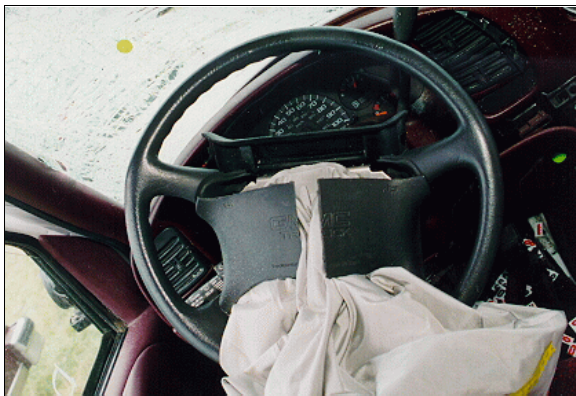
Figure 14: 1996 GMC Safari driver air bag module's three cover flaps (i.e., top, left, and right) showing no occupant contact evidence (case photo #24)

An inspection of the air bag module's cover flaps and air bag revealed that the cover flaps opened at the designated tear points, and there was no evidence of damage during the deployment to the air bag or the cover flaps (**Figure 14**). The driver's air bag was designed with two tethers, but their width is unknown. The driver's air bag had two vent ports, approximately 3 centimeters (1.2 inches) in diameter, located at the 11 and 1 o'clock positions. The deployed driver's air bag was round with a diameter of 65 centimeters (25.6 inches). There was visible contact evidence readily apparent on the driver's air bag, primarily to the right half of the air bag. The evidence consisted of a vertical skin transfer on the right side of the air bag and scattered blood smears and

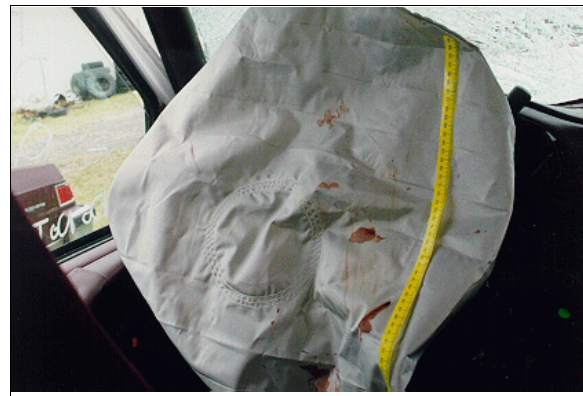
Figure 15: 1996 GMC Safari's deployed driver air bag showing vertical skin transfer (yellow tape) and blood spots on right side of bag (case photo #28)

blood drainage spots which extended from the top edge to just above the bottom edge (Figure 15 above and see SELECTED PHOTOGRAPHS, Figure 22 below). There was blood splatter to the backside of the air bag on the upper portion. In addition, there were scratches on the top of the back surface, near the one o'clock position, from contact with the intruding windshield glazing.

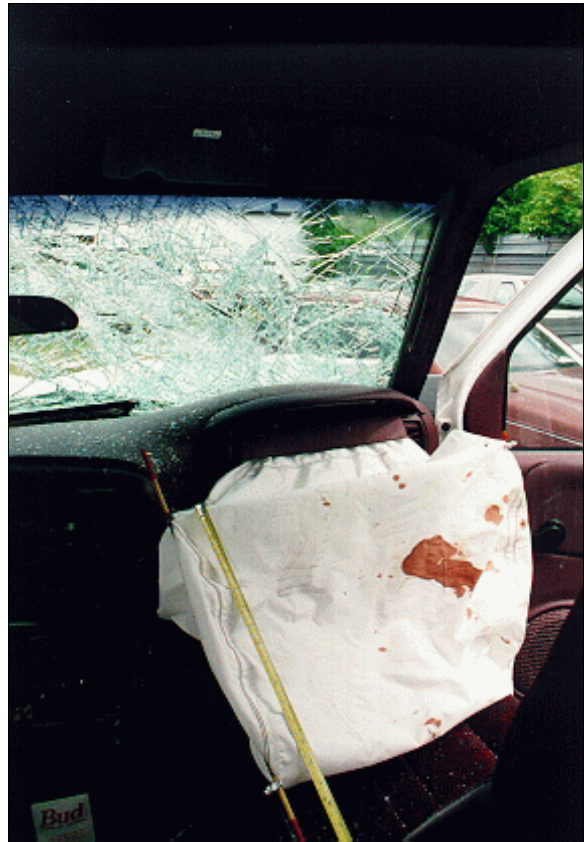
The front right passenger's air bag was located in the middle of the instrument panel (Figure 16). The module cover consisted of asymmetrical "H"-configuration cover flaps made of thick vinyl over a sheet metal frame/liner which acted as the hinge point for the deploying flaps. The flap's dimensions were: 32 centimeters (12.6 inches) at the horizontal seam and 6 centimeters (2.4 inches) vertically for the upper flap and 7 centimeters (2.8 inches) vertically for the lower flap. The top hinged flap was not capable, due to its height, of contacting the windshield in this crash. The profile of the 1996 GMC Safari's instrument panel resulted in a 0 centimeter (0.0 inch) setback of the hinged edge of the bottom cover flap relative to the protruding right instrument panel. In addition, there was a 4 centimeter (1.6 inch) set back from the leading edge of the instrument panel to the hinged edge of the top cover flap. An inspection of the front right air bag module's cover flaps and air bag revealed that the cover flaps opened at the designated tear points, and there was no evidence of damage during the deployment to the air bag or the cover flaps (Figure 17). The front right passenger's air bag was designed without any tethers. The front right air bag had two vent ports, approximately 5 centimeters (2.0 inches) in diameter, located at the 10 and 2 o'clock positions. The deployed front right air bag was rectangular with a height of approximately 44 centimeters (17.3 inches) and a width of approximately 58 centimeters (22.8 inches).

Figure 16: Vertical view of 1996 GMC Safari's deployed front right passenger air bag showing blood evidence on air bag; Note: passenger handle-type grip above top cover flap (case photo #36)

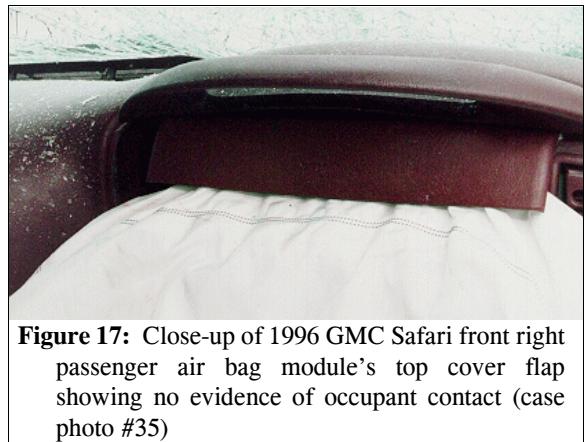
Figure 17: Close-up of 1996 GMC Safari front right passenger air bag module's top cover flap showing no evidence of occupant contact (case photo #35)

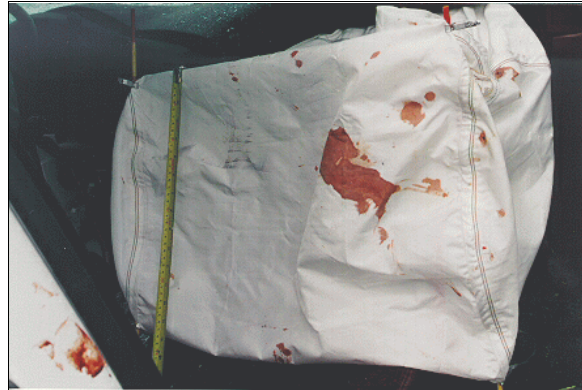
There was contact evidence readily apparent on the fabric of the front right air bag. The inspection revealed an area of lateral blue cloth transfers, primarily in the top left quadrant of the front surface. The blue cloth transfers most likely came from the out-of-position passenger's shirt

during the deployment sequence. The lateral blue cloth transfers started just above the top horizontal edge and continued down the front of the air bag for an additional 15 centimeters (5.9 inches). Further, there were scattered blood spots to the top and front portions of the air bag (Figure 18). There was a large blood spot approximately 7 centimeters (2.8 inches) in diameter, towards the center of the air bag, approximately 37 centimeters (14.6 inches) from the left edge. In addition, there was an area of skin transfer which began on the left portion of the top surface (Figure 19 and see **SELECTED PHOTOGRAPHS, Figure 23** below) and continued downward onto the left side of the front surface. The skin evidence at the top of the air bag was approximately 7 centimeters (2.8 inches) wide and started 9 centimeters (3.5 inches) to the right of the left edge of the air bag and just 10 centimeters (3.9 inches) down from the top cover flap hinge. The skin evidence extended forward (towards passenger) 28 centimeters (11.0 inches) to the top horizontal edge of the air bag. The skin evidence continued down the front of the air bag 29 centimeters (11.4 inches) and as it ended the width increased to 14 centimeters (5.5 inches).

Figure 18: 1996 GMC Safari's front right passenger air bag showing cloth and skin transfer along with blood to front portion (case photo #37)

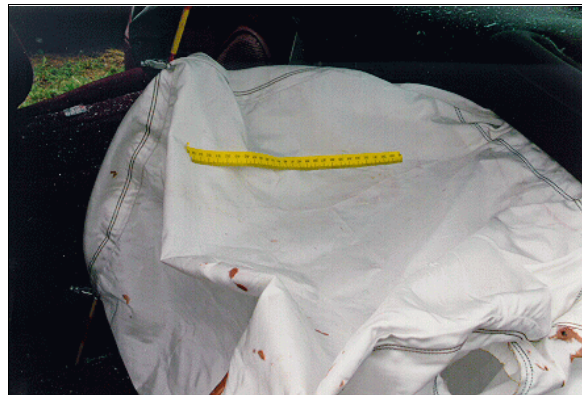
Figure 19: Skin transfer to top portion of 1996 GMC Safari's front right passenger air bag from contact by "in-lap" passenger (case photo #40)

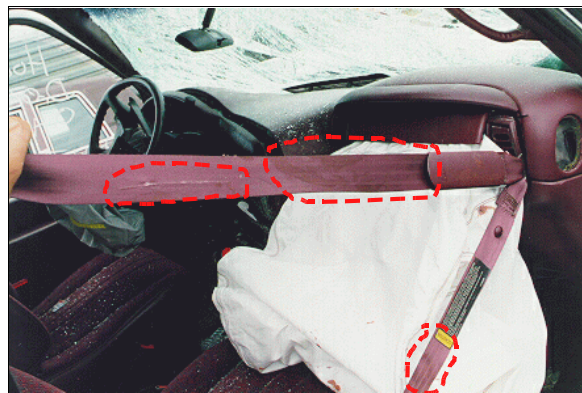
Figure 20: 1996 GMC Safari's front right seat belt showing blood on and stretching to webbing which indicates usage (although improper) during crash (case photo #44)

Furthermore, there was evidence of bruising to the “in-lap” front right passenger’s abdomen, most likely caused by a combination of the lap portion of the safety belt system and the loading to this occupant’s abdomen/pelvic area sustained from the momentum of his father (i.e., the front right passenger) who was seated behind him. In addition, the inspection of the front right seat belt webbing, “D”-ring, and latch plate showed an excessive amount of blood on both the lap and shoulder belt webbing towards the latch plate, as well as stretching to the webbing of the torso portion only (**Figure 20** above). This latter evidence indicates definite usage by the father during the crash.

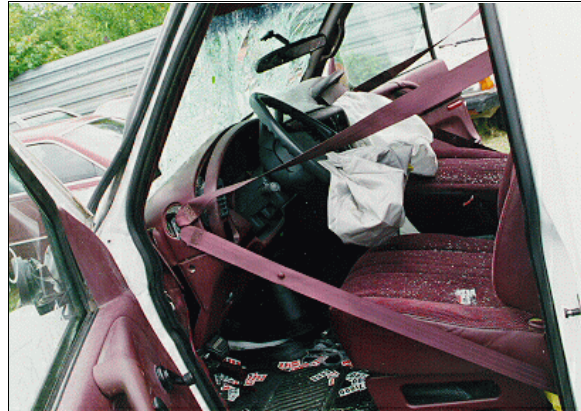
Figure 21: 1996 GMC Safari's outstretched driver seat belt showing no evidence of usage during crash (case photo #32)

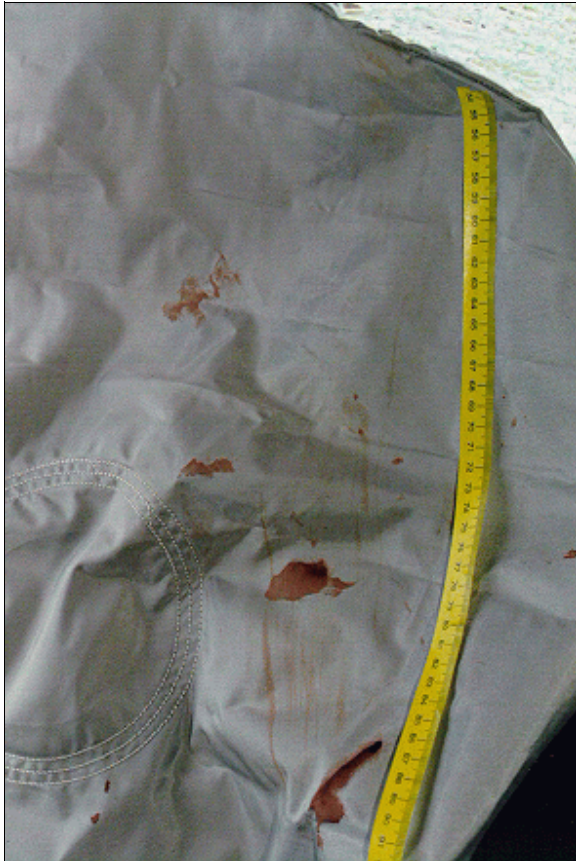
Figure 22: Close-up of skin transfer and blood smear along right side of 1996 GMC Safari's driver air bag to left of yellow tape (case photo #29)

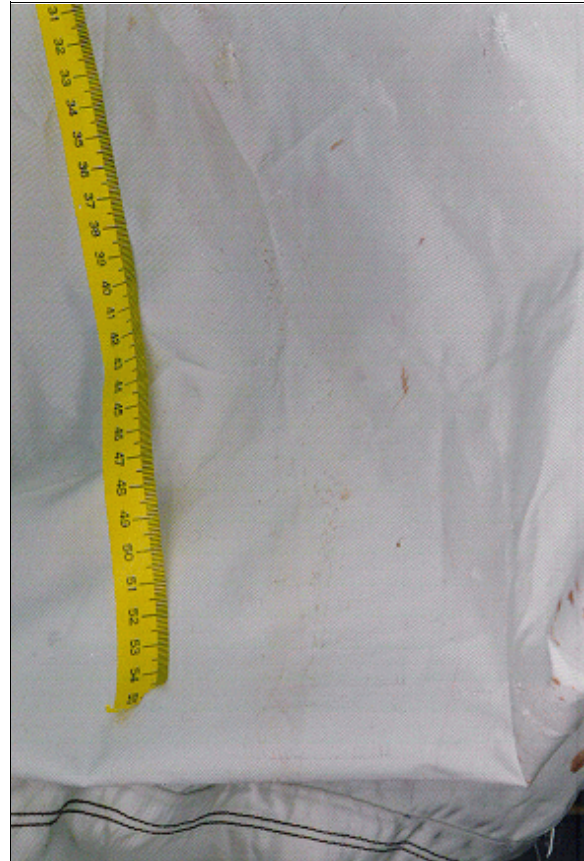
Figure 23: Close-up of skin transfer to top portion of the 1996 GMC Safari's front right passenger air bag from contact by "in-lap" passenger (case photo #41)
