**CALSPAN ON-SITE DRIVER AIR BAG FATALITY INVESTIGATION  
CALSPAN CASE NO. CA97-23  
VEHICLE: 1996 FORD EXPLORER  
LOCATION: NEW JERSEY  
CRASH DATE: FEBRUARY 1997**

Contract No. DTNH22-94-D-07058

**CALSPAN ON-SITE DRIVER AIR BAG FATALITY INVESTIGATION**  
**CALSPAN CASE NO. CA97-23**  
**LOCATION: NEW JERSEY**  
**CRASH DATE: FEBRUARY 1997**

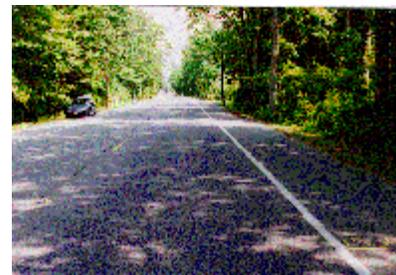
The crash occurred on the right shoulder of a two lane county road in a rural/undeveloped area during nighttime hours. The asphalt road surface was straight and level with paved shoulders bordering both travel lanes. On the evening of the crash, a heavy snowfall occurred which covered the environmental surfaces with several inches of snow. Visibility was limited due to the rate of the snowfall. The posted speed limit in the area of the crash was 80 km/h (50 mph). **Figure 1** is an overall view of the crash site.

**Figure 1. Overall view of the crash site and trajectory of the Ford Explorer.**

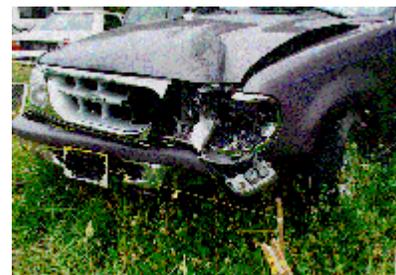
A wood utility pole, that acted as a lateral support guy wire pole for a telephone pole on the north side of the roadway, was positioned approximately 1 m (3.0') outboard of the paved shoulder. The front left area of the Ford Explorer impacted and sheared the guy wire pole. The vehicle sustained 26.7 cm (10.5") of bumper crush located at the front left corner, outboard of the frame rail (**Figure 2**). The resultant direction of force was 12 o'clock with a Collision Deformation Classification (CDC) of 12-FLEN-2. A speed change

**Figure 2. Front left damage to the Ford Explorer.**

of 13.0 km/h (8.1 mph) was calculated by the damage algorithm of the WinSMASH program. As a result of the frontal impact sequence with the struck pole, the driver and passenger air bags deployed. The Explorer fractured the pole and continued approximately 15 m (50.0') before coming to rest 7.0 m (23.0') south of the south edge line. At rest, the vehicle was facing in a easterly direction with the engine stalled and the lights illuminated.

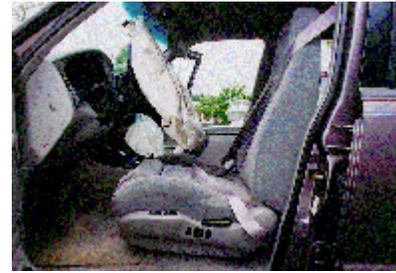
The driver was seated in a normal upright attitude with the seat track adjusted to a presumed forward track position (**Figure 3**). She was properly restrained by the manual 3-point lap and shoulder belt system with the D-ring positioned to a low adjustment point. At impact, the frontal air bag system deployed. The driver's forward position at deployment resulted in the lower segment of the air bag to expand against her protruding abdomen and chest which initially restricted the deployment path of the air bag. This resulted in the vinyl transfers on the lower quadrant of the bag. In addition, the expanding air bag contacted her denim top which produced the fabric transfer at the 5 o'clock position. The expanding air bag contacted the chest, anterior neck, and face of the driver which resulted in multiple soft tissue injuries. She sustained a doubled-bordered parallel contusion over the right scapula, a chinstrap-like contusion with abrasion to the underside of the chin, three parallel contusions with abrasion of the right face, superficial lacerations, contusions and abrasions of the lower lip, ecchymosis between the eyebrows, bilateral subconjunctival hemorrhages, and a hemorrhage of the left eyelid. The bag expanded across the anterior neck which probably hyperextended her head. The neck injuries included petechial hemorrhages in the epiglottis and laryngeal mucosa, a 1 cm hemorrhage overlying the right hyoid bone, a 1.5 cm hemorrhage over the posterior cricoid cartilage, extradural hemorrhage of the spinal cord and dura, and petechial hemorrhages on the posterior neck.

**Figure 3. Profile view of the driver's seated position in relation to the deployed air bag.**

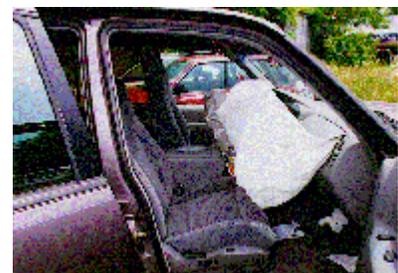
**Figure 4. Profile view of the front passenger's seated position and the deployed air bag.**

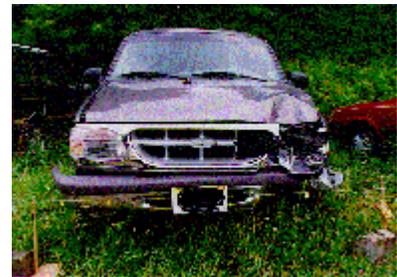
The 1996 Ford Explorer sustained moderate frontal damage (**Figure 5**) as a result of its impact sequence with a small diameter utility pole. Maximum crush was 26.7 cm (10.5") located at the front left bumper corner. The direct contact damage began 38.7 cm (15.25") left of center and extended 17.8 cm (7.0") to the left, terminating inboard of the bumper corner. The resultant damage pattern extended across the full width of the front bumper which resulted in a combined direct and induced damage length (Field L) of 135.3 cm (53.25").

**Figure 5. Frontal damage to the Ford Explorer.**

Damaged components included the front bumper and integral rub strip, grille, left headlamp assembly, left turn signal assembly, hood and the left front fender. The left wheelbase was reduced in length by 3.2 cm (1.25") from the original specification length of 283.2 cm (111.5").

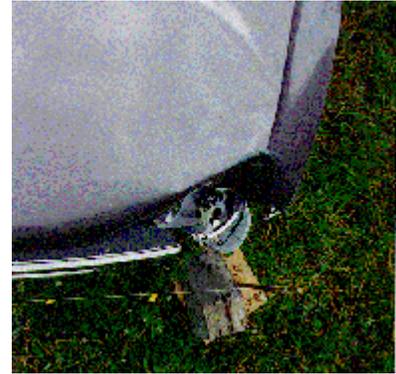
**Figure 6. Overhead view of the damage profile.**

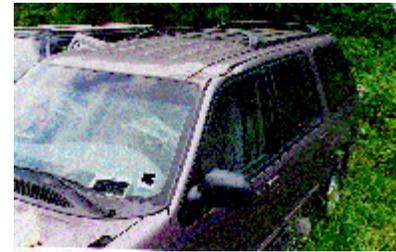
The secondary impact sequence occurred as the upper segment of the fractured utility pole fell onto the roof area of the Ford Explorer as the vehicle continued in a forward direction. The direct contact damage began 36.8 cm (14.5") forward of the left B-pillar and extended 25.4 cm (10.0") forward. The lateral extent of the direct damage extended from the outboard aspect of the left front door window frame 15.2 cm (6.0") inboard onto the roof panel. The pole impact produced a maximum crush value of 2.3 cm (0.9") that was located 47.0 cm (18.5") forward of the B-pillar and approximately 5.1 cm (2.0") inboard of the left side rail. The secondary damage is depicted in **Figure 7**.

**Figure 7. Secondary damage to the left roof area.**

As the Explorer continued on its post-crash trajectory, the upper aspect of the fractured pole impacted the left roof side rail area of the vehicle. The non-horizontal (00) impact force produced 2.3 cm (0.9") of residual crush to the left roof/side rail area. The subsequent impact did not influence the post-crash trajectory of the vehicle.

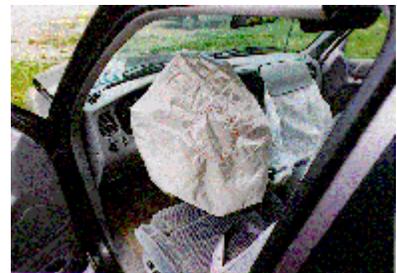
The Ford Explorer was equipped with a Supplemental Restraint System (SRS) that consisted of frontal air bags (**Figure 8**) for the driver and front right passenger positions which deployed as a result of the frontal impact sequence with the utility pole. The driver's air bag deployed from a symmetrical H-configuration module cover assembly that was concealed within the four-spoke steering wheel rim. The upper flap was contoured to the top and vertical face of the module assembly. The vertical aspect of the upper flap was 7.6 cm (3.0") in height with an overall width of 22.9 cm (9.0"). The sides of the flap were contoured and tapered to a width of 17.8 cm (7.0") at the horizontal tear seam. The vehicle name FORD was embossed in the mid portion of the upper flap. Horn symbols were also embossed in the lower outboard quadrants of the upper flap for the contact points for horn activation. The lower module cover flap was 9.1 cm (3.6") in height with an overall width of 17.8 cm (7.0") at the horizontal tear seam. The side profile of the lower

**Figure 8. Overall view of the deployed frontal air bags.**

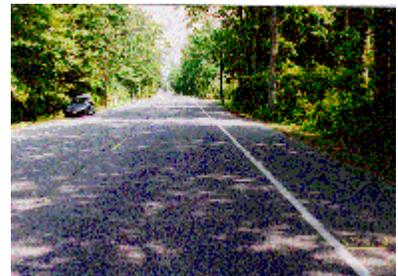
The driver backed out of the driveway onto the local street and proceeded 0.4 km (0.3 miles) in a northerly direction to the stop sign at the mouth of the intersection for their subdivision. The husband stated that the driver noted the snow covered conditions of the two lane county road as she initiated a right turn to proceed in an easterly direction. As they had traveled a distance of 1.6 km (1.0 mile) on the snow covered county road (**Figure 9**), the driver detected a deer in the eastbound travel lane. She alerted the front right occupant of its presence, however, he failed to detect the animal initially due to the snow conditions. The occupant subsequently detected the deer and noted to the investigating officer that the animal was facing in a northerly direction with its left side exposed to the travel direction of the Explorer. The vehicle's travel speed was estimated at 40-48 km/h (25-30 mph).

**Figure 9. Pre-crash trajectory of the Ford Explorer.**

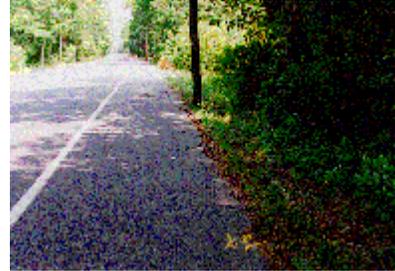
In an attempt to avoid the deer, the driver initiated a clockwise steering input which redirected the vehicle toward the south (right) shoulder. In addition, she probably applied a braking force to the Explorer on the straight and level road surface. As a result of the steering maneuver, the Explorer departed the eastbound travel lane at a departure angle of approximately 8-10 degrees and traveled a police documented distance of 18.4 m (60.3') while traversing the snow covered paved shoulder (Figure 10).

**Figure 10. Departure of the right front tire from the paved shoulder.**

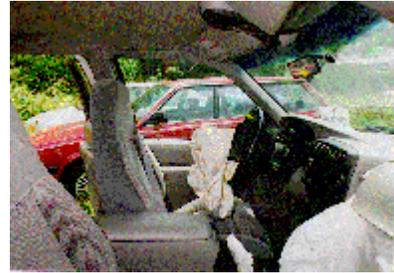
The driver was presumed to have been seated in a forward position with respect to the steering wheel assembly with her seat adjusted to a forward track position (**Figure 11**). Her husband noted that she preferred to driver the Explorer due to its height over automobiles and that she drove with the seat track and back rest adjusted to forward positions. At the time of our inspection of the vehicle, which occurred over four months after the crash, the driver's seat track was adjusted to a mid track position, 11.7 cm (4.6") rearward of the full forward position and 13.0 cm (5.1") forward of the full rearward position. The seat back was adjusted to the most vertical position with a measured angle of 20 degrees at the lumbar support area. With the seat assembly adjusted to this position, the horizontal distance between the mid point of the air bag module cover assembly and the seat back support was 50.1 cm (19.75"). The tilt steering wheel was adjusted to a mid position.

**Figure 11. Right profile view of the driver's seat position and the deployed air bag.**

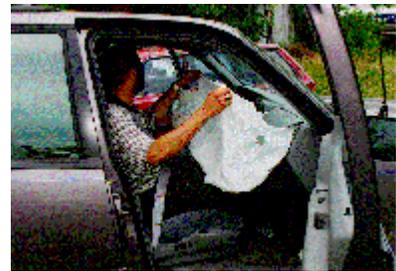
The passenger air bag deployed from its mid mount configuration within the right instrument panel. The passenger air bag was a non-tethered design with a maximum rearward excursion of 62.2 cm (24.5") in its deflated state (**Figure 12**). The horizontal distance between the adjusted front right seat position and the leading edge of the mid mount passenger air bag module cover was 83.2 cm (32.75").

**Figure 12. Front right passenger seated position and the deployed air bag.**
