**VERIDIAN ON-SITE AIR BAG RELATED ADULT DRIVER
FATALITY INVESTIGATION
VERIDIAN CASE NO. CA97-024
VEHICLE: 1997 MITSUBISHI GALANT
LOCATION: DELAWARE
CRASH DATE: JUNE 1997**

14. <i>Sponsoring Agency Code</i>	
15. <i>Supplementary Notes</i> On-site investigation of a road-side departure crash that resulted in deployment of the frontal air bag system and fatal injuries to the belted 53 year old female driver.

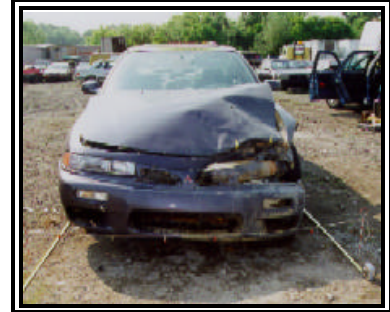
This on-site crash investigation focused on the injury mechanisms and cause of death for a 53 year old female driver of a 1997 Mitsubishi Galant. The Galant was equipped with frontal air bags that deployed as a result of a frontal impact sequence (**Figure 1**) with an impact attenuator and subsequent left side engagement with a guardrail system. The driver was properly restrained by the manual 3-point lap and shoulder belt system and was seated in a mid track position. She had a history of hypertension, an enlarged heart, and was prescribed blood pressure medication by her physician. She was struck by the expanding driver air bag and module cover flap which resulted in numerous soft tissue injuries of the face and chest with bilateral subarachnoid and subural hemorrhage. The driver was transported by ambulance to a local hospital where she expired within minutes of arrival.

Figure 1. Frontal damage to the Mitsubishi Galant.

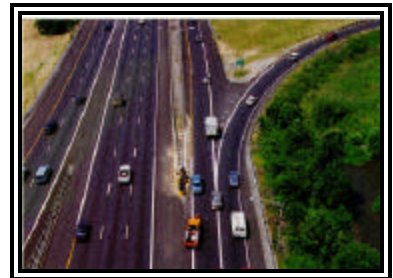
The crash occurred on the southbound lanes of an interstate roadway in a posted 89 km/h (55 mph) speed zone. On approach to the crash site, the southbound lanes consisted of five travel lanes. The right outboard lane transitioned into an exit ramp while the inboard lane terminated, merging the traffic flow into three lanes. A painted gore separated the exit lane from the through southbound lanes. A double guardrail system divided the through lanes from the exit ramp. This double system offered protection to traffic from both the through lanes and the exit ramp. The system utilized a W-beam rail mounted to strong I-beam posts with I-beam block-outs. The downstream blunt end of the guard system was protected from southbound traffic by sand-filled impact attenuators. The attenuator system consisted of a single row of four barrels followed by a double row of four barrels. **Figure 2** is an aerial view of the crash site.

Figure 2. Aerial view of the crash site.

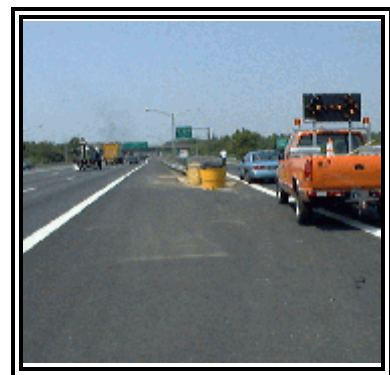
The 53 year old female driver was en route to her residence after working a double eight hour shift at a local medical facility. The driver had a history of hypertension and was under medication prior to the crash. She was traveling on the outboard right through lane of the interstate roadway, adjacent to the dedicated right exit lane, when the driver apparently fell asleep. The Mitsubishi Galant drifted over the right solid lane edge line and entered the asphalt gore area that delineated the through travel lane from the exit ramp. The vehicle traversed this area in a tracking mode (**Figure 3**) to impact with the impact attenuators that protected the blunt end of a double back-to-back parallel guardrail system. The impact attenuator consisted of Fitch and Energite type sand barrels which weighed 181 kg (400 lb)

Figure 3. Pre-crash approach of the Mitsubishi Galant.

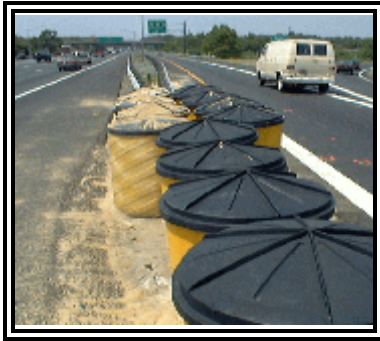
The front left area of the Mitsubishi Galant impacted the single line of attenuator barrels (**Figure 4**) and continued through the right side of the dual line of barrels, impacting and damaging a total of eight barrels (**Figure 4**). The crash resulted in a 12 o'clock impact force and crushed the left corner of the upper radiator support panel to a depth of 30.5 cm (12.0"). Although the crash conditions were outside the scope of the WinSMASH reconstruction program due to the yielding object, the damage profile was used to compute a barrier equivalent speed of 18 km/h (11.2 mph). This impact deployed the vehicle's frontal air bag system. It should be noted that impact attenuators were engineered to gradually reduce the velocity of the vehicle, therefore the crash pulse experienced by the vehicle was elongated, resulting in a probable late deployment of the frontal air bag system.

Figure 4. Placement of the sand barrel attenuators.

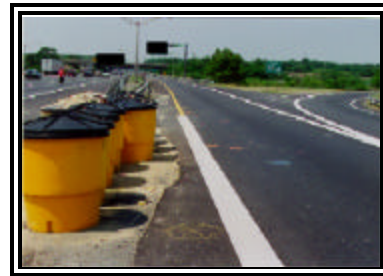
Figure 5. Continued trajectory of the Galant.

The Galant yawed slightly in a counterclockwise (CCW) direction due to the off-set left frontal impact. It traveled approximately 16.6 m (54.4') and struck the W-beam guardrail located adjacent to the left side of the exit ramp with the left front fender area. The vehicle was redirected in a clockwise direction and continued along the ramp (**Figure 5**), striking the guardrail four additional times before coming to rest adjacent to the guardrail 148.9 m (488.5') south of the initial point of impact with the impact attenuators. It was believed that the driver relinquished control of the vehicle immediately following air bag deployment and that the vehicle's front wheels were turned in a CCW direction which allowed the vehicle to continuously contact and "ride" along the guardrail system.

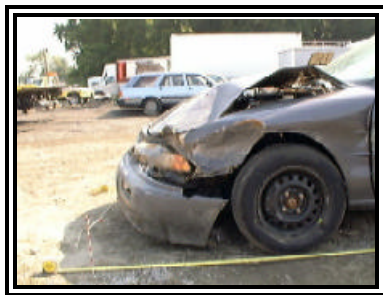
The Mitsubishi Galant sustained moderate frontal damage and minor left side damage from impacts with the impact attenuator and guardrail system, respectively. The initial impact with the attenuator system produced damage at the bumper and radiator support levels. The direct contact damage on the bumper fascia began 13.3 cm (5.25") left of center and extended 58.4 cm (23.0") to the left corner (**Figure 5**). The impact deformed the full frontal width of the vehicle resulting in a combined induced and direct damage length of 144.1 cm (56.75"). The crush profile at bumper level was as follows: C1 = 7.8 cm (3.1"), C2 = 3.6 cm (1.4"), C3 = 0 cm, C4 = 0 cm, C5 = 0 cm, C6 = 0 cm. Maximum crush was 30.5 cm (12.0") located at the left corner of the radiator support panel. The crush profile at the level of the radiator support was as follows: C1 = 30.5 cm (12.0"), C2 = 29.8 cm (11.75"), C3 = 11.4 cm (4.5"), C4 = 2.5 cm (1.0"), C5 = 1.9 cm (0.75"), C6 = 0 cm. These profiles (**Figure 6**) were averaged for input into the damage algorithm of the WinSMASH program. The Collision Deformation Classification (CDC) for the first impact with the impact attenuator was 12-FYEW-2.

Figure 6. Profile view of the frontal crush.

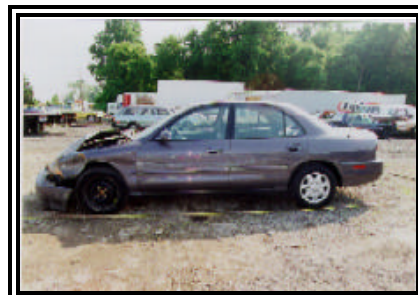
The multiple impact sequence with the guardrail system was combined and assigned a single CDC of 11-LDMS-2. The maximum crush to the left front fender from this impact measured 22.9 cm (9.0"). The combined induced and direct contact damage length was 369.6 cm (145.5") which extended from the left corner rearward to a point 50.8 cm (20.0") aft of the left rear axle position (**Figure 7**). Damage to the vehicle was estimated by police at \$5,000.

Figure 7. Left side guardrail damage.

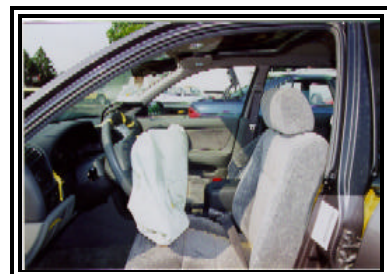
The interior damage to the Mitsubishi Galant was rated as minor and was associated with driver contact and deployment of the frontal air bag system. There was no interior damage associated with exterior deformation or intrusion to the passenger compartment. The frontal air bag system deployed as designed from the respective driver and passenger modules. **Figure 8** is a profile view of the driver's compartment of the Mitsubishi Galant.

Figure 8. Overall view of the driver's compartment.

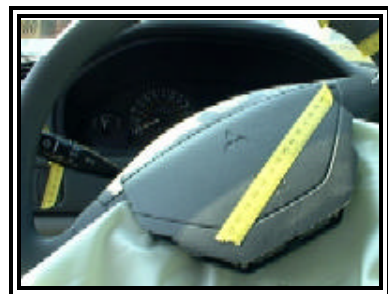
The driver was out-of-position forward as the frontal air bag system deployed. The leading edge of the driver air bag module cover flap contacted the driver's torso area as evidenced by a horizontally oriented scuff/abrasion to the cover flap. This interaction momentarily restricted the expansion of the air bag membrane as evidenced by black vinyl transfers on the bag membrane from contact against the interior aspect of the horn pad. The bag subsequently expanded against the driver's torso and face. A make-up transfer was noted to the center of the bag within the tether reinforcement area.

The driver air bag module consisted of a single cover flap that was hinged at the top surface of the module assembly. The vinyl flap material measured 12.7 cm (5.0") vertically and 17.5 cm (6.9") laterally with a measured thickness of 3.1 mm (0.125"). The module cover exhibited a scuff pattern along the bottom leading edge (**Figure 9**) that measured 5.7 cm x 5.1 cm (2.25" x 2.0"). The scuff was attributed to driver contact during the air bag deployment sequence. Located behind the module cover flap was the horn activation pad which measured 9.5 mm (0.375") thick.

Figure 9. Driver air bag module cover flap.

The single module cover flap contacted the driver's chest as the air bag membrane deployed. A horizontally oriented scuff mark was present on the face of the flap bordering the tear seam. The driver sustained a large stellate contusion of the left breast with soft tissue hemorrhage from the flap contact. The expanding air bag membrane contacted the driver's face and chest, accelerating her head rearward into the seat back. The bag contact produced multiple facial abrasions, contusions, and lacerations, with hemorrhage into the deep tissues under the chin and into the strap muscles of the neck. Additionally, the air bag expansion against the driver's face and head resulted in focal subarachnoid hemorrhage of the inferior aspect of the bilateral frontal lobes of the brain. The combination of direct air bag contact and the rearward acceleration of the head induced by the air bag resulted in thin subdural hemorrhage over the cerebral hemispheres bilaterally.

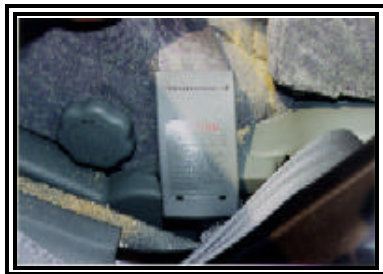
The manual safety systems consisted of 3-point, continuous loop lap and shoulder belt systems for the four outboard seated positions. The center rear position was equipped with a lap belt. The front belt systems utilized adjustable D-rings and energy management loops incorporated into the lap belt webbing adjacent to the outboard aspect of the seat cushion. Both D-rings were adjusted to the full up positions. There was 9.5 cm (3.75") of vertical adjustment to both units. The management loops were concealed by vinyl sleeves. The driver was restrained by the manual belt system, however, her loading force against the belt system was minimal due her mid track position and the deployment of the frontal air bag system. As a result, the left management loop remained intact.

Figure 10. Non-deployed management loop.

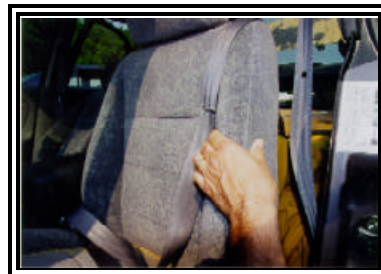
The front outboard seated positions of the Galant were equipped with 3-point lap and shoulder belt systems. The systems consisted of continuous loop webbings with sliding latch plates and retractors that were emergency locking and belt sensitive. The B-pillar mounted D-rings were adjustable and both were adjusted to the full-up position. The outboard aspect of the lap belt webbings were equipped with energy management loops that were located above the outboard anchorages. The loops were concealed within a vinyl sleeve and although the driver was belted, her loading force against the system was minimal as the loop remained intact (**Figure 10**). There was no loading evidence on the driver's belt system. Rescue personnel cut the shoulder belt webbing at the level of the shoulder as they provided treatment to the driver (**Figure 11**).

Figure 11. Cut shoulder belt webbing.

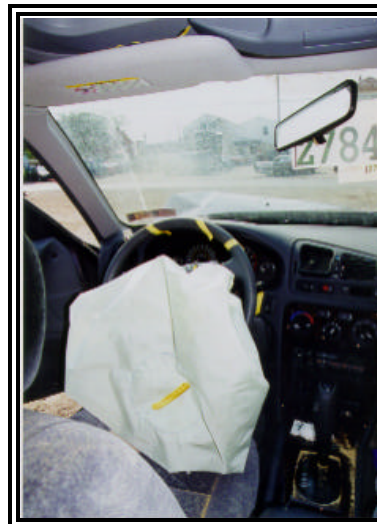
At impact with the sand barrel impact attenuator, the frontal air bag system in the Mitsubishi Galant deployed late in the crash sequence due to the graduated stacking of the impact attenuators. The late deployment allowed the driver to move forward in response to the 12 o'clock direction of force impact into

the path of the driver air bag module (**Figure 12**). Although restrained by the 3-point lap and shoulder belt system, the driver's mid track seat position combined with her forward movement prior to air bag deployment, positioned her torso with the deployment range of the single air bag module cover flap. It should be noted that the driver loaded the manual belt system as she initiated her forward trajectory, however, her loading force was not sufficient to deploy the energy management loop that was incorporated into the outboard aspect of the lap belt webbing, above the lower anchorage point. She did sustain petechial hemorrhages over the left shoulder from loading against the belt webbing.

Figure 12. View of the driver's trajectory.

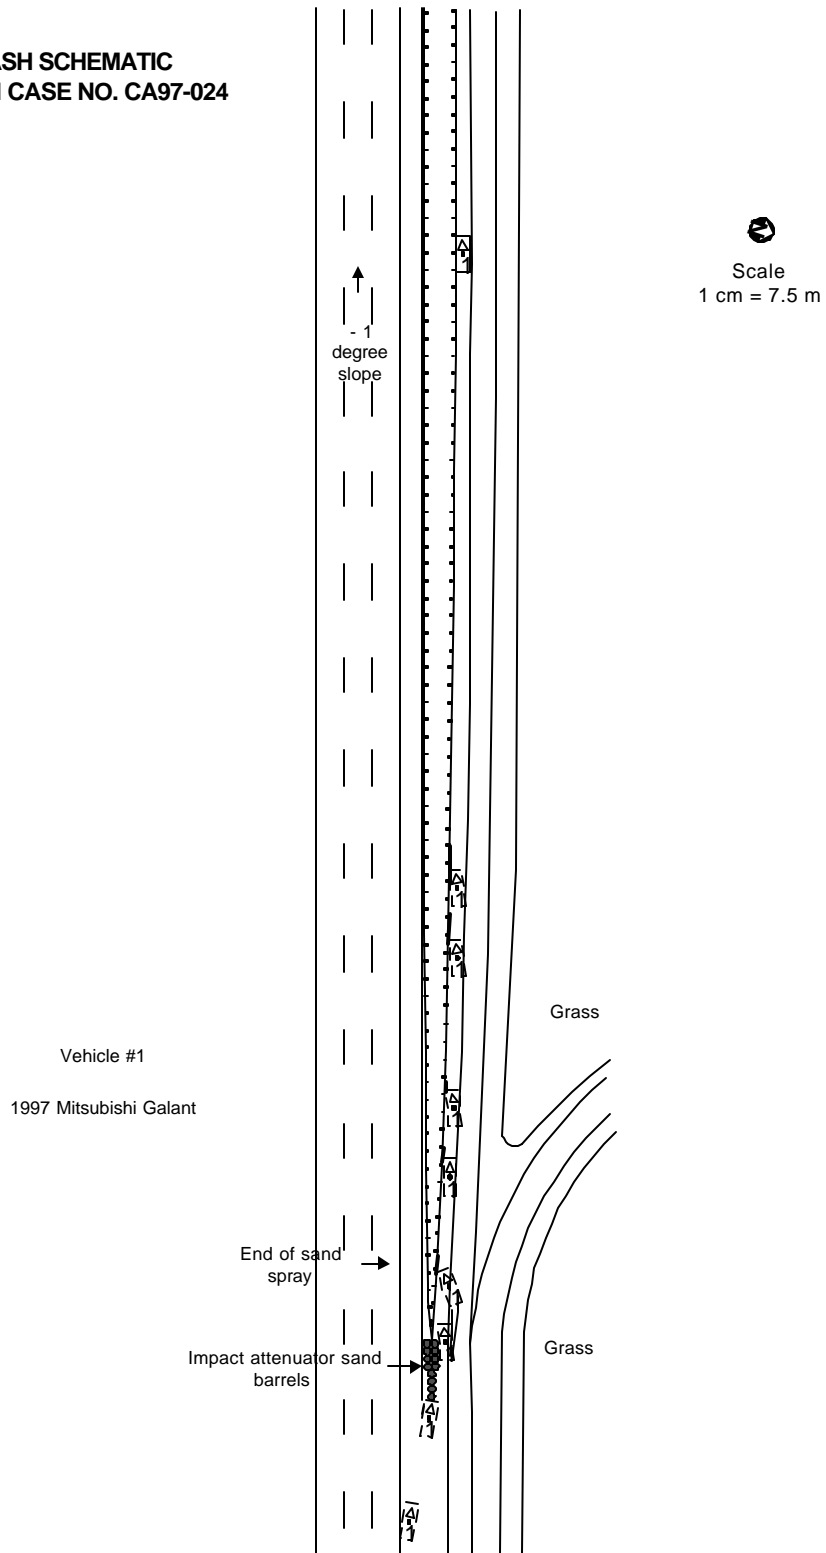
Figure 13. Crash Schematic.

The northbound lanes were separated by a wide median [estimated lateral distance of 0.8 km (0.5 miles)] that consisted of natural terrain features (e.g., trees, brush, grass, etc.) between the travel directions. South of the crash site, a left on-ramp merged into the southbound lanes. The new asphalt road surface was dry at the time of the nighttime crash. The ambient condition was clear with illumination adjacent to the dedicated exit lane. The Crash Schematic is attached as **Figure 13**.
