**CALSPAN ON-SITE AIR BAG NON-DEPLOYMENT INVESTIGATION
CALSPAN CASE NO. 97-026
LOCATION: NEW YORK
VEHICLE: 1995 JEEP GRAND CHEROKEE
CRASH DATE: JULY, 1997**

**CALSPAN ON-SITE AIR BAG NON-DEPLOYMENT INVESTIGATION
CALSPAN CASE NO: 97-026**

**LOCATION: NEW YORK
VEHICLE: 1995 JEEP GRAND CHEROKEE
CRASH DATE: JULY, 1997**

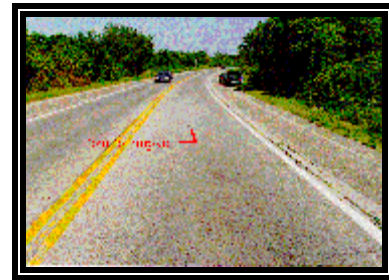
Figure 1: Eastbound trajectory view of the Jeep.

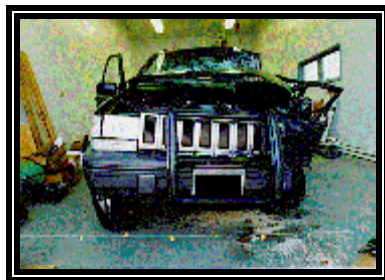
The left front corner of the Jeep sustained approximately 46 cm (18 in) of longitudinal crush over a lateral width of 20.3 cm (8.0 in) from the left side of the vehicle inboard right (**Figures 2 and 3**). This deformation occurred outboard of the left unibody frame rail. The left front tire and suspension were heavily impacted causing the left side wheelbase to be foreshortened 23.4 cm (9.2 in). The left A-pillar and left side of the instrument panel (IP) were deformed longitudinally rearward into the driver's space. The A-pillar and lower sill deformed laterally right 23 cm (9 in). The toe pan also intruded rearward into the foot well. The direction of force was from 11 o'clock. The left side damage of the Jeep continued rearward to the C-pillar, approximately 305 cm (120 in) from the front of the vehicle. The Collision Deformation Classification (CDC) of the vehicle was 11-FLEE-9. The estimated delta V of the Jeep was moderate, approximately 16 to 32 kph (10 to 20 mph). There was also secondary superficial damage to the right side of the Jeep caused by contact with a small tree and brush when the vehicle came to rest off the road edge.

Figure 2: Front view of the Jeep.

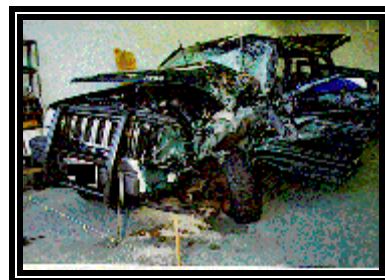
Figure 3: Left front view of the Jeep.

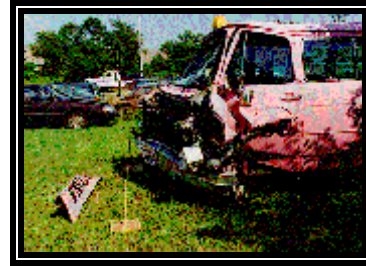
The GMC van sustained 170 cm (67 in) of direct contact damage across the full width of the front bumper. The maximum crush was 89 cm (35 in) at the left front corner (**Figure 4**). The right front corner was displaced laterally to the left 64.8 cm (25.5 in). The direction of force was in the 2 o'clock sector. The CDC of the vehicle was 02-FDEW-6. Inspection of the tread depths of the rear tires revealed the tires were worn. Measured tread depths ranged from 0/32 in. to a maximum of 2/32 in. The minimum legal tread depth per New York State law is 2/32 in.

Figure 4: Left lateral view of the GMC van.

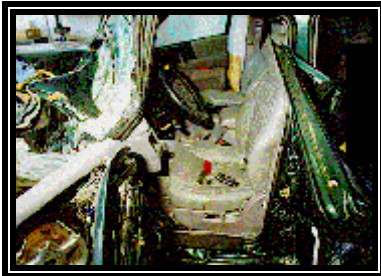
At impact, the driver of the Jeep was seated in a presumed normal posture. Given the large stature of the driver, the mid-track position of his seat positioned him forward, somewhat “close” to the steering wheel. Upon impact, the driver assumed a left front trajectory in response to the 11 o'clock direction of the impact force and loaded the steering wheel with his chest. The impact caused the left A-pillar, left door and left side of the instrument panel to deform rearward and intrude into the driver's space, **Figure 5**.

Figure 5: Left side view of the front interior.

The intrusion prevented inspection of the steering column's shear capsules, but there appeared to be separation on the left side. The right capsule was not accessible. The lower end of the column showed signs of having stroked, however, this could be caused by occupant loading, intrusion or a combination. The post-crash horizontal measurement from the center hub of the steering wheel to the left front seat back was 38 cm (15 in). Contacts to the left A-pillar, interior trim panel, and left side knee bolster from the driver's head and knees respectively were identified during the inspection.

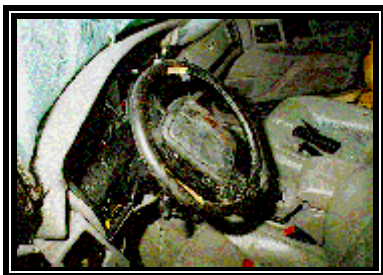
The Supplemental Restraint System in the Jeep was an electro-mechanical system that consisted of a driver air bag module, three impact sensors, an air bag control module (ACM) and the associated wiring harness. The air bag module was located in the typical manner in the center hub of the steering wheel, **Figure 7**.

Figure 7: Driver air bag module.

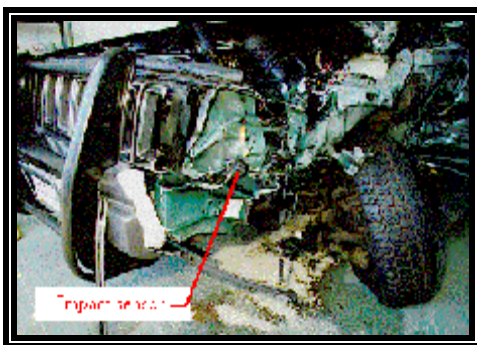
There was only one fault code stored in the ACM and that code indicated there was an open sensor. The 16 min refers to 16 minutes of electrical power to the circuit after the fault code and the 0 cycles refers to the number of ignition cycles that occurred following the fault. The sensor was opened presumably by the crash, the ignition was on for 16 minutes post-crash and there were no ignition cycles since the crash. The time (16 minutes) and ignition cycles (zero) indicated that prior to the crash the air bag system was functioning properly.

The open sensor was determined to be the left front sensor, **Figure 8**. In the crash and subsequent deformation of the left front fender and radiator support panel, the outboard section of the left front sensor's mounting deformed rearward. This caused the sensor to rotate counterclockwise, miss-aligning the longitudinal direction of the sensor with respect to that of the vehicle, **Figure 9**. The wiring harness connecting the sensor into the system ran internally through the built-up sheet metal section. The collapse of the sheet metal section, in the crash, pulled the connector from the rear of the sensor causing the open circuit fault, **Figure 10**.

Figure 8: Forward left sensor location.

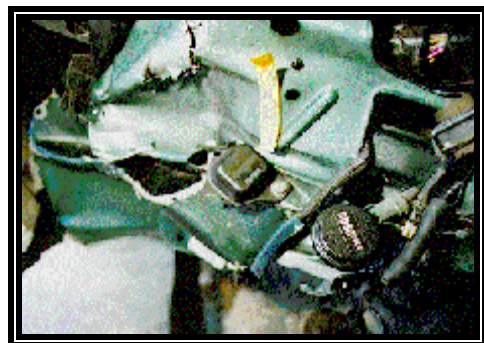
Figure 9: Close-up view of the post-crash sensor misalignment.

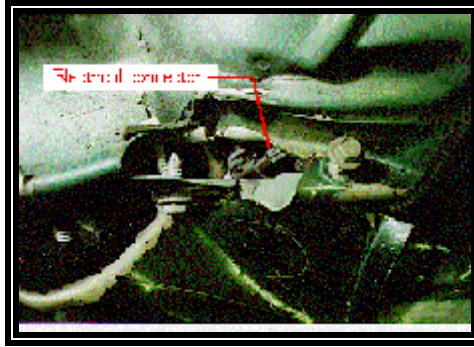
Figure 10: Close-up view of the electrical connector after sensor removal.
