On-scene / Vehicle to Vehicle  
Dynamic Science, Inc. / Case Number: DS97028  
1998 Toyota RAV 4  
California  
December/1997

1. Report No. DS97028		2. Government Accession No.		3. Recipient Catalog No.	
4. Title and Subtitle In-Depth Accident Investigation				5. Report Date	
				6. Performing Organization Report No.

Description: This case was initiated in response to a report of de-powered air bag deployment in a 1998 Toyota RAV4.

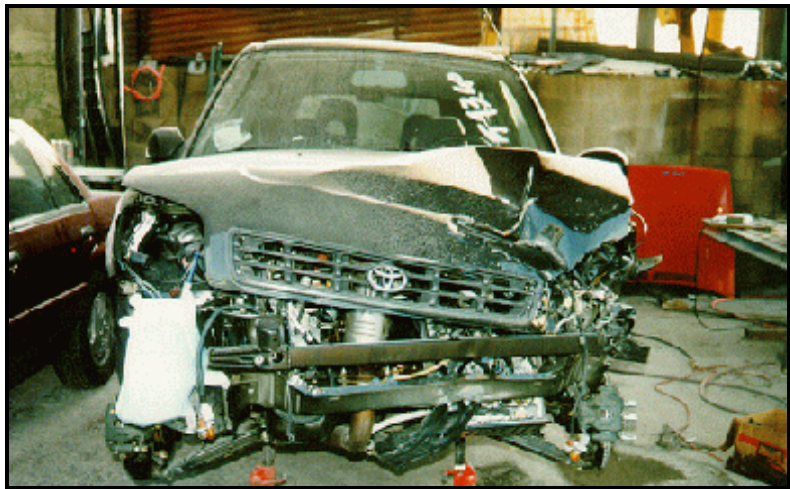
**Figure 1.** Exterior, Vehicle 1

Description:	1998 Toyota RAV 4, four-door, 2 wheel drive	
VIN:	JT3GP10V8WXXXXXXX	
Odometer:	Unknown (Digital)	
Engine:	2.0 liter, 4 cyl.	
Reported Defects:	None	
Cargo:	None	
Damage Description:	Moderate crush to front bumper and grille, left front tire was cut and the rim cracked, rear door buckled.	
CDC:	12FYEW2	
Minimum pre-braking travel speed, using slide to stop as one speed and the delta V as an impact speed: <sup>1</sup>	39.4 km/h (24.5)	
Delta V:	Total	21.6 km/h (13.4 MPH)
	Longitudinal	-21.3 km/h (-13.2 MPH)
	Lateral	-3.8 km/h (-2.3 MPH)
	Energy	39,589 joules (29,221 ft-lbs)

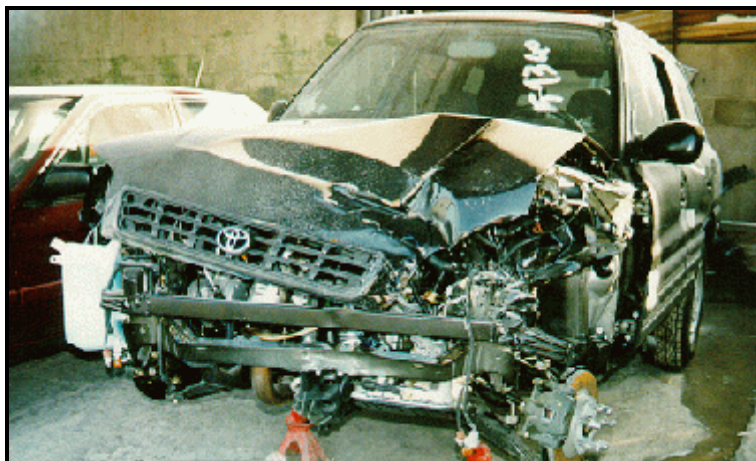
There was a small amount of intrusion to the toe pan area. There was no integrity loss, but the rear door was buckled somewhat.

**Figure 3.** Exterior, Vehicle 1

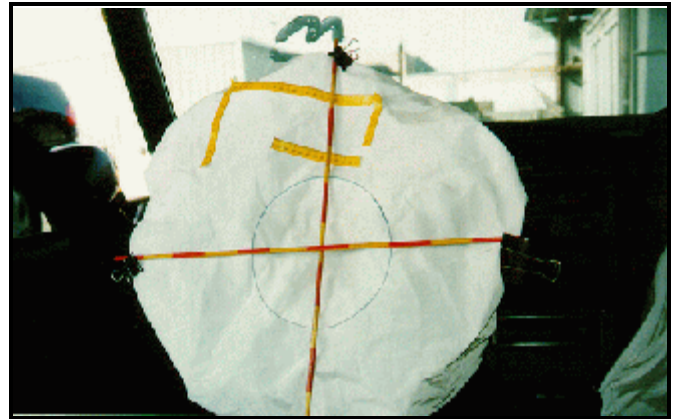
The right front seat was positioned between the forward most and middle track position--11.5 cm (4.5 in.) from the rear most position. The vehicle was equipped with front shoulder belt pretensioners with force limiters, and adjustable front outboard shoulder belt anchors. Both shoulder belts were found in the locked position at the time of the inspection. The three spoke steering wheel was equipped with driver's side air bag. The driver's side air bag is 54 cm (21.2 in.) in diameter with a maximum excursion of 30 cm (11.8 in.). It has two tethers and two vents. There was a blue 20 x 10 cm (7.9 x 3.9 in.) fabric transfer found on this air bag.

Figure 6. Driver's side air bag

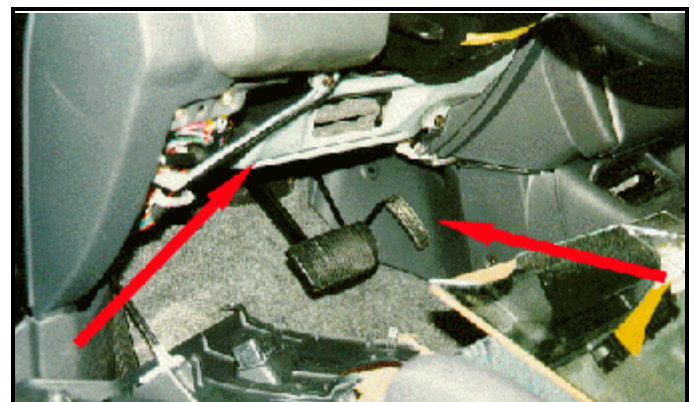
Figure 7. Damaged lower IP, shifted accelerator

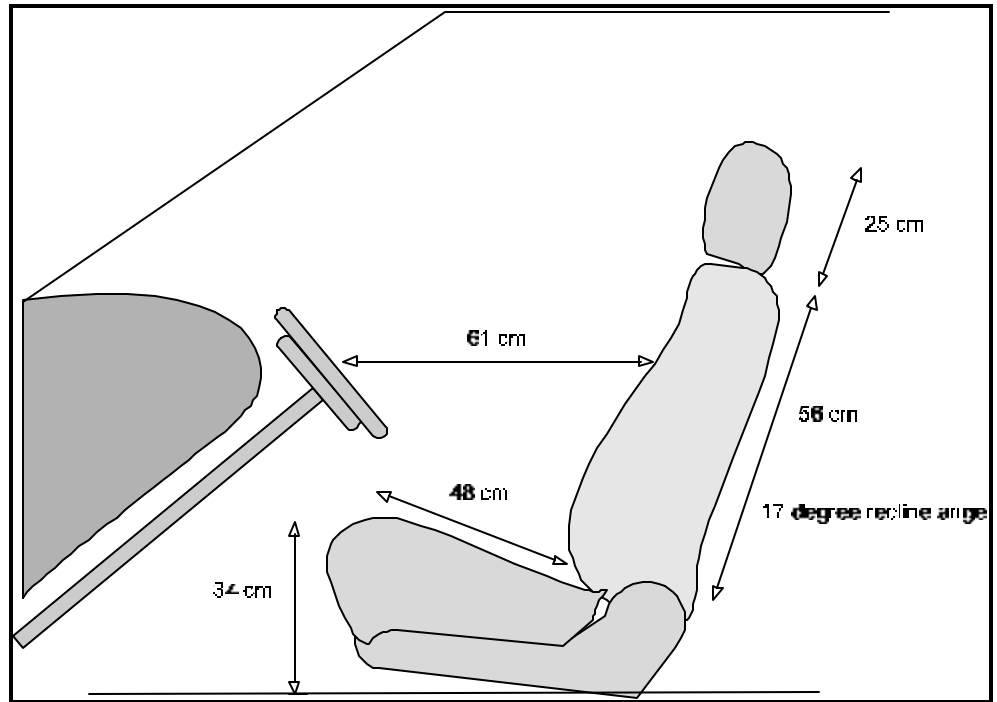
This vehicle is equipped with fabric-trimmed reclining front bucket seats and rear reclining/folding rear seats. The left front seat was positioned between middle and rear most track positions--10.5 cm (4 in.) from the rear most position. The driver's seat back was 39 cm (15.3 in.) from the maximum excursion. The driver's seat was adjusted to 10.5 cm from the rear most position.

Figure 8. Driver's seat

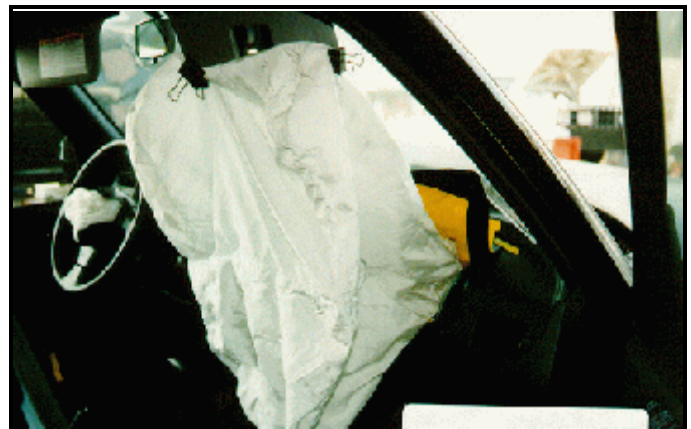
The module cover is tri-seamed configuration. The passenger side air bag is 52 x 53 cm (20.5 x 20.8 in.). The seat was adjusted to 11.5 cm from the rear most position. It has one tether and two vents. There are four horizontal and two vertical folds. The module cover is rectangular, measuring 34 cm (13.4 in.) wide by 22 cm (8.6 in.) high.

The 18-year-old male right front occupant (188 cm /74 in., 88 kg /193 lbs.) was seated in a bucket seat. He was wearing the lap and shoulder belt. The shoulder belt was equipped with a pretensioner, and was adjusted to the full up position. The seat was positioned 11.5 cm from the rear most position. This occupant was aware of the pending collision. He raised his arms with the palms facing outward toward the front of the vehicle. At impact, the passenger side air bag deployed. The deploying air bag struck the passenger's right hand and arm, spraining the hand and abrading the arm.

Figure 9. Passenger side air bag
