**VERIDIAN ON-SITE AIR BAG RELATED CHILD PASSENGER  
FATALITY INVESTIGATION  
VERIDIAN CASE NO. CA97-028  
VEHICLE: 1994 JAGUAR XJ6  
LOCATION: NORTH CAROLINA  
CRASH DATE: AUGUST 1997**

Contract No.  
DTNH22-94-D-07058

<p>14. <i>Sponsoring Agency Code</i></p>	
<p>15. <i>Supplementary Notes</i> On-site investigation of a front-to-rear crash that resulted in front right air bag deployment and the death of an 8 year old male front right child passenger.</p>			
<p>16. <i>Abstract</i> This on-site investigation focused on the injury severity, injury mechanisms, and cause of death of an eight year old female front right passenger in a 1994 Jaguar XJ6. The Jaguar was equipped with frontal air bags for the driver and front right passenger positions. The front right air bag deployed as a result of a front-to-rear impact sequence with a 1996 Chevrolet Impala SS. The driver of the Jaguar was traveling in a northerly direction on a two lane state route, following the Chevrolet Impala. The driver of the Impala noted a slow moving non-contact vehicle traveling northbound ahead of his path of travel, and slowed to avoid contact. The Impala driver checked his rear view mirror and noted that the

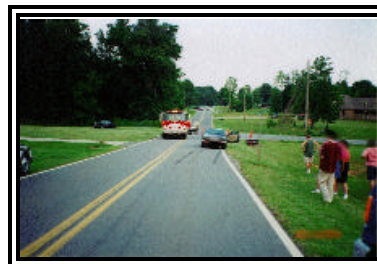
**Figure 1. Overall view of the crash site and final rest positions of the vehicles.**

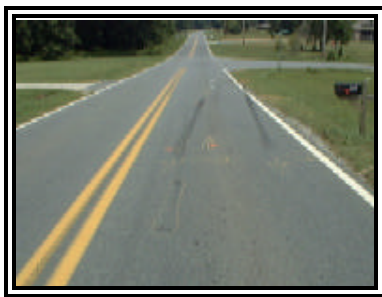
**Figure 2. Post-impact skid marks from the Jaguar.**

The driver of the Jaguar maintained a sufficient braking force throughout the crash event to activate the ABS of the XJ6. The front tires marked on the asphalt road surface following impact which evidenced her level of braking and the trajectory of the vehicle (**Figure 2**). The Jaguar came to rest approximately 15.25

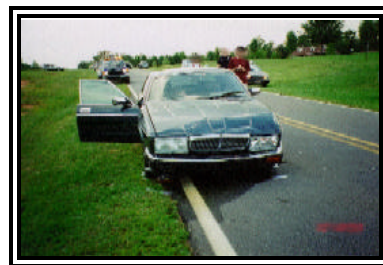
**Figure 3. Final rest position of the Jaguar.**

m (50.0') north of the point of impact, straddling the east edge line. At rest, the vehicle was facing in a slightly skewed attitude from its initial pre-crash trajectory (**Figure 3**).

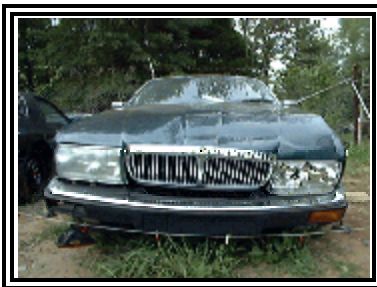
The Jaguar sustained moderate frontal damage (**Figure 4**) from its impact sequence with the 1996 Chevrolet Impala. The direct contact damage began 37.5 cm (14.75") right of the vehicle's centerline and extended 113.0 cm (44.5") to the left bumper corner. The combined direct and induced damage length was 152.4 cm (60.0") which extended across the full frontal width of the vehicle. Maximum crush was 18.4 cm (7.25") located at the left corner of the front bumper (**Figure 5**). The Jaguar's crush profile at bumper level was as follows: C1 = 18.4 cm (7.25"), C2 = 15.9 cm (6.25"), C3 = 13.3 cm (5.25"), C4 = 10.8 cm (4.25"), C5 = 11.4 cm (4.5"), C6 = 11.4 cm (4.25").

**Figure 4. Frontal damage to the Jaguar.**

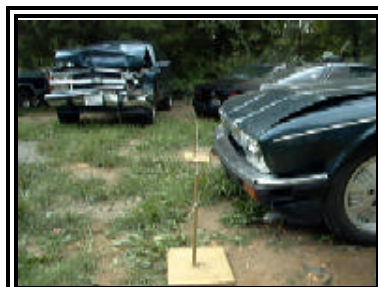
**Figure 5. Profile view documenting the extent of crash at the front left corner.**

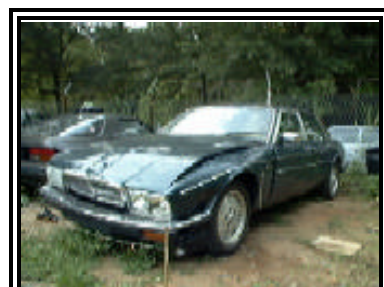
The initial contact involved the front bumper of the Jaguar against the rear bumper of the Impala. As the vehicles crushed to maximum engagement, the front bumper of the Jaguar partially underrode the Impala's bumper resulting in minimal crush to the Jaguar's grille, left headlamp assembly, and hood. The impact buckled the hood and both front fenders of the XJ6 (**Figure 6**). The Collision Deformation Classification (CDC) for the Jaguar was 12-FDEW-1.

**Figure 6. Three-quarter view of the Jaguar's frontal damage.**

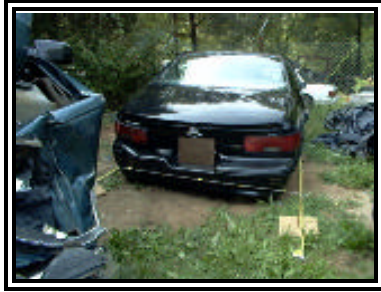
The back plane of the Chevrolet Impala sustained moderate damage (**Figure 7**) as a result of the front-to-rear impact sequence with the 1994 Jaguar XJ6. Maximum crush was 19.8 cm (10.8") located on the rear bumper, 10.0 cm (4.0") inboard of the left bumper corner. The direct contact damage began at the left rear bumper corner and extended 142.2 cm (56.0") to the right, terminating 12.7 cm (5.0") inboard of the right corner. The direct damage was located exclusively to the rear bumper fascia. The combined direct and induced damage length was 154.9 cm (61.0") that involved the full end-width of the vehicle. The crush profile at bumper level was as follows: C1 = 16.0 cm (6.3"), C2 = 14.7 cm (5.8"), C3 = 18.0 cm (7.1"), C4 = 16.5 cm (6.5"), C5 = 13.5 cm (5.3"), C6 = 11.2 cm (4.4").

**Figure 7. Back damage to the struck Impala.**

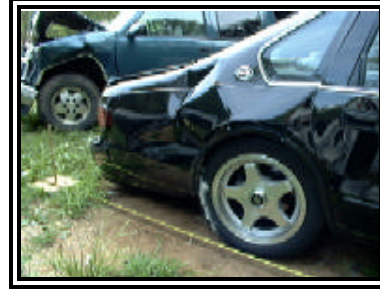
The rear impact crushed the end plane of the Impala forward and buckled the quarter panels at the base of the upper D-pillars and C-pillars (**Figure 8**). This resulted in a downward displacement of the rear structure. The right front and both rear doors of the Impala were jammed closed by the exterior deformation. Minor reductions of the wheelbases were noted with 2.3 cm (0.9") on the left and 3.6 cm (1.4") on the right. There was no glazing damage to the vehicle and no intrusion of the passenger compartment. The CDC for this event was 46-BDLW-2. The 06 o'clock direction of force was incremented by a value of 40 to reflect the downward vertical displacement of the end structure.

**Figure 8. Induced damage to the right rear quarter panel area.**

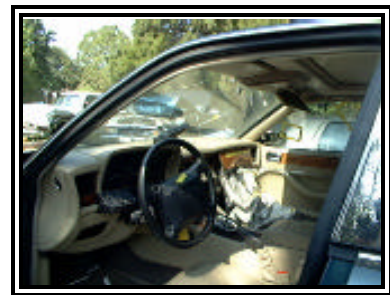
**Figure 9. Overall view of the Jaguar's frontal air bag system.**

The driver air bag was mounted in the typical configuration within the center hub of the four spoke steering wheel rim. The spokes were located at the 5 and 7, and 2:30 and 9:30 o'clock sectors (**Figure 9**). The air bag was concealed by symmetrical H-configuration cover flaps. There was no damage or contact evidence noted to the non-deployed driver air bag module.

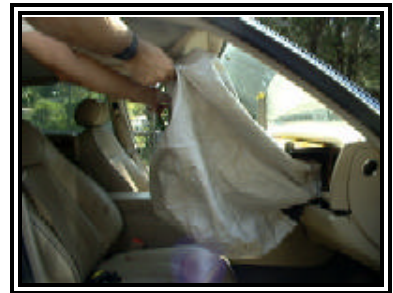
The front right passenger air bag was a mid-mount design located in the right aspect of the instrument panel (**Figure 10**). The module was concealed by a single cover flap that opened in an upward direction. The cover flap was hinged by two arms that attached forward of the face of the mid panel, thus allowing the cover flap to partially retract into the instrument panel at deployment. This garage door-type design reduced the risk of contact to out-of-position occupants. The overall dimensions of the cover flap were 13.7 cm (5.375") vertically and 44.8 cm (17.625") horizontally. The left edge of the cover flap was located 18.4 cm (7.25") right of the vehicle's center line. The cover flap consisted of a wood grain outer skin with a rigid plastic trim affixed to the bottom edge of the flap. This trim panel protruded 2.5 cm (1.0") below the wood grain face panel of the flap. The padded upper instrument panel protruded 2.2 cm (0.875") over the mid panel. The lower right corner of the cover flap was printed with the acronym SRS (Supplemental Restraint System).

**Figure 10. Deployed mid mount front right passenger air bag.**

The child passenger was contacted by the mid mount cover flap as the passenger air bag system deployed. Her contact with the flap deformed the mid aspect of the flap in a semi-circular pattern. The contact was evidenced by a tissue transfer on the trim panel at the leading edge of the flap. This trim panel partially separated from the cover flap and was bowed from contact against the child passenger.

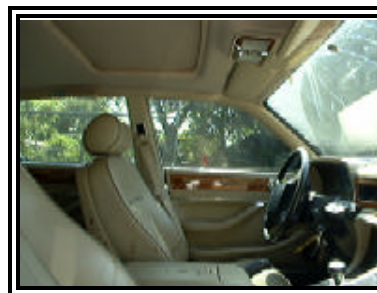
The driver of the Jaguar was seated in a presumed normal driving posture with her seat adjusted to a mid track position and the seat back reclined to a measured angle of 24 degrees. In this adjusted position, the horizontal distance between the non-deployed driver air bag module and the seat back (**Figure 11**) was 55.9 cm (22.0"). The driver was restrained by the manual 3-point lap and shoulder belt system. The belt system did yield evidence of occasional usage, however, there was no loading evidence to support usage at the time of the crash.

**Figure 11. Driver's seated position and trajectory.**

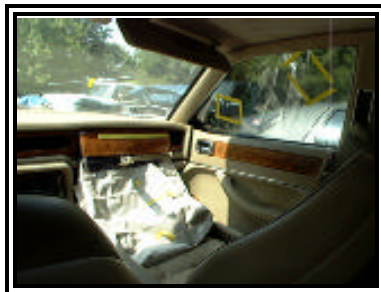
The child passenger responded to the driver's pre-crash braking actions by moving forward on the leather seat (**Figure 12**). The leather surface provided a lower frictional coefficient between the child and the seat cushion. As she moved forward in response to the braking force, her pelvic region engaged the lap belt webbing and due to the improper placement of the shoulder belt, her upper torso and head pitched downward. This pre-crash motion placed the child's face in close proximity to the mid mount passenger air bag module cover flap.

**Figure 12. Forward trajectory of the child passenger into the path of the mid mount air bag.**

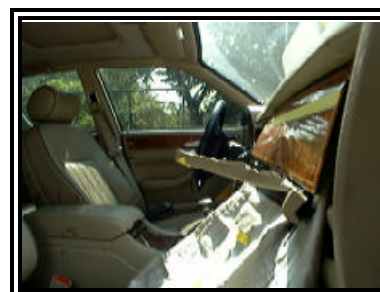
**Figure 13. Cover flap damage front contact with the forward positioned child passenger.**

At impact, the front right passenger air bag deployed. The leading edge of the cover flap impacted the submental and anterior neck regions of the out-of-positioned child passenger. This contact was evidenced by tissue transfers to the trim panel of the flap and severe bowing of the trim with a semi-circular depression of the face of the woodgrain cover flap (**Figure 13**). This flap contact initiated a hyper-extension of the neck as the air bag membrane began to expand from the module. The combination of flap and membrane contact produced band-like abrasions across the submental and anterior neck regions that extended from ear-to-ear of the child. In addition, she sustained two lacerations of this region from the trim on the leading edge of the flap. The continued upward motion of the flap and the subsequent bag expansion resulted in a fracture/dislocation of the atlanto-occipital joint, cerebral subarachnoid hemorrhage, and cerebral swelling. Although unconfirmed, the child passenger probably sustained a cervical cord/brain stem injury. The non-invasive autopsy reported an impression of a lethal injury from a CT scan.

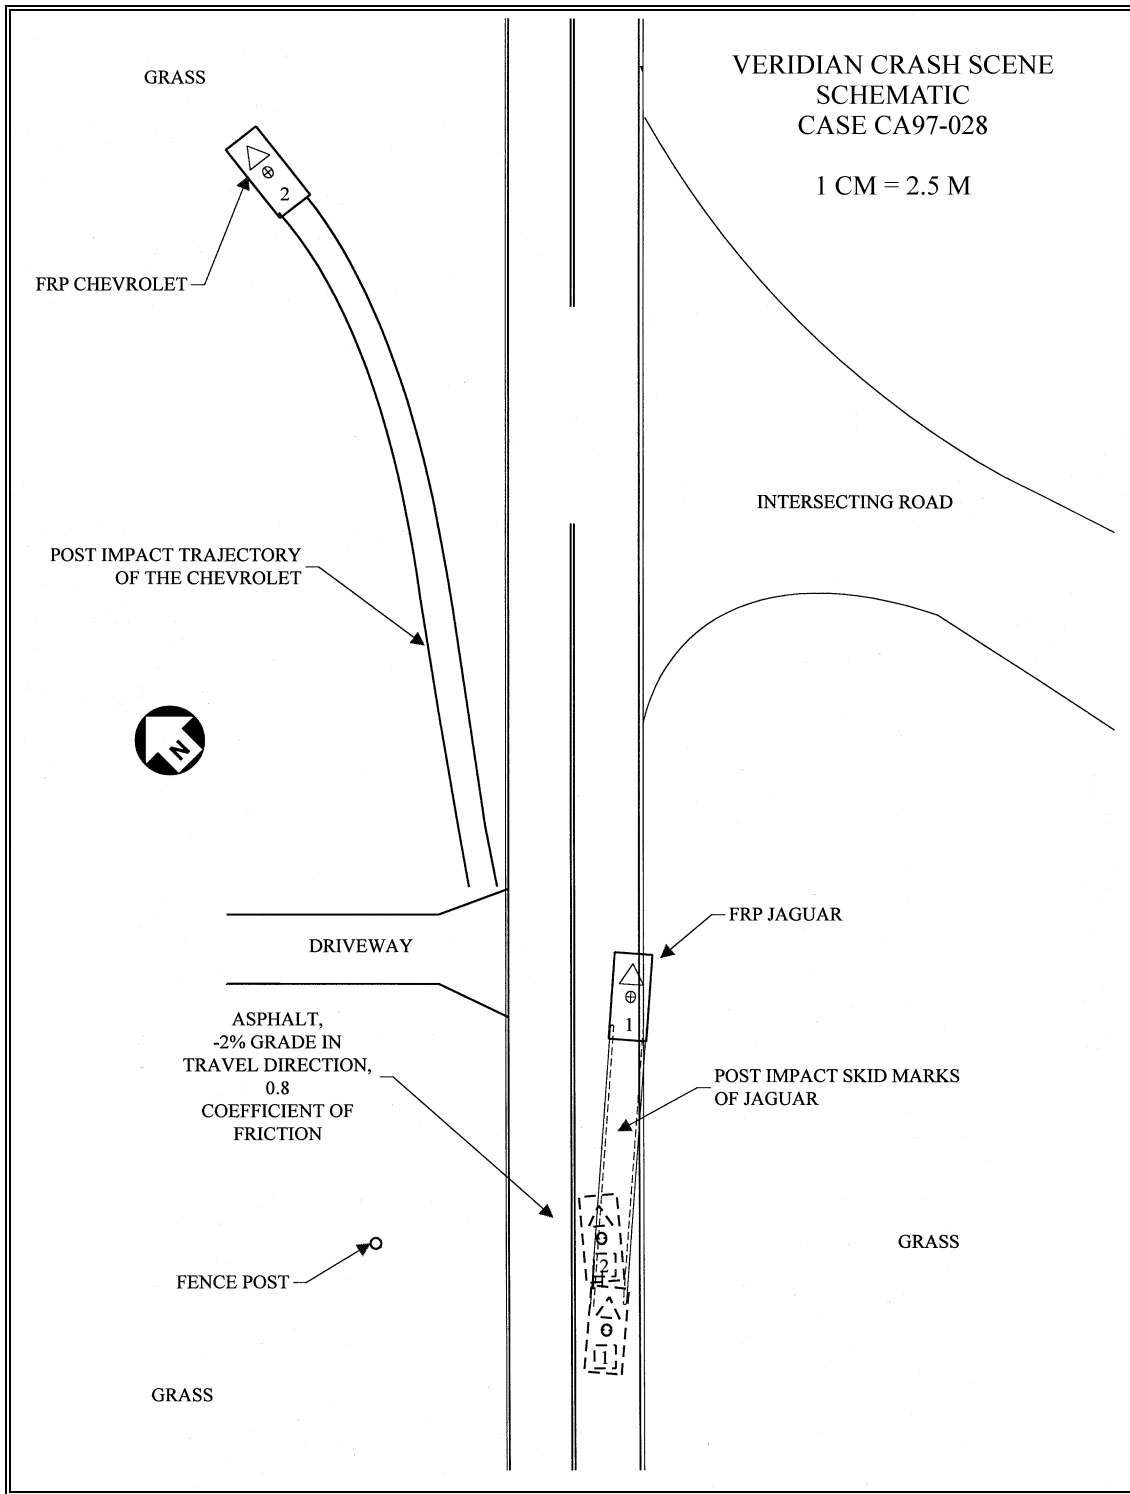
**Figure 14. Crash Scene Schematic**

The 26 year old female driver of the Jaguar had departed a social function and was traveling to her residence with her eight year old daughter seated in the front right position and her five year old son seated in the left rear of the XJ6. She was traveling in a northerly direction on the two lane state route at a police reported speed of 80 km/h (50 mph). She was following her husband who was driving a 1996 Chevrolet Impala SS. Traveling ahead of the Impala was a non-contact vehicle that was proceeding at a police and driver reported slow rate of speed. The driver of the Impala braked for the non-contact vehicle. As he decelerated, the driver of the Impala checked his rear view mirror and noted that the driver of the Jaguar failed to detect his braking actions for the non-contact vehicle. The Impala driver, aware of an impending impact, accelerated his vehicle and steered to the left in an attempt to avoid the crash. The driver of the Jaguar steered to her right and braked with sufficient force to activate the ABS braking system of the Jaguar in an attempt to avoid impact with the Impala. The crash schematic is attached as **Figure 14**, Page 12.
