ON-SITE DRIVER AIR BAG RELATED SEVERE INJURY CRASH INVESTIGATION

VEHICLE: 1991 FORD TAURUS

VERIDIAN CASE NO. CA97-029

LOCATION: NORTH CAROLINA

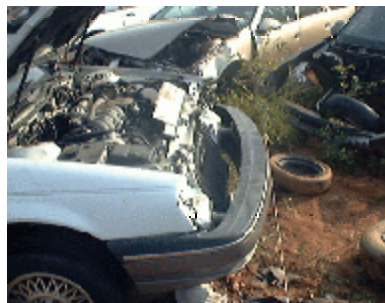
The impact resulted in a 12 o'clock/6 o'clock impact configuration to the Taurus and Explorer respectively and initiated the deployment sequence of the Taurus' driver side air bag system. The impact to the Ford Taurus compressed the front bumper Energy Absorption Devices (EAD), resulting in longitudinal striations to the male end component. Direct contact damage produced longitudinal abrasions to the top surface of the bumper fascia which extended rearward into the header panel with subsequent deformation of the upper radiator support panel. There was no residual crush at the bumper level. Crush measurements at the radiator support yielded a maximum crush value of 17.2 cm (6.75 in)

at C4 which was located 60 cm (24 in) left of the right front bumper corner. Crush values are reported in Table 1. The damage resulted in a 12 o'clock direction of force with a Collision Deformation Classification (CDC) of 12-FDEW-1. The Taurus sustained a ROLDMISS calculated total delta V of 18.4 km/h (11.4 mph).

Figure 2. Right lateral view of the crush damage to the upper radiator support of the Ford Taurus.

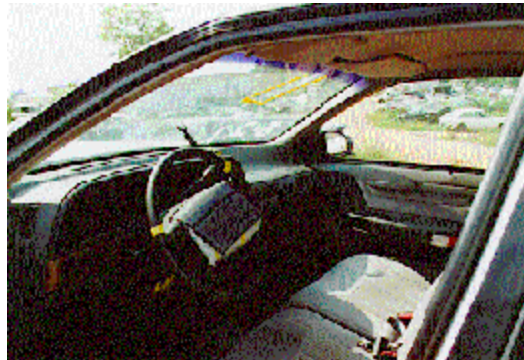
Figure 3. Overall view of the Ford Taurus' passenger compartment
