On-scene Investigation / Vehicle to Tree
Dynamic Science, Inc. / Case Number: DS97030
1996 Nissan Sentra GXE 4-door
California
December, 1997

1. Report No. DS97030		2. Government Accession No.		3. Recipient Catalog No.	
4. Title and Subtitle In-Depth Accident Investigation				5. Report Date May 20, 2000

Dynamic Science, Inc.
Accident Investigation
Case Number: DS97030

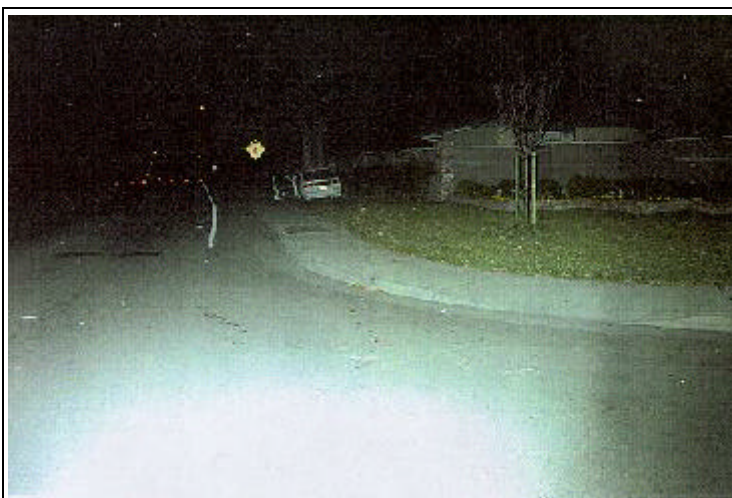
Figure 1. Scene of collision.

not negotiate the curve and continued straight running up and over the north-east edge concrete curb (see Figure 1). At the vehicle inspection, the front right, front left, and rear right tires were flat. The front right and rear right tire rims were also dented from the impact with the concrete curb. The impact with the curb was not of sufficient magnitude to the deploy the air bags. There was no indication that the driver took any evasive maneuvers after the vehicle struck the curb. Vehicle 1 continued in a northerly direction and collided head-on into a tree (34.0 cm/13.4 in diameter) approximately 20 m (65 ft) from impact with the concrete curb (see Figure 2). Vehicle 1 came to rest heading north on all four wheels and resting with its front end against the tree.

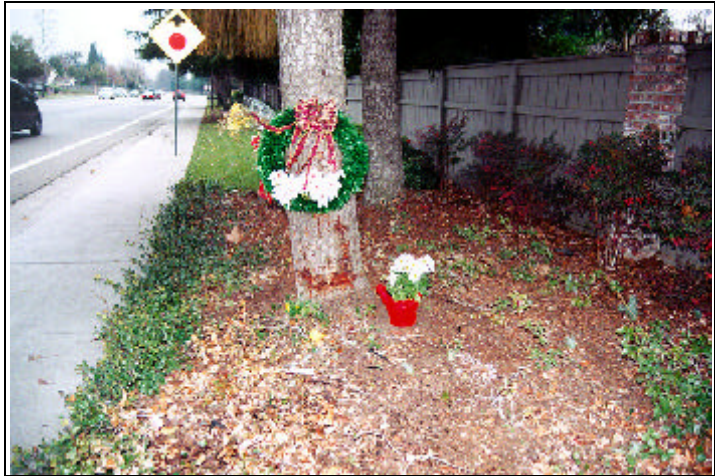
Figure 2. Tree Vehicle 1 struck.

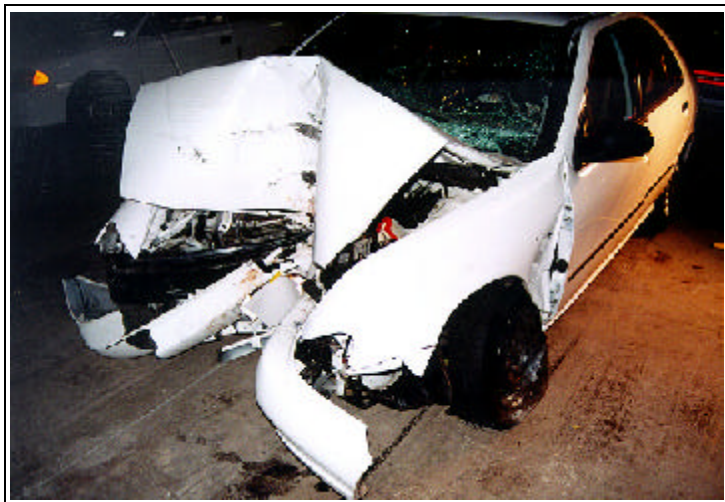
Vehicle 1 sustained major damage to the entire front end. The front axle was displaced rearward approximately 28.0 cm (11.0 in) as a result of the impact with the tree. Event number 4, the front end of Vehicle 1 striking the tree, was the highest delta v event. A CDC of 12FCEN3 has been assigned to the impact with the tree, and maximum crush was measured at C³ and equaled 82.3 cm (32.4 in). The barrier portion of the WinSmash algorithm computed a total delta v of 68.3 km/h (42.4 mph), a longitudinal delta v of - 68.3 km/h (- 42.4 mph), and a latitudinal delta v of 0.0 km/h (0.0 mph). The results fit the collision model and appear reasonable. Vehicle 1 was towed from the scene.

Figure 3. Exterior damage to Vehicle 1.

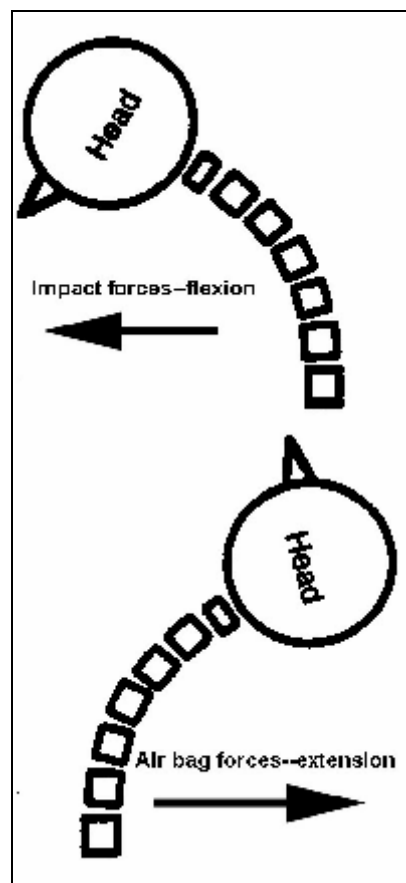
She had a contusion of spinal cord with fracture of the C2 vertebral column (AIS 3). There is a dislocation gap between C1 and C2, but the C2 vertebral body has been shifted anteriorly into the neck, and surrounding the fracture site in the prevertebral space of the neck is abundant hemorrhage and clot. The C2 fracture line is jagged, and forms an upside down V. Associated with the C2 fracture are fractures of the hyoid bone. The right side of the hyoid bone is fractured 2 cm from the tip, and the left horn of the hyoid bone is 0.5 cm (0.3 in) from the tip. This injury is a combination of forward flexion of the cervical spine as a result of the impact with the tree,

Figure 4. Cervical spine flexion and extension.

and extension of the cervical spine as a result of rearward acceleration of the cervical spine by the deployment of the driver's air bag (see Figure 4).

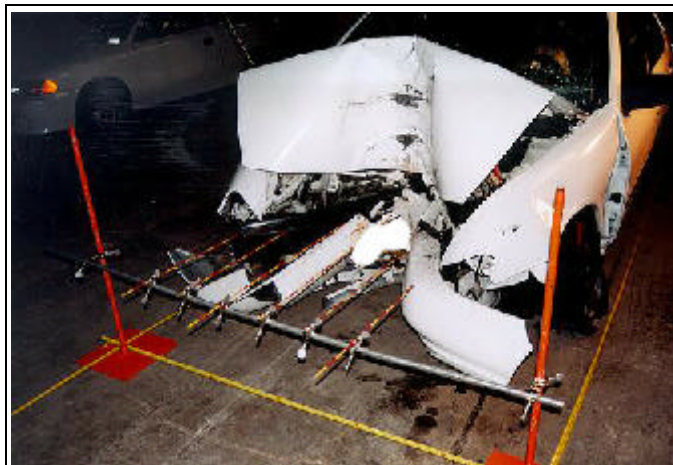
Description:	1996 Nissan Sentra GXE 4-door	
VIN:	1N4AB41D5TCXXXXXX	
Odometer:	8,267 km (25,973 miles)	
Engine:	1.6 L V4	
Reported Defects:	None reported	
Cargo:	None	
Damage Description:	Severe/total front end damage, hood, grille area, and both front fenders. The frame around the driver's door buckled, as did the roof top. The front right and left tires were restricted, and the front axle was damaged.	
CDC (4 th event–highest Delta V):	12FCEN3	
Delta V ⁴ :	Total	68.3 km/h (42.4 mph)
	Longitudinal	-68.3 km/h (-42.4 mph)
	Latitudinal	0 km/h (0 mph)
	Energy	205,609 joules (151,750 ft-lb)

Figure 6. Exterior damage to vehicle.

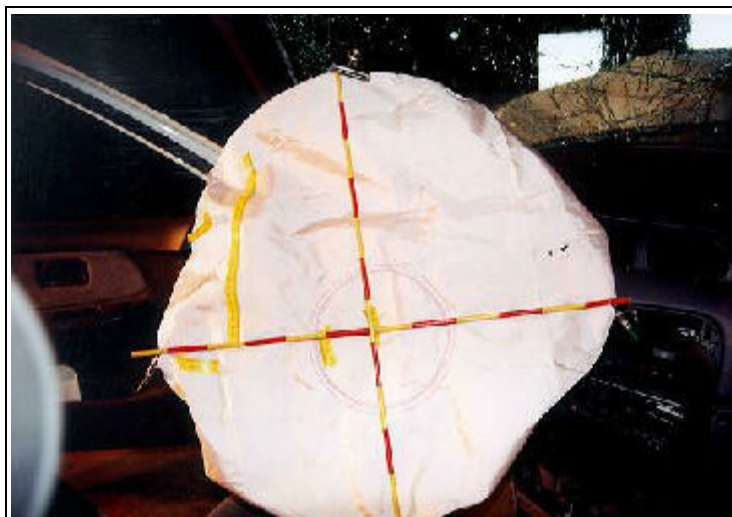
Vehicle 1 was equipped with a driver's air bag and a top-mounted front right passenger's air bag. The steering wheel hub mounted driver's air bag was circular and measured 57.0 cm (22.4 in) in diameter. It had three tethers and two rear vent ports at the 11 and 1 o'clock positions. There were four vertical, and four horizontal folds. There were black linear smudges along the outer top part, and on the back outer mid area of the air bag. These linear smudges are consistent with contact with the module covers as the air bag unfolds. There were grease spots in the center and lower mid part of the air bag. The air bag had a maximum excursion of 30.0 cm (11.8 in). There was no damage to the air bag. The dual module covers opened in a typical "H" configuration, and the upper and lower module covers were not deformed, but there was an oil smudge on the upper cover. The passenger side air bag is rectangular in shape and measures 56.0 cm (22.0 in) high by 37.0 cm (14.6 in) wide; it was not tethered and had two vent holes at the rear and outboard part of the air bag. It was not damaged, and there was food found on the lower left corner of the air bag. The single module cover is rectangular in shape and there were no indications of damage or occupant contact.

Figure 7. Driver's air bag.
