ON-SITE AIR BAG INVESTIGATION

CASE NUMBER - IN97-034

VEHICLE - 1997 HYUNDAI ACCENT L

CRASH DATE - October, 1997

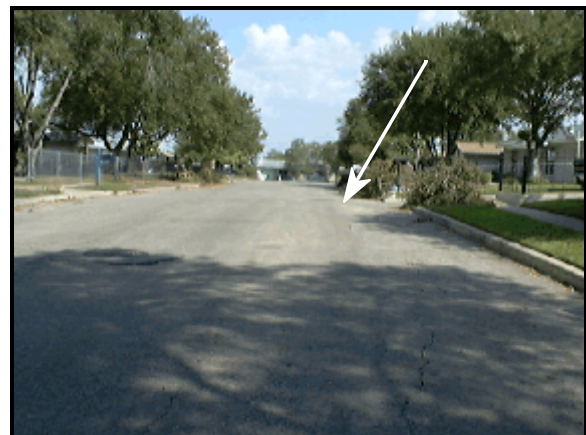
Figure 1: Case vehicle's eastbound travel path; Note: arrow indicates approximate point of impact (case photo #01)

Both the case vehicle and vehicle #2 were traveling on a dry, bituminous roadway that was straight and level at the area of impact (Figure 1 above). The width of the travel lanes for both vehicles was 4.5 meters (14.9 feet). There were no lane markings (e.g., painted yellow center line) or traffic controls present. The roadway is bordered by mountable curbs. The estimated coefficient of friction for the roadway is 0.75%. The posted speed limit was 48 km.p.h. (30 m.p.h.). The surrounding area is residential.

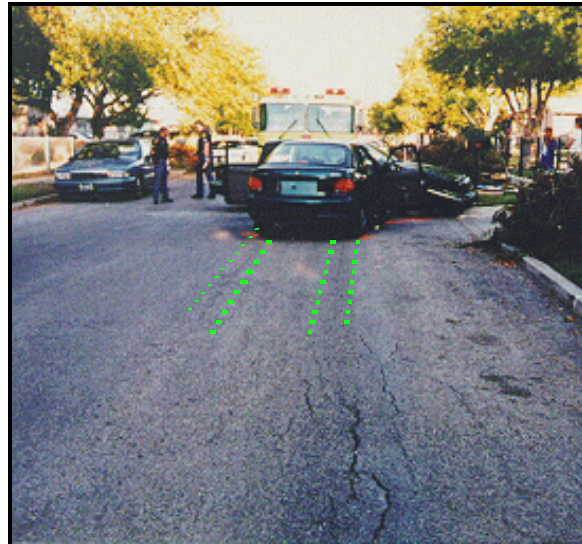
Figure 2: On-scene view of case vehicle and vehicle #2 at final rest positions; Note: highlighted faint tire scrub marks leading to case vehicle's final rest position (case photo #53)

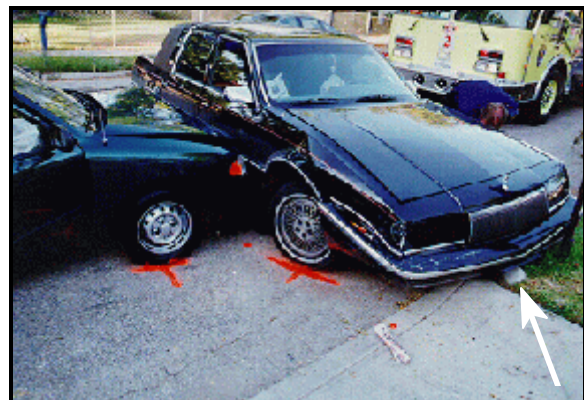
Figure 3: On-scene view of case vehicle (left) and vehicle #2 (right) at final rest; Note: struck brick landscape edging underneath vehicle #2's front bumper (case photo #54)

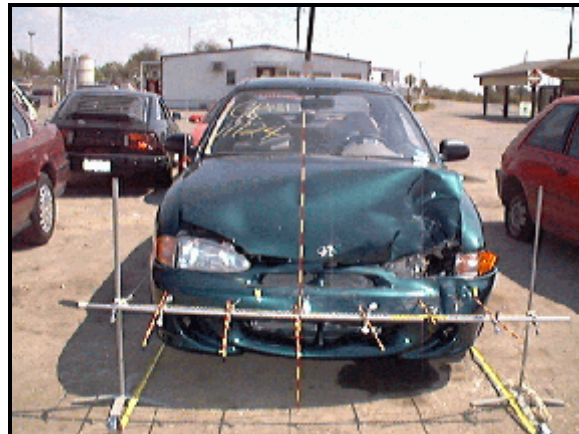
The case vehicle’s initial contact with vehicle #2 involved the left **b** of the front bumper and began with the case vehicle’s front bumper fascia impacting against the front right bumper corner of vehicle #2 (**Figure 4**). Direct contact damage consisted of a lateral abrasive pattern that began at the front left bumper corner and extended 92 centimeters (36.2 inches) to the right (**Figure 5**). The left fender, hood, bumper fascia, and bumper reinforcement bar were deformed rearward. The residual deformation to the bumper reinforcement bar was relatively minor. The damage pattern suggests an obtuse angle impact such as occurred with vehicle #2 turning left into the case vehicle’s travel path. The case vehicle’s crush was uneven with the deformation above bumper (i.e., hood--**Figure 5**) being greater than at bumper level. This uneven crush profile is indicative of the case vehicle underriding vehicle #2’s front bumper during its braking maneuver. The maximum deformation above bumper was 24 centimeters (9.4 inches) while only 12 centimeters (4.7 inches) maximum at bumper level. The field L was measured at 133 centimeters (52.4 inches). The wheelbase on the left (drivers) side was shortened 3 centimeters (1.2 inches). None of the case vehicle’s tires were deflated or physically restricted. There was no evidence of intrusion to the case vehicle’s interior. The CDC was determined to be: **12-FYEW-2 (-10)**.

Figure 4: Case vehicle’s front with contour gauge present showing damage from impact with vehicle #2; Note: vehicle #2’s front right bumper corner impacted case vehicle’s front left (case photo #11)

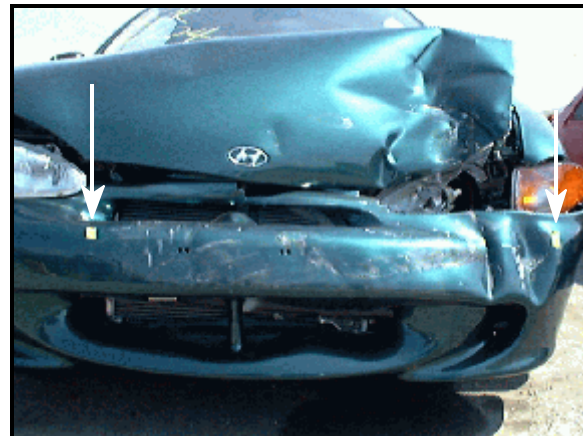
This uneven crush profile is indicative of the case

Figure 5: Close-up of direct damage (between yellow tape) to case vehicle’s front bumper and left hood and corner area (case photo #22)

highest severity impact. The Total, Longitudinal, and Lateral Delta V's are, respectively: 18.2 km.p.h. (11.3 m.p.h.), -17.9 km.p.h. (-11.1 m.p.h.), and +3.2 km.p.h. (+2.0 m.p.h.). The case vehicle was towed due to damage.

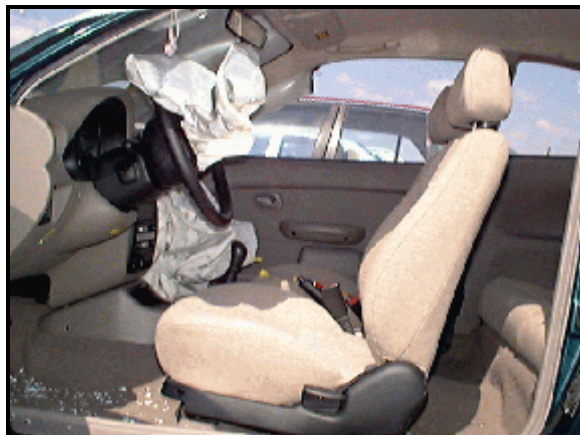
The case vehicle was equipped with a SRS that consisted of frontal air bags at the driver and front right passenger positions. The SRS deployed as a result of the case vehicle's frontal impact with the front right corner of vehicle #2 (Figure 6).

Figure 6: On-scene view of case vehicle's front seating area showing deployed front air bags and close proximity of seats to air bags (case photo #23)

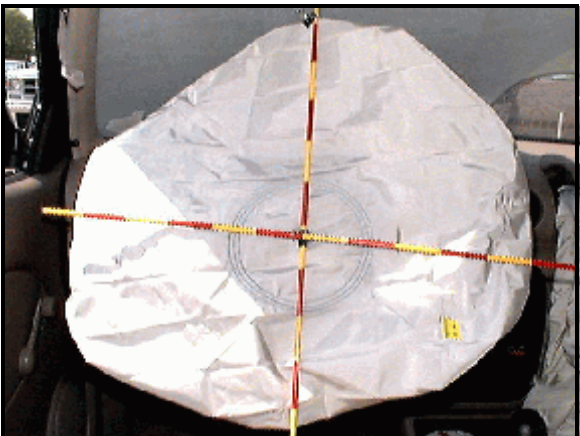
The driver's air bag had three tethers sewn to the interior center face of the air bag, two vent ports--of unknown diameter, located at the 10 and 2 o'clock positions, and was round with a diameter of 60 centimeters (23.6 inches). There was a 0.5 centimeter (0.2 inch) black transfer (possibly mascara) on the driver's air bag near the 11 o'clock position (Figure 7).

Figure 7: Case vehicle's deployed driver air bag showing area (yellow tape) of mascara transfer near 11 o'clock position; Note: steering wheel has been rotated clockwise (case photo #29)

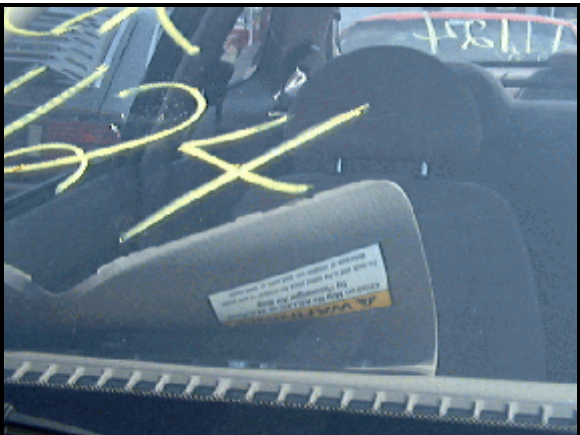
Figure 8: Case vehicle's deformed front right air bag module's cover flap, positioned against and viewed through windshield (case photo #35)

cover flap was 35 centimeters (13.8 inches) wide and 15 centimeters (5.9 inches) high. The hinged flap did contacted the windshield, resulting in the scuffing but no cracking to the windshield. The cover flap was deformed during the air bags deployment (**Figure 8** above). Furthermore, the flap showed evidence of contact [3 x 1.5 centimeter (1.2 x 0.6 inch) oil smudge] to the leading edge near its center (**Figure 9**). The profile of the case vehicle's instrument panel resulted in an approximate 3 centimeter (1.2 inch) setback of the leading edge of the cover flap from the protruding mid instrument panel.

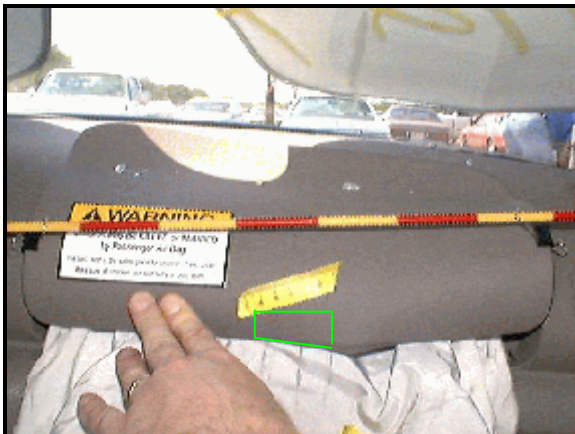
Figure 9: Suspected oil smudge on case vehicle's front right air bag module's cover flap (case photo #34)

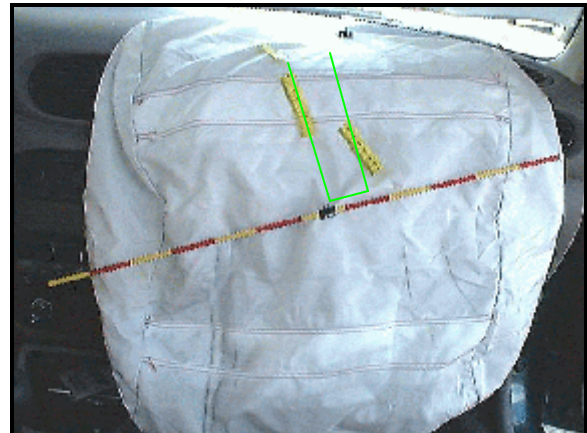
Figure 10: Skin transfer to front portion of case vehicle's front right air bag; Note: cross stitching indicates tether attachments (case photo #38)

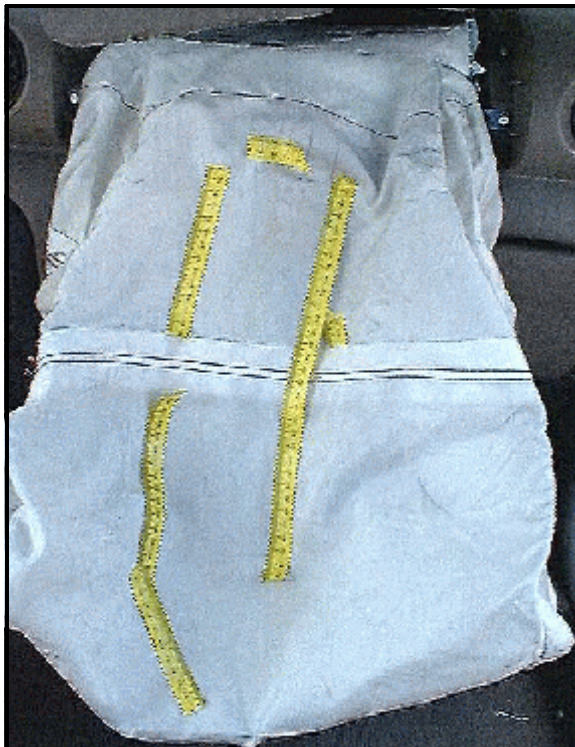
Figure 11: Overhead view of skin transfer to top portion of case vehicle's front right air bag from contact with front right passenger's neck/chin (case photo #37)

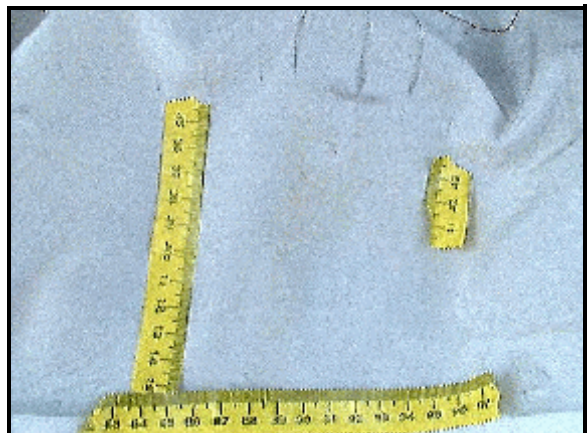
Figure 12: Close-up of skin evidence on top surface of case vehicle's front right passenger air bag (case photo #36)

o'clock positions. The deployed front right air bag was rectangular with a height of approximately 47 centimeters (18.5 inches) and a width of approximately 43 centimeters (16.9 inches). Examination of the front right passenger air bag revealed a heavy skin transfer and a red cloth transfer to the top and front portions of the air bag (**Figure 11** above). Also found on the top portion of the air bag was a long strand of black hair. The skin evidence on the top of the air bag started approximately 12 centimeters (4.7 inches) behind the top horizontal edge and 12 centimeters (4.7 inches) in from the left edge of the air bag (**Figure 12**). The skin contact continued down onto the front of the air bag for a distance of 25 centimeters (9.8 inches) and was 6 centimeters (2.4 inches) wide. The red cloth transfer paralleled the skin transfer on the top and extended down the front 8 centimeters (3.2 inches).

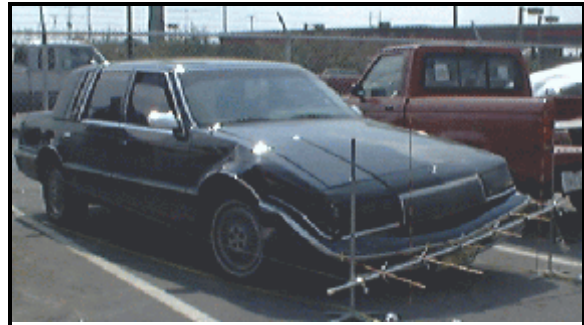
The vehicle inspection showed that the direct damage extended from the front right bumper corner

to the left 53 centimeters (20.9 inches). Direct damage extended vertically from the bumper to the hood. The bumper assembly on the right side was shifted downward, giving the appearance of an underride/override type collision (**Figure 13**). As the vehicle rotated counterclockwise the vehicle sustained direct damage down the right side. The direct damage extended from the front right bumper corner rearwards 46 centimeters (18.1 inches). The right front tire was restricted, and the wheelbase on the right side was shortened 1 centimeter (0.4 inches). The CDC was determined to be: **01-FZEW-1(+30)** [maximum crush was 5 centimeters (2.0 inches)]. The WinSMASH reconstruction program, damage only algorithm, was used on vehicle #2's highest severity impact. The Total, Longitudinal, and Lateral Delta V's are, respectively: 12.0 km.p.h. (7.5 m.p.h.), -10.4 km.p.h. (-6.5 m.p.h.), and -6.0 km.p.h. (-3.7 m.p.h). Vehicle #2 was towed due to damage.

Figure 13: Vehicle #2's damaged front right corner with contour gauge present viewed from right of front (case photo #46)
