## REDESIGNED AIR BAG REPORT

CASE NUMBER - IN97-036

VEHICLE - 1998 LINCOLN NAVIGATOR

CRASH DATE - October, 1997

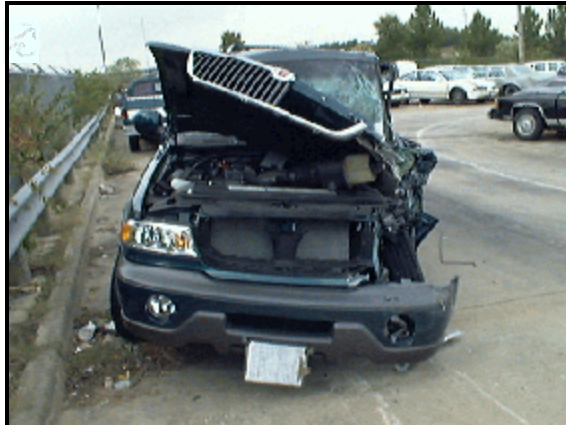
The front left corner (**Figures 1 and 2** below) of the Lincoln impacted the right front of the Ford in an end swiping manner, causing the Lincoln's driver and front right passenger supplemental restraints

**Figure 1:** Lincoln's very narrow front left impact viewed from front; Note: Lincoln's front left bumper underrode right front bumper corner of Ford truck-tractor (case photo #01)

The Lincoln's contact with the Ford truck-tractor involved the left one-third of the Lincoln's front (**Figure 1**) with the direct damage primarily at the front left corner. Direct damage began at the front left

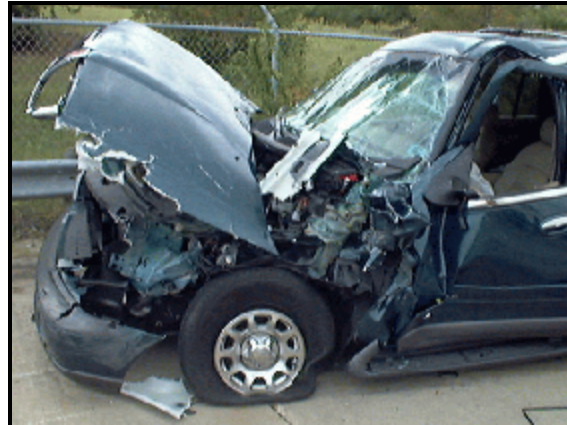
**Figure 2:** Lincoln's very narrow front left damage viewed from left front; Note: direct damage extends to just short of left "A"-pillar, left "A"-pillar is pushed backwards, and left front tire is deflated and restricted (case photo #02)

bumper corner and extended, a measured distance of 49 centimeters (19.3 inches), inward from the front left bumper corner with indirect damage extending across the entire front bumper. Maximum crush (adjusted for free space) was measured as 40 centimeters (15.7 inches) at C<sub>1</sub> (Figure 2). The wheelbase on the Lincoln's left side was shortened 15 centimeters (5.9 inches) while the right side was not shortened. The Lincoln's front bumper, bumper fascia, grille, hood, front left turn headlight and turn signal assemblies, and left fender were directly damaged and crushed rearward. The Lincoln's left front tire was deflated and physically restricted (Figure 2 above). The front right headlight and turn signal assemblies, hood, windshield, and left outside rearview mirror sustained induced damage; the left "A"-pillar was buckled rearward. Remote buckling was also found on the left portion of the Lincoln's roof over the driver's door (Figures 3 and 4). The driver's seating area sustained intrusion from the left "A"-pillar, windshield header, left instrument panel (Figure 5), and toe pan components. The center instrument panel intruded into the front center area of the Lincoln (Figure 6 below).

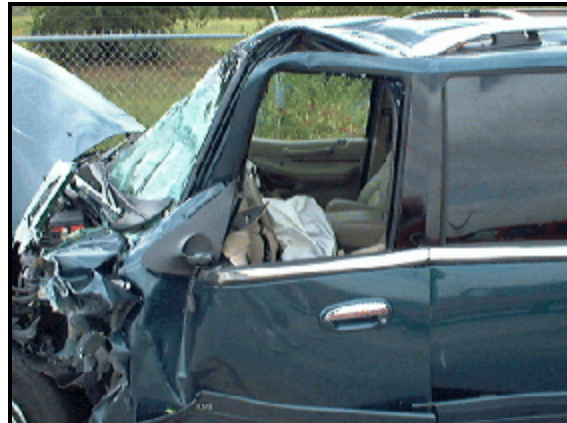
**Figure 3:** Close-up of Lincoln's driver door area showing narrow frontal impact's penetration along left side, rearward displacement of left "A"-pillar, left roof buckling, and jammed driver's door (case photo #03)

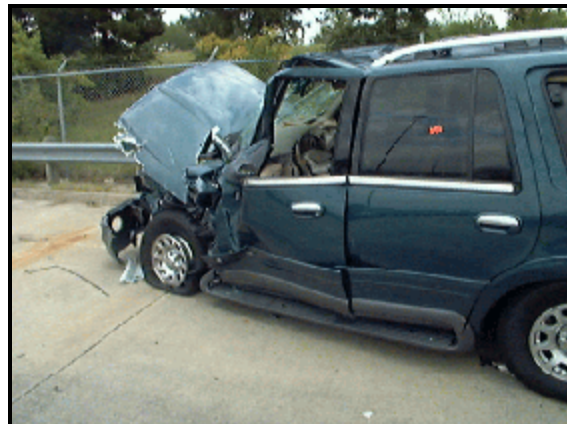
**Figure 4:** Lincoln's very narrow front left impact viewed from left back (case photo #04)

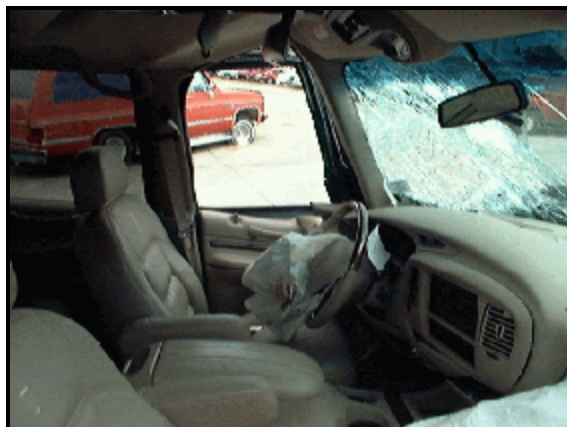
**Figure 5:** Lincoln's front seating area from right showing deployed front air bags and longitudinal intrusion to driver's seating area from left "A"-pillar and left and center instrument panels (case photo #05)

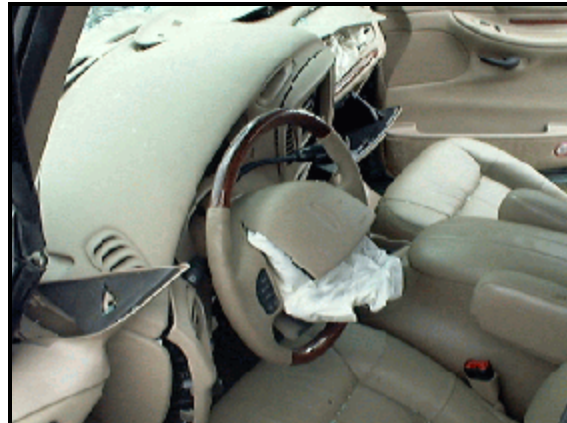
**Figure 6:** Lincoln's front seating area from left showing longitudinal intrusion to driver's seating area from left and center instrument panels and likely position of driver's seat (case photo #06)

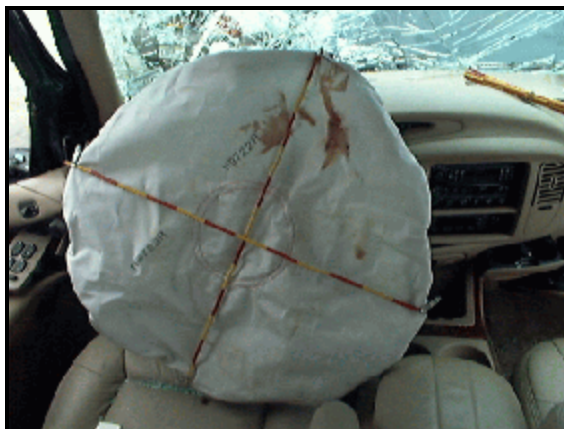
steering wheel hub. The module cover consisted of asymmetrical “H”-configuration cover flaps made of thick vinyl with overall dimensions of 19 centimeters (7.5 inches) at the horizontal seam and 20 centimeters (7.9 inches) vertically for the upper flap and 8 centimeters (3.1 inches) vertically for the lower flap. An inspection of the air bag module's cover flaps and air bag fabric revealed that the cover flaps opened at the designated tear points, and there was no evidence of damage during the deployment to the air bag or the cover flaps (**Figure 6** and see **SELECTED PHOTOGRAPHS**, specifically **Figure 9** below). The driver's air bag was designed with tethers, but the exact number is unknown. The driver's air bag had two vent ports, of unknown diameter, located at the 11 and 1 o'clock positions. The deployed driver's air bag was round with diameter 64 centimeters (25.2 inches). Inspection of the driver's air bag revealed blood evidence at the top of the air bag's front surface at the 12 o'clock position and toward the 2 and 5 o'clock positions, but relatively close to the center of the air bag (**Figure 7**). In addition, there were some scuffs present on the right upper and lower quadrants. The scuffs in the upper right quadrant were toward the 1 o'clock position but relatively close to the center of the air bag. On the other hand, the scuffs in the lower right hand quadrant were near the bottom of the air bag's front surface toward the 5:30 o'clock position.

**Figure 7:** Lincoln's deployed driver air bag showing blood evidence, primarily at 12 o'clock position (case photo #08)

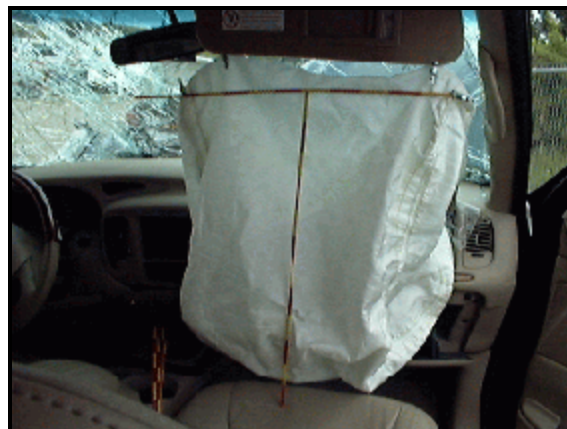
**Figure 8:** Lincoln's deployed front right passenger air bag showing no occupant contact evidence (case photo #12)

10 below). The cover flap was made of a thick vinyl over a thick cardboard type frame. The flap's dimensions were 39 centimeters (15.4 inches) at the lower horizontal seam and 17 centimeters (6.7 inches) along both vertical seams. An inspection of the front right air bag module's cover flap and air bag fabric revealed that the cover flap opened at the designated tear points, and there was no evidence of damage during the deployment to the air bag or the cover flap. The front right passenger's air bag was designed without any tethers. The front right air bag had no vent ports. The deployed front right air bag was rectangular with a height of approximately 55 centimeters (21.7 inches) and a width of approximately 50 centimeters (19.7 inches). An inspection of the front right air bag revealed that there was no contact evidence readily apparent on the air bag (**Figure 8** above).

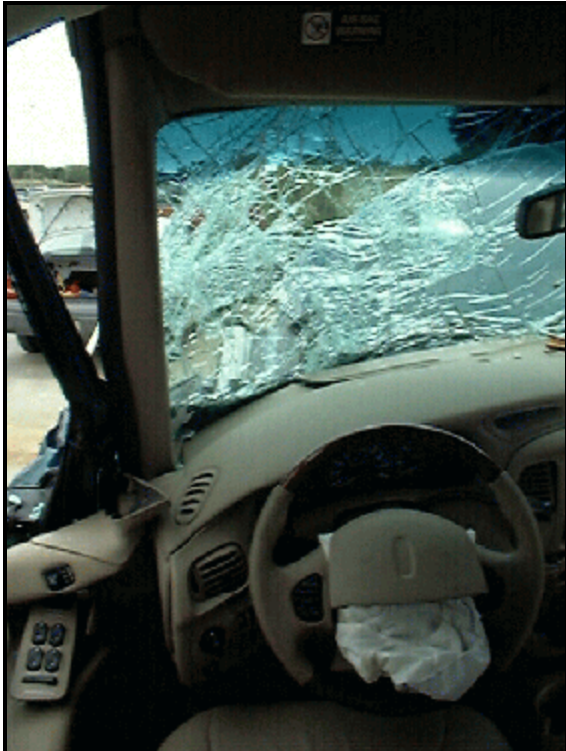
**Figure 9:** Vertical view of Lincoln's driver seating area showing crash induced damage to windshield's glazing, intrusion from left "A"-pillar and instrument panel, and driver air bag module's top cover flap which was without evidence of contact (case photo #17)

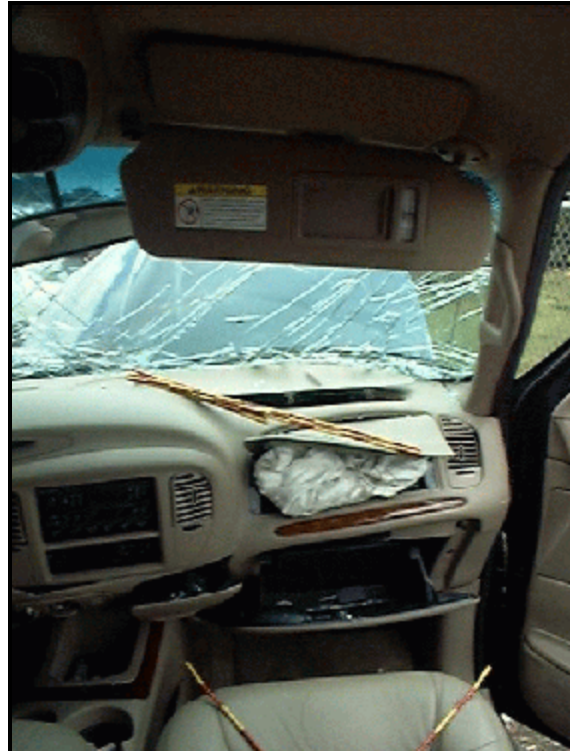
The front right passenger's air bag was located in the middle of the instrument panel. There was a single, essentially rectangular, modular cover flap (see **SELECTED PHOTOGRAPHS**, specifically **Figure**

**Figure 10:** Vertical view of Lincoln's front right passenger seating area showing front right passenger air bag module's cover flap and folded, deployed air bag (case photo #19)
