REDESIGNED AIR BAG DEPLOYMENT INVESTIGATION

CASE NO. CA97-036

1998 FORD ESCORT- REDESIGNED AIR BAG

1993 FORD AEROSTAR MINIVAN

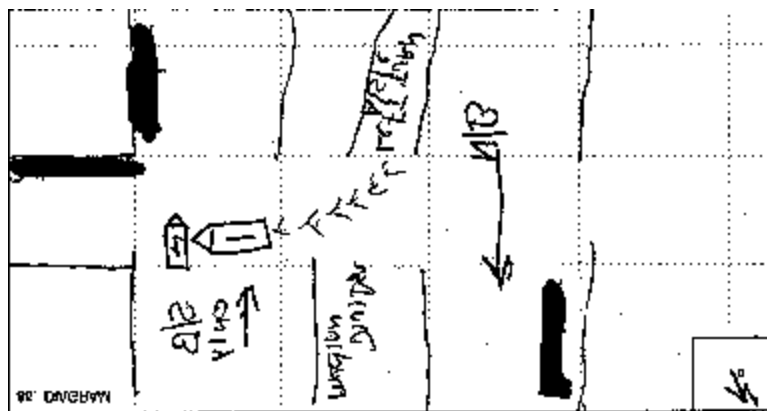
Figure 1 - Police scene diagram, Vehicle #1 (1993 Ford Aerostar),
Vehicle #2 (1998 Ford Escort)

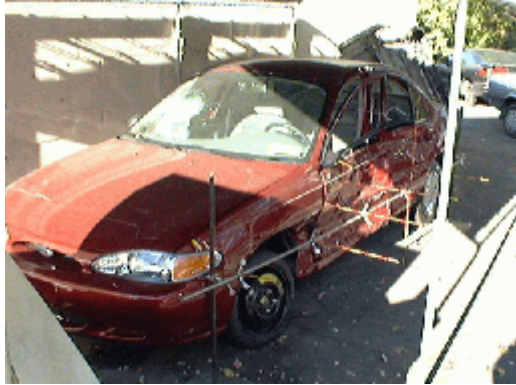
The Ford Escort sustained direct contact damage along the left side plane from the collision with the Ford Aerostar. Exterior damage to the vehicle involved the front bumper, left front fender, left front wheel, the windshield, left side doors, left side glazing, and B-pillar (**Figure 2**). Damage began 46.0 cm (18.1") forward of the right front axle and extended 290.0 cm (114.2") rearward. The maximum crush of 12 cm was located on the driver’s door (**Figure 3**). The Ford Escort sustained a WinSMASH computed total delta V of 13.3 km/h (8.2 mph) while the Ford Aerostar sustained an estimated delta V of 8.0 km/h (5.0 mph).

Figure 2- Left corner view of the 1998 Ford Escort showing the damage profile

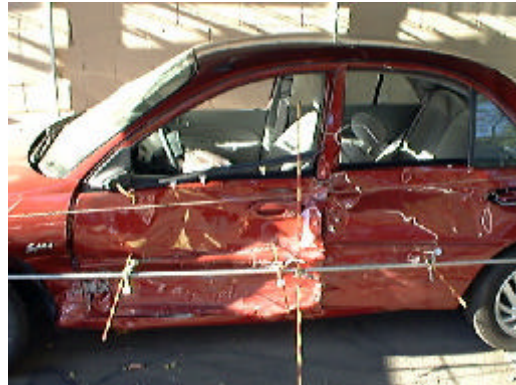
Figure 3- View showing the extent of damage at the driver door

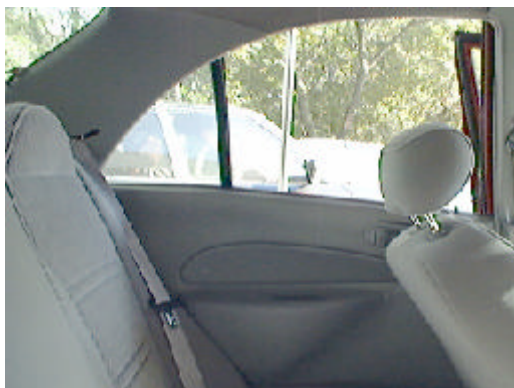
The driver's bucket seat was found in the full rear adjusted position with a seat back angle which was reclined at a mid range position (**Figure 4**). The adjustable head restraint appeared to be near the full up adjusted position. There was no damage noted to the head restraint or seat back support. The front right bucket seat was found in the full rear adjustment position with the adjustable head restraint in a mid range adjustment position. The seat back support appeared to be reclined in a mid rearward position (**Figure 5**). There was no damage noted to the seat.

Figure 4- View of the rear seat looking toward the left showing the position of the seat back support and the head restraint

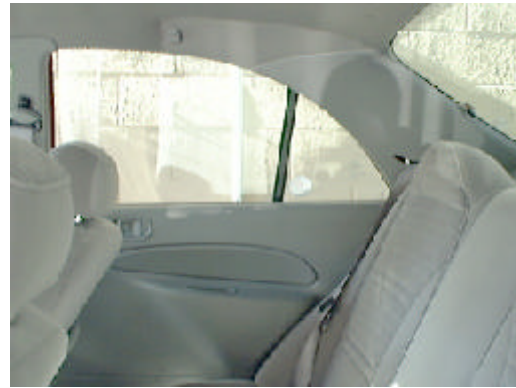
Figure 5- View of the rear seat area looking toward the right showing the relative recline position of the seat back support and the adjustment height of the head restraint

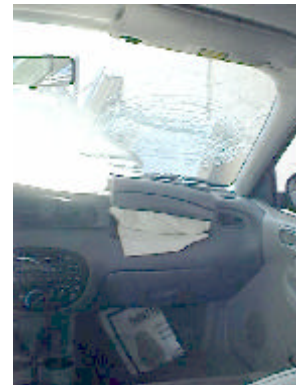
The windshield sustained a fractured pattern which was located directly forward of the front right air bag module cover (**Figure 6**). During the supplemental restraint system (SRS) actuation sequence, the air bag module cover rotated upward where the leading edge struck the glazing resulting in a well defined linear fracture pattern.

Figure 6- View of the windshield damage resulting from contact by the air bag module cover

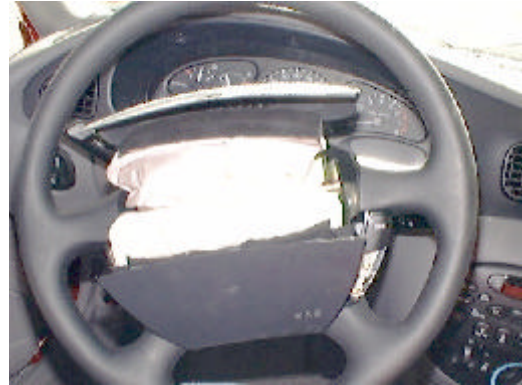
The Ford Escort was equipped with redesigned dual front air bags that deployed during the crash sequence. The front left air bag module cover opened in the typical “H” configuration with the vertical height of the upper flap measuring 7.0 cm (2.75”) and the lower flap measuring 10 cm (3.9”). The lateral width of the flaps measured 20.5 cm (8.1”) along the common seam line (**Figure 7**). There was no driver related contact evidence noted on the air bag module flaps.

Figure 7 - View of the front right air bag module cover

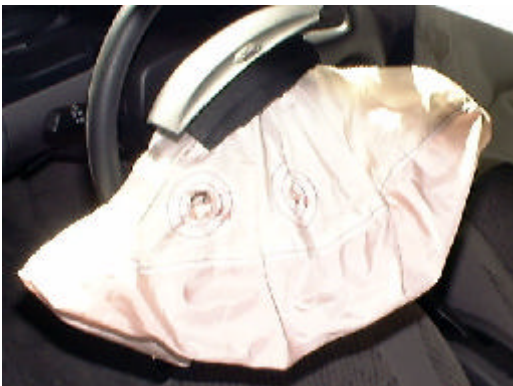
The front left bag was designed with two tethers and two vent ports located at the 11 o’clock and 1 o’clock sector of the air bag (**Figure 8**). The diameter of the air bag measured 50.0 cm (19.7”) and exhibited two bodily fluid transfer patterns over the front surface. One transfer pattern appeared to be a spray type pattern where several small dot like artifacts were widely scattered over the surface. A second pattern involved a more concentrated artifact located in the lower right quadrant of the air bag (**Figure 9**). This pattern appeared to be indicative of the driver’s post crash head position where bodily fluids from his head/face dripped down onto the air bag.

Figure 8 - View of the upper front left air bag vent ports

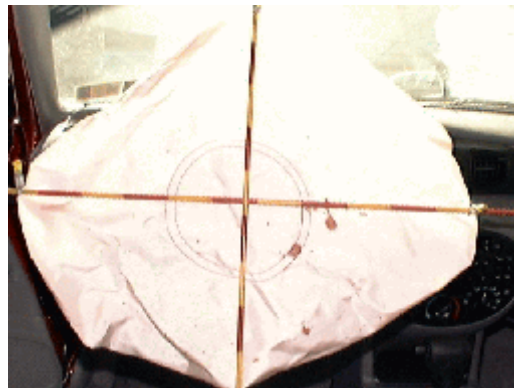
The front left air bag exhibited two patterns of bodily fluid transfers. A general scattered transfer field was noted across the entire surface of the air bag and appeared to be a spray dispersion type which continued on to the surface of the front right air bag. This was attributed to the driver striking a hard interior component (e.g., side glazing) resulting in a lesion of his face. The rebound motion and subsequent rotation of his head then resulted in the dispersion pattern. The second artifact on the front left air bag was more of a concentrated bodily fluid transfer which was attributed to position of the driver's face at his final rest position.

Figure 9 - View of the front left air bag showing the tether related center stitch area and bodily fluid deposits

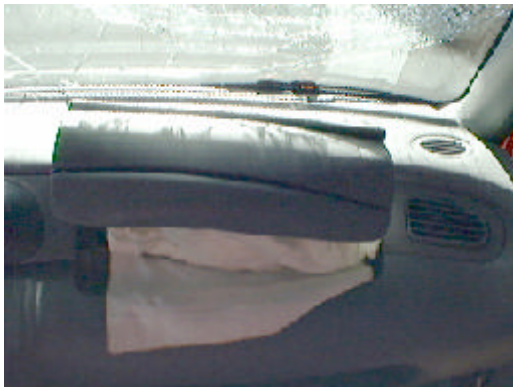
The front right air bag module cover was a mid mount design which was hinged along the top surface of the front right instrument panel (**Figure 10**). During the air bag expansion sequence, the air bag module cover rotated upward and contacted the windshield resulting in a fracture of the glazing area that correlated with the dimensions and location of the module cover. The cover measured 20.5 cm (8.0") wide with a vertical height of 10.0 cm (3.9") and a horizontal dimension of 7.0 cm (2.75").

Figure 10 - View of the front right mid mounted air bag module

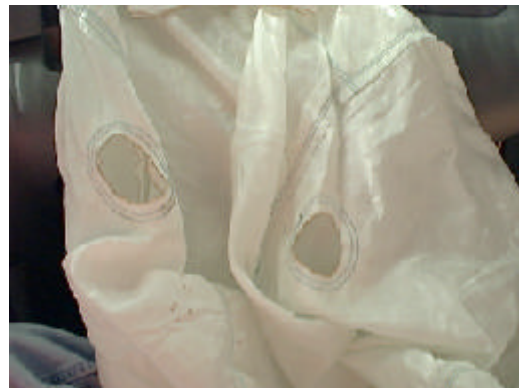
The untethered front right air bag was designed with two vent ports which were located on the inboard and outboard side panels near the top surface (**Figure 11**). The vertical surface of the air bag measured 60 cm (23.6") and the width measured 45 cm (17.7"). The top and inboard side surfaces of the air bag exhibited scattered bodily fluid transfers which were attributed to the driver's facial lesion.

Figure 11 - View of the air bag vent ports along the inboard/outboard side panels of the front right air bag
