INDIANA UNIVERSITY

TRANSPORTATION RESEARCH CENTER

ON-SITE ADAPTIVE EQUIPMENT INVESTIGATION

CASE NUMBER - IN97-038
LOCATION - MINNESOTA
VEHICLE - 1992 TOYOTA CELICA
CRASH DATE - November, 1997

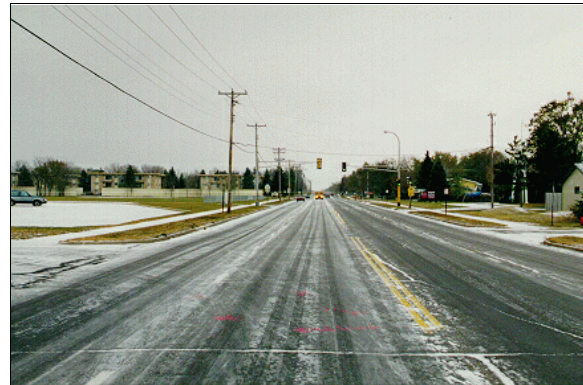
Figure 1: Southward view of case vehicle's northward travel path in inside northbound lane, viewed from area of final rest; Note: red paint marks indicate tire positions (case photo #06)

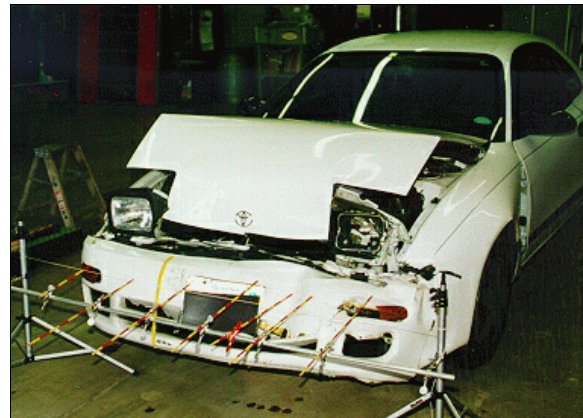
Figure 2: Case vehicle's frontal deformation with contour gauge present; Note: yellow tape indicates start of direct damage (case photo #10)

The crash involved the front bumper of the case vehicle against the back bumper of vehicle #2. The direct contact damage consisted of underride type damage to the case vehicle's bumper and hood. The underride type damage pattern resulted because the sloping front end of the case vehicle happened to be slightly lower than vehicle #2's back bumper. The direct damage to the case vehicle's front end began 28 centimeters (11.0 inches) to the right of center and extended leftward 93 centimeters (36.6 inches) to the left front bumper corner (**Figure 4**). The field L width was 117 centimeters (46.1 inches) and the undeformed end width was 130 centimeters (51.2 inches). The maximum crush was located between C₂-C₃ and was 30 centimeters (11.8 inches) in depth. The hood, bumper fascia, bumper reinforcement bar, grille, both fenders, left headlight assembly, and windshield were all deformed from the impact (**Figures 2 and 4** above). The hood was folded back accordion style. The windshield on the passenger side was starred from the front right passenger's head. The case vehicle's left front tire was physically restricted but not deflated. The wheelbase was shorten 3 centimeters (1.2 inches) on both sides. There was no visible evidence of intrusion to the case vehicle's interior.

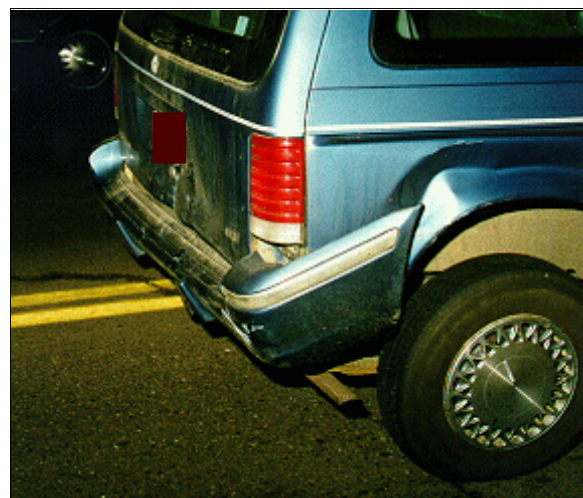
Figure 3: On-scene view of vehicle #2's damaged back showing downward rotation of rear bumper (case photo #71)

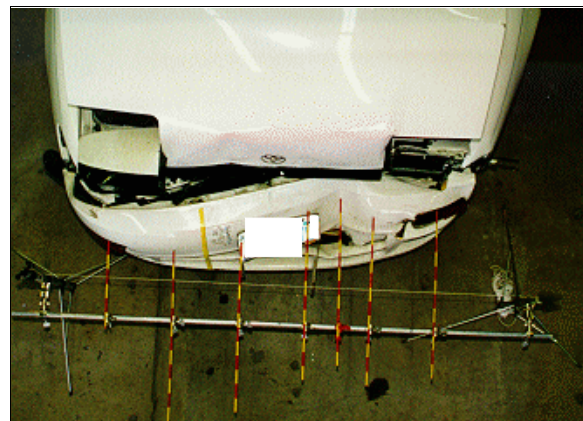
Figure 4: Overhead view of case vehicle's frontal damage with contour gauge showing crush values (case photo #09)

FYEW-1 (360). The WinSMASH reconstruction program, damage only algorithm, was used on the case vehicle's highest severity impact. The Total, Longitudinal, and Lateral Delta Vs are, respectively: 22.8 km.p.h. (14.2 m.p.h.), -22.8 km.p.h. (-14.2 m.p.h.), and 0.0 km.p.h. (0.0 m.p.h.). The case vehicle was towed due to damage.

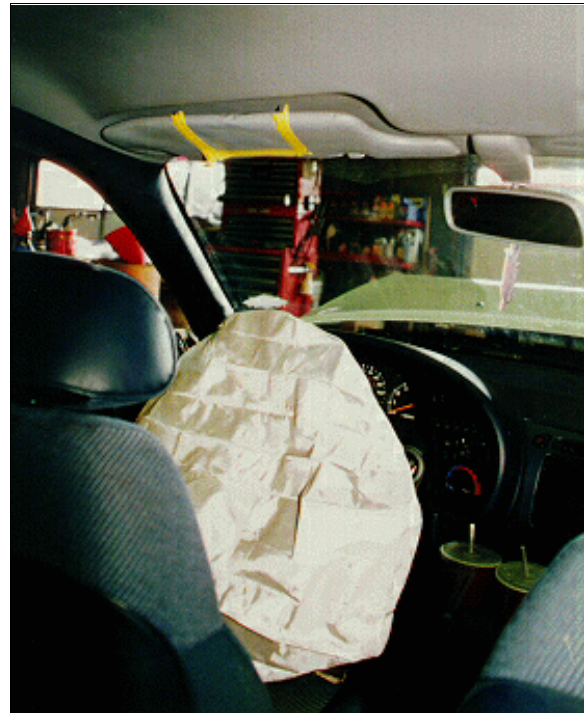
As previously mentioned, the case vehicle was equipped with a SRS that consisted of a frontal air bag at the driver position. The SRS deployed (**Figure 5**) as a result of the case vehicle's frontal impact with the back of vehicle #2. The case vehicle's driver air bag was located in the steering wheel hub. The module cover consisted of asymmetrical cover flaps with a width dimension of 17 centimeters (6.7 inches) at the horizontal seams and 9 centimeters (3.5 inches) vertically for the top cover flap and 6.5 centimeters (2.6 inches) vertically for the bottom cover flap. An inspection of the air bag module's cover flaps and air bag revealed that the cover flaps opened at the designated tear points, but the top cover flap was torn off the air bag module due to the driver blocking the air bag's path during the deployment causing the air bag to find subsequent avenues to deploy. Furthermore, there appeared to be blue cloth transfers to the driver air bag module's top and bottom cover flaps. In addition, the inspection revealed evidence of damage during the deployment to the air bag. Two anomalies were found. One was a small tear, 1.5 centimeters (0.6 inches), near the top edge of the air bag near the 11 o'clock position, and the other was a small puncture/snag mark to the top center of the air bag near the 1 o'clock position. The driver's air bag was designed without any tethers and had two vent ports, approximately 2.5 centimeters (1.0 inch) in diameter, located at the 11 and 1 o'clock positions. The deployed driver's air bag was elliptical with a height of 58 centimeters (22.8 inches) and a width of 63 centimeters (24.8 inches).

Figure 5: Case vehicle's driver seating area showing deployed air bag, contacted sun visor and rear view mirror, and noncontacted windshield (i.e., driver's portion); Note: crumpled hood visible through windshield (case photo #27)

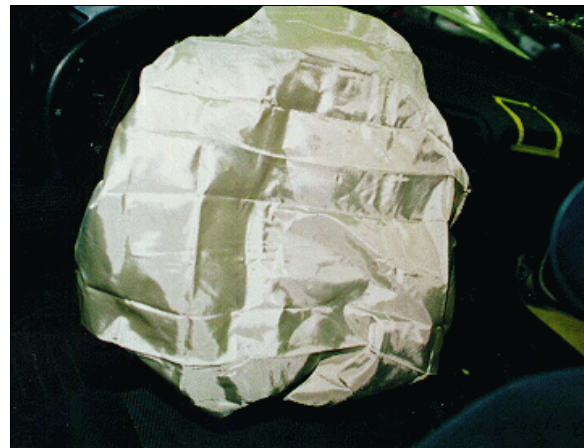
The inspection of the driver's air bag revealed an excessive amount of blue and red cloth transfers on the front portion from the driver's coat (**Figure 6**), and there was a 2 x 4

Figure 6: Close-up of case vehicle's driver air bag showing faint (i.e., barely visible) blue and red cloth transfers from driver (case photo #39)

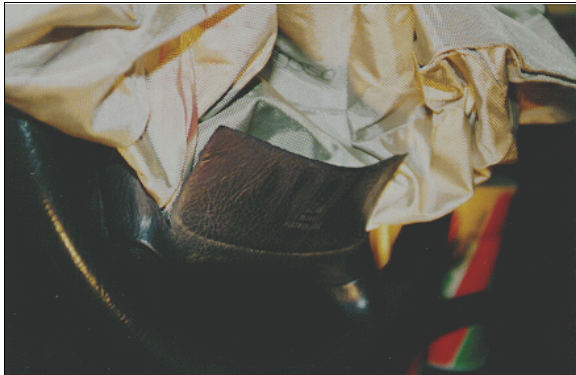
Figure 7: Close-up of cloth transfer on case vehicle driver air bag module's bottom cover flap; Note: top flap showed same type of transfers (case photo #47)

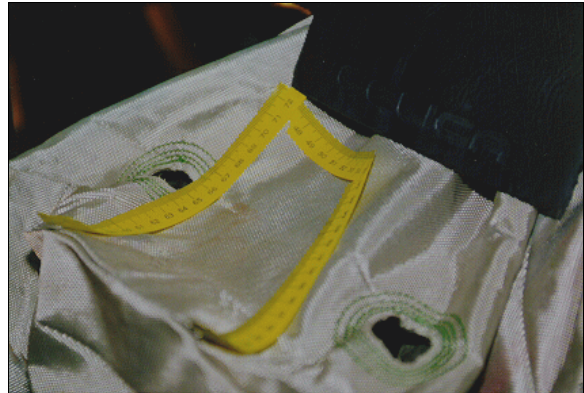
Figure 8: Close-up of case vehicle's driver air bag showing skin transfer and blood smear from driver's neck on top, backside of air bag (case photo #43)

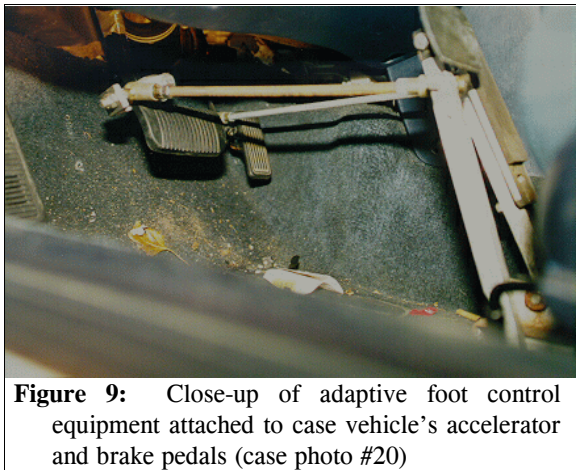
Figure 9: Close-up of adaptive foot control equipment attached to case vehicle's accelerator and brake pedals (case photo #20)

The case vehicle was equipped with special adaptive pedal extenders and a windshield wiper stalk. The pedal extenders were made by "Drive Master" and the fold down pedal extenders made of aluminum and stainless steel. The pedals extenders were attached to both the brake and accelerator pedals (**Figures 9 and 10**). The adaptive equipment extended the brake pedal rearward 34 centimeters (13.4 inches), within 10 centimeters (3.9 inches) forward of the driver's seat cushion, and the gas pedal rearward 38 centimeters (15.0 inches), within 14 centimeters (5.5 inches) forward of the driver's seat cushion. Both pedals were bolted to the floor pan and

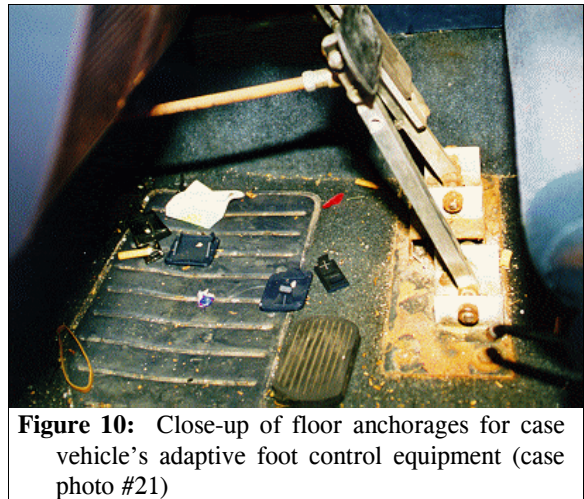
Figure 10: Close-up of floor anchorages for case vehicle's adaptive foot control equipment (case photo #21)

extended 30 centimeters (11.8 inches) up from the floor pan to just below the top of the driver's seat cushion. Both pedal extensions were clamped to their respective OEM pedals. cursory inspection of the pedal extenders showed no evidence of failure. The only anomaly was the rubber, brake pedal cover pad appeared to have been knocked off the stainless steel pedal's face (Figure 10 above).

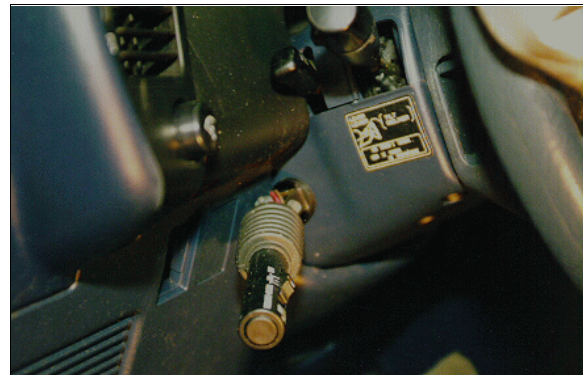
The other adaptive equipment on the case vehicle involved the driver's seat back being fixed in a 89 degree, upright position, and the windshield wiper stalk being angled towards the driver in order to accommodate the driver's shorter reach (Figure 11).

Figure 11: View of adapted turn signal/cruise control lever on case vehicle's steering column; Note: compression of steering column into instrument panel (case photo #24)

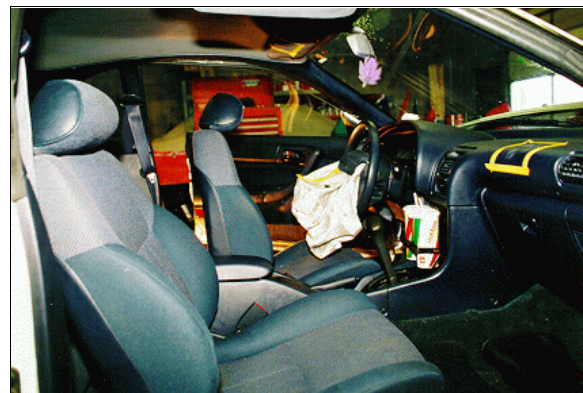
Immediately prior to the crash the case vehicle's driver was seated in an upright posture with her back against the seat back, her left foot sticking out from the seat cushion, her right foot on the accelerator, and both hands on the steering wheel. Her seat track was located in its forward-most position, and her tilt steering wheel was located in its down-most position. It should be noted that the distance from the center of the driver's seat back to the steering wheel hub was approximately 43 centimeters (16.9 inches), which includes 5 centimeters (2.0 inches) of compression to the shear capsules (energy absorbing device on base of steering column). In addition, the length of the driver's arms was approximately 30 centimeters (11.8 inches) which would have placed the driver extremely close to the driver air bag module (Figure 12).

Figure 12: Case Vehicle's front seating area showing driver seat's close proximity to steering wheel and highlighted occupant contacts (case photo #31)

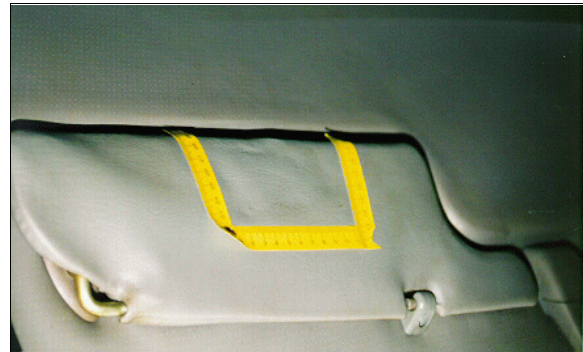
Figure 13: Close-up of head contact on case vehicle's driver sun visor; Note: short-statured driver was seated directly underneath sun visor (case photo #28)

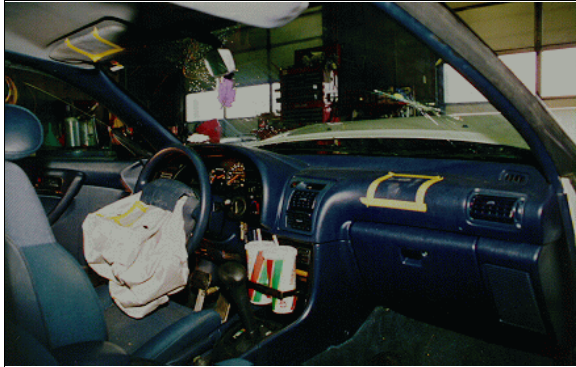
Figure 14: Case vehicle's front seating area viewed from outside right front door showing contacts (taped areas) to driver's air bag and sun visor as well as to dash and windshield on passenger's side (case photo #32)

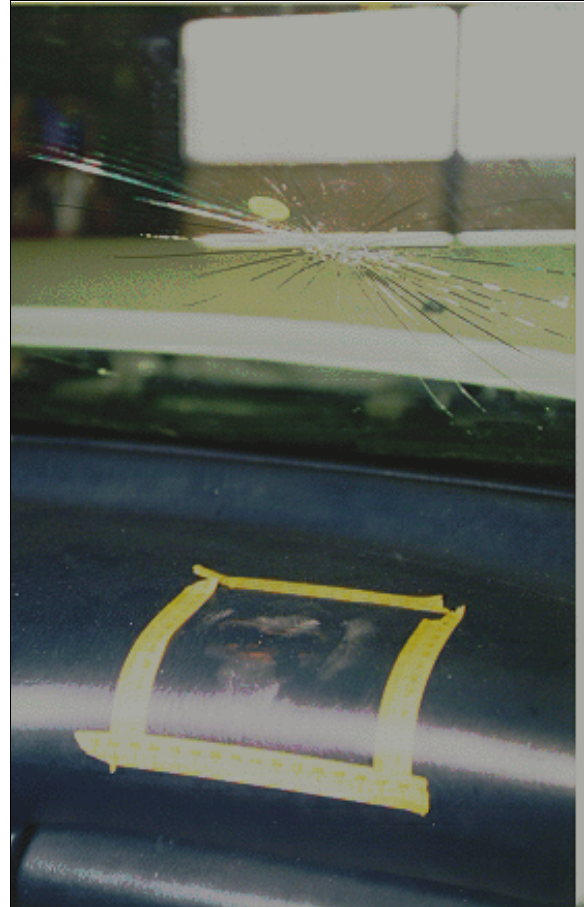
Figure 15: Close-up of starred windshield and make-up smear on top of case vehicle's right instrument panel; Note: both contacts came from front right passenger (case photo #34)

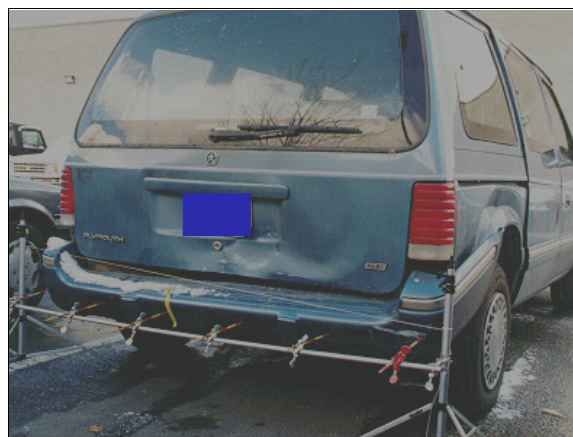
Vehicle #2's back impact from the case vehicle caused the rear bumper to be crushed inward and rotated downward under the vehicle as the case vehicle underrode it (**Figure 3** above and **Figure 16**). Direct damage started at the back right bumper corner and extended to the left 103 centimeters (40.6 inches). The maximum crush was measured at 10 centimeters (3.9 inches) at both C₅ and C₆. The total field L was measured at 163 centimeters (64.2 inches). The rear impact deformed the driver's seat back rearward approximately 15 degrees. Vehicle #2 was driven from the scene.

Figure 16: Deformation to vehicle #2's back with contour gauge present (case photo #55)
