### ON-SITE AIR BAG INVESTIGATION

CASE NUMBER - IN97-042  
LOCATION - MISSISSIPPI  
VEHICLE - 1995 FORD CONTOUR GL  
CRASH DATE - November, 1997

1. <i>Report No.</i> IN97-042		2. <i>Government Accession No.</i>		3. <i>Recipient's Catalog No.</i>	
4. <i>Title and Subtitle</i> On-Site Air Bag Fatality Investigation Vehicle - 1995 Ford Contour GL Location - Mississippi			5. <i>Report Date:</i> June 12, 2001; October 30, 2001

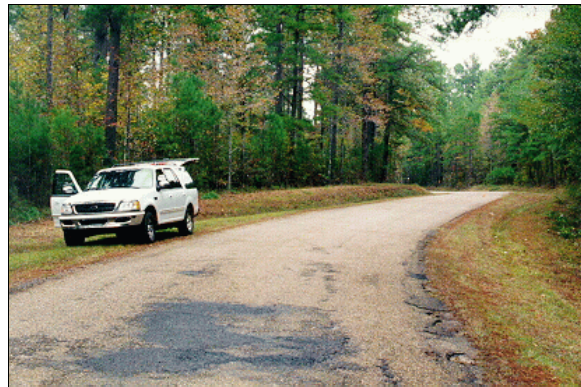
The county roadway in the area of the crash was an "S"-curve. The roadway curved to the right (**Figure 1 and Figure 3** below) for northbound traffic [i.e., Radius = 100 meters (328.1 feet)] prior to straightening out for

**Figure 1:** Case vehicle's northwest travel path in "S" curve approaching short straight section of roadway (case photo #02)

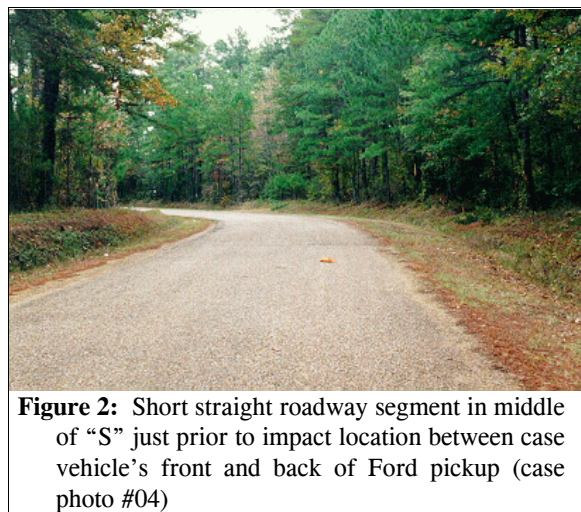
**Figure 2:** Short straight roadway segment in middle of "S" just prior to impact location between case vehicle's front and back of Ford pickup (case photo #04)

approximately 21 meters (68.9 feet), including the point of impact, and then began to curve back to the left (**Figure 2** above). The country roadway was straight in the immediate vicinity of the crash. The roadway had a 2.2% pre-crash grade negative to the north (i.e., a downgrade the case vehicle's direction of travel), but the roadway leveled out (i.e., actual slope was 0.9%, negative to the north) at the area of impact. The pavement was bituminous but traveled, and the width of the travel lanes for both vehicles was 5.2 meters (17.1 feet). The shoulders were not improved, and there was a 2.0 meter (6.6 foot) wide area of trimmed grass adjacent to the roadway on the east side and a 2.6 meter (8.5 foot) wide area of trimmed grass adjacent to the roadway on the west side. The trimmed grass was followed by dense forest (**Figure 3**). There were no roadway markings or visible controls in the surrounding area other than an occasional Advisory sign that read: "WATCH FOR LOGGING TRUCKS ENTERING ROAD". The estimated coefficient of friction was 0.65. The statutory speed limit was 89 km.p.h. (55 m.p.h.). No regulatory speed limit sign was posted near the crash site. At the time of the crash the light condition was dusk, the atmospheric condition was dusty, and the road pavement was dry. Because there was a dense tree cover along this county road and no overhead illumination at the area of impact, the roadway gets prematurely dark. The "dusty" atmospheric condition, which was indicated on the Police Crash Report, can be explained by the fact that the roadway is heavily used by logging trucks, making the atmospheric environment over the roadway "dusty" when it's being driven. Traffic density was light, and the site of the crash was rural undeveloped, with scattered houses and mobile homes in the area.

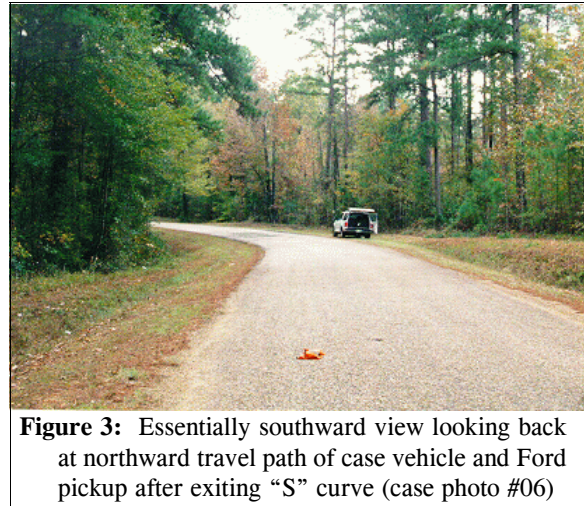
**Figure 3:** Essentially southward view looking back at northward travel path of case vehicle and Ford pickup after exiting "S" curve (case photo #06)

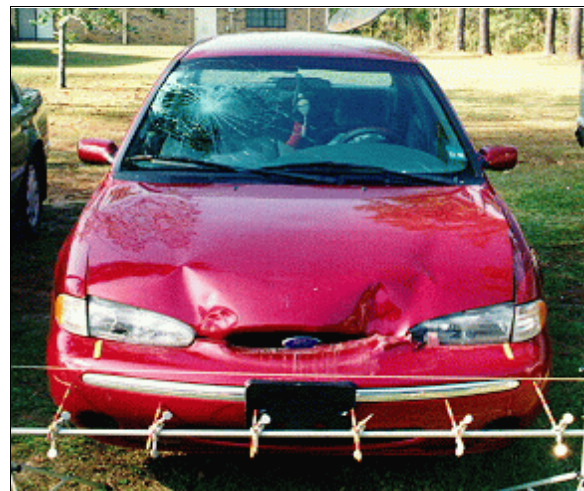
The front (**Figure 4**) of the case vehicle impacted the back of Ford pickup (**Figure 5** below), causing the case vehicle's driver and front right passenger supplemental restraints (air bags) to deploy. The case vehicle and the Ford pickup moved forward slightly post-crash with each vehicle coming to rest heading in a north-northeasterly direction in the northbound lane of the roadway.

**Figure 4:** Case vehicle's frontal deformation from impact with Ford pickup; Note: impact to right windshield's glazing from front right passenger and imprint of pickup's back center on hood of case vehicle (case photo #08)

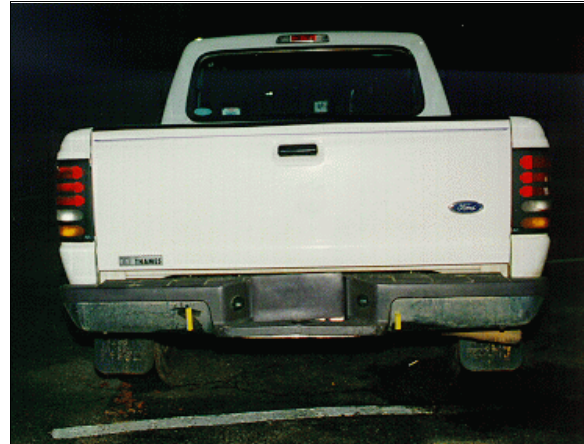
**Figure 5:** Minor damage to Ford pickup's back bumper; Note: yellow tape indicates direct damage to case vehicle's hood and scrapes to top of front bumper's fascia (case photo #63)

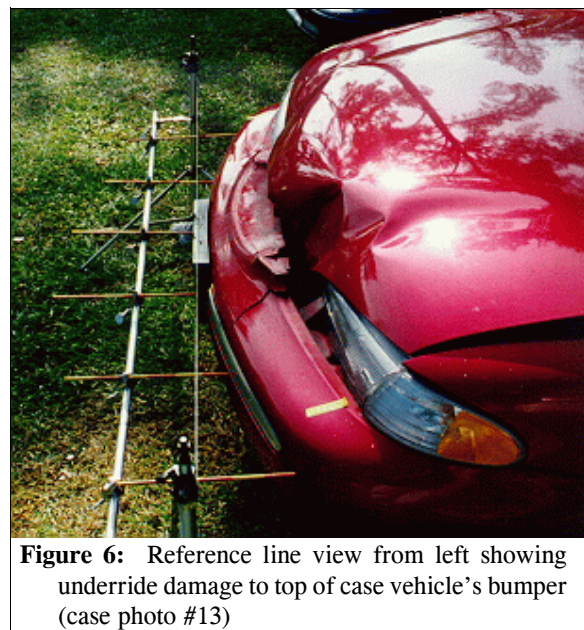
The case vehicle's contact with the Ford pickup's back bumper involved the top surface of the front bumper (**Figure 6** and **Figure 7** below) and the hood (**Figures 8** and **9** below), indicating it underrode the back bumper of the pickup. Direct damage began 61 centimeters (24.0 inches) leftward of the vehicle's center and extended to the right, a measured distance of 122 centimeters (48.0 inches), along the top of the front bumper, ending just prior to the front right bumper corner. There was no evidence of direct contact to the front face of the bumper's fascia. Crush was measured both along the front bumper and across the entire grille area; however, the differences were not sufficient for averaging. Maximum crush was measured as 8 centimeters (3.2 inches) between C<sub>2</sub> and C<sub>3</sub>. The case vehicle's wheelbase was not shortened on either the left or right sides. The case vehicle's hood, grille, and radiator with supports were directly damaged and crushed rearward. The deformation that initiated the deployment of the air bags was above the bumper and into the grille area and involved

**Figure 6:** Reference line view from left showing underride damage to top of case vehicle's bumper (case photo #13)

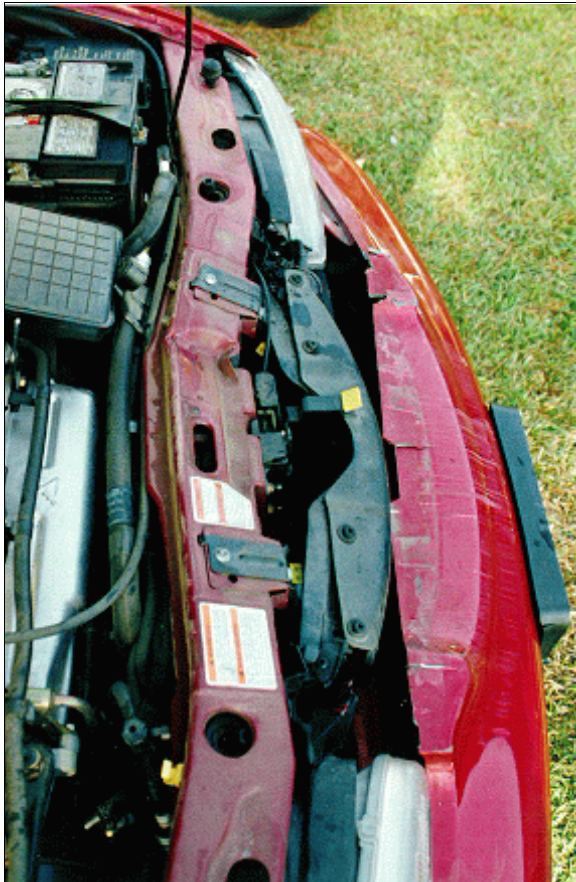
direct contact to the radiator supports to which the air bag sensors are attached (**Figure 7**). Based on previous SCI cases, when contacted, the sensor supports tend to deploy the air bags in low Delta V crashes. In addition, there was scraping to the top of the front bumper. Both front fenders sustained minor induced damage from the frontal impact which also deformed both headlight brackets leaving the headlights undamaged. None of the case vehicle's tires were physically restricted or deflated from the front end damage.

**Figure 7:** Elevated view from right with hood raised showing scrape on top of case vehicle's front bumper fascia; Note: air bag sensors not visible (case photo #19)

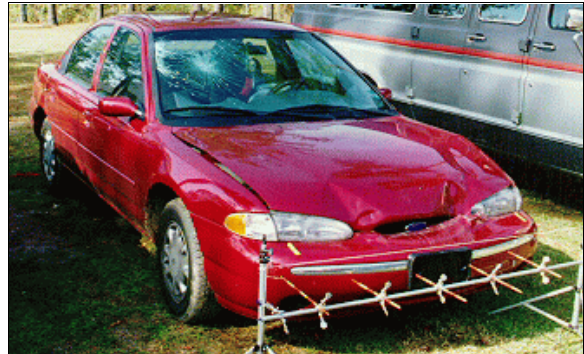
**Figure 8:** Case vehicle's frontal damage with contour gauge present; Note: contact to windshield's glazing on passenger side and damage on top of bumper from underride (case photo #24)

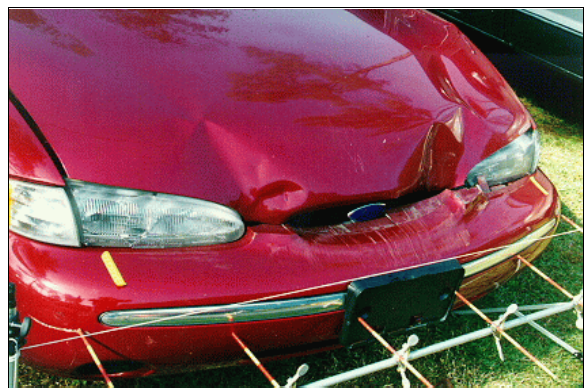
**Figure 9:** Close-up of case vehicle's damaged front showing (yellow tape) direct damage width from Ford's back bumper which overrode case vehicle's front bumper; Note: hood contact from back center of Ford (case photo #22)

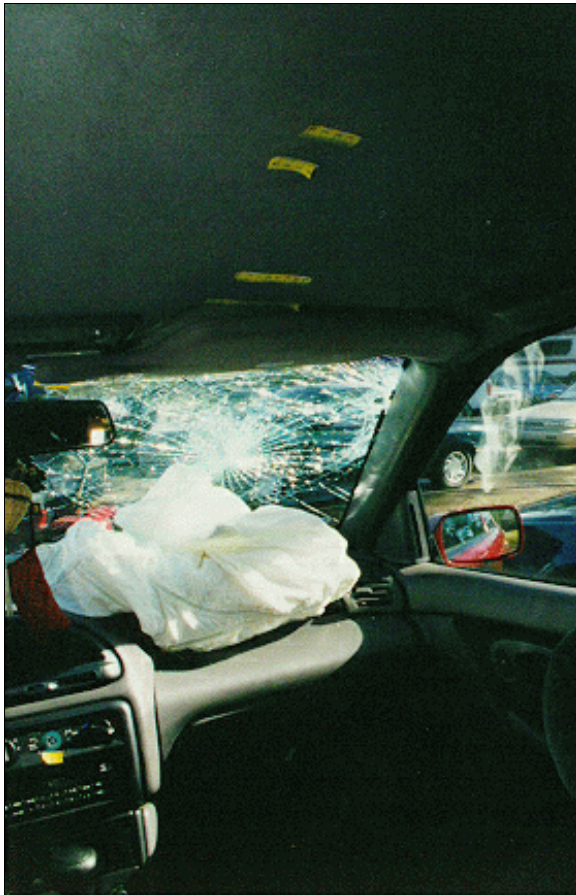
The inspection of the case vehicle's interior revealed that there was damage in the shape of a large spider web to the front right of the windshield's glazing (**Figure 10** below). Hair and skin deposited by the case vehicle's front right passenger was present within that damage pattern. Furthermore, there was a scuff and some hair present on the front right sun visor and header, most likely from the front right passenger's head (**Figure 11** below). In addition, the roof above the steering wheel had an area of scuffing with blood present (**Figure 12** below). It is unknown, however, if the blood was from the driver or front right passenger. The energy absorbing steering column showed no evidence of compression. The air flow knob located in the center instrument panel was knocked off its stem (**Figure 12** below). There was what appeared to be a spray of body fluids to the interior of the front right door's glazing. Finally, there was a slightly oblique

**Figure 11:** Vertical view of case vehicle's front right passenger seating area showing contacts to right windshield's glazing, right sun visor and header, and possibly to right roof areas (case photo #47)

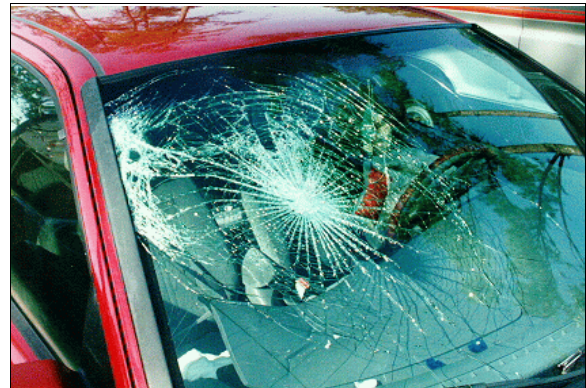
**Figure 10:** Close-up of case vehicle's right windshield glazing damaged from impact by front right passenger (case photo #16)

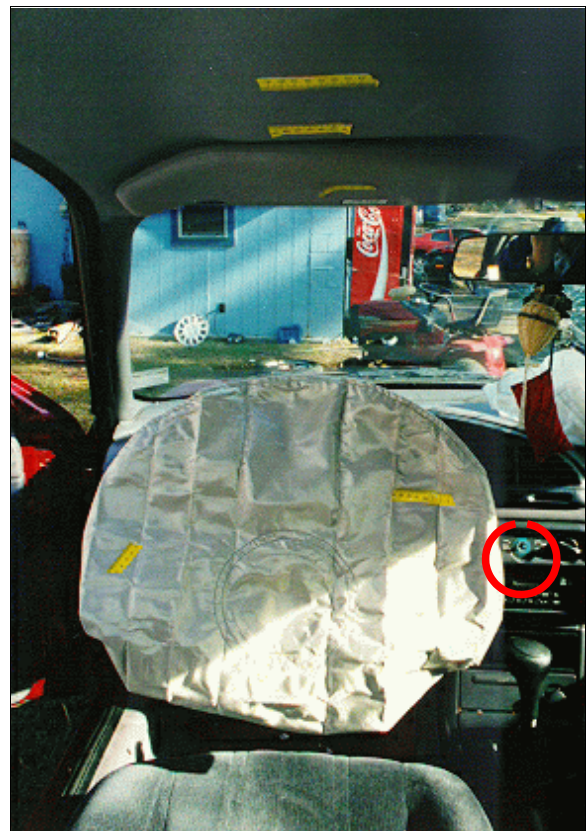
**Figure 12:** Vertical view of case vehicle's driver seating area showing contact evidence on air bag's fabric, center instrument panel (highlighted), and possibly to roof (case photo #31)

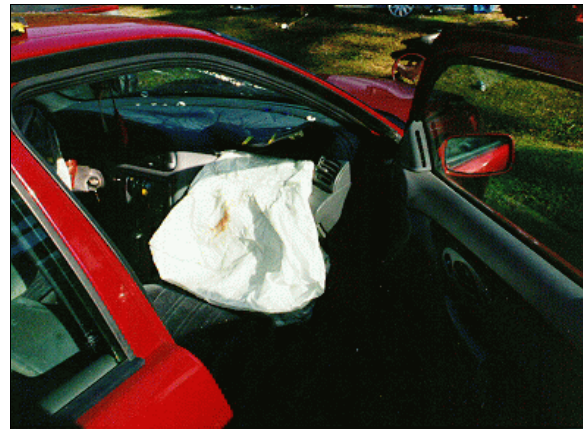
The front right passenger's air bag was located in the top of the instrument panel (**Figure 13**). There was a single, asymmetrical, modular cover flap. The cover flap was made of a thick vinyl over a sheet metal frame. The flap's dimensions were: 37 centimeters (14.6 inches) at the forward horizontal seam, 49 centimeters (19.3 inches) at the rear (i.e., toward the windshield) horizontal seam, 35 centimeters (13.8 inches) along the angled left vertical seam, and 18 centimeters (7.1 inches) along the right vertical seam. However, the cover flap was creased with the majority of each side's vertical distance below the crease [i.e., 22 centimeters (8.7 inches) of the angled left vertical seam and 15 centimeters (5.9 inches) of the right vertical seam]. The profile of the case vehicle's instrument panel resulted in a 14 centimeter (5.5 inch) setback of the leading edge of the cover flap relative to the protruding right instrument panel. An inspection of the front right air bag module's cover flap and air bag fabric revealed that the cover flap opened at the designated tear points and there was definitive evidence of direct contact to the cover flap. Inspection of the cover flap revealed significant deformation with a skin transfer and blood to the

**Figure 13:** Case vehicle's front right seating area showing deformed front right air bag module's cover flap and blood/skin on top surface of air bag's fabric (case photo #55)

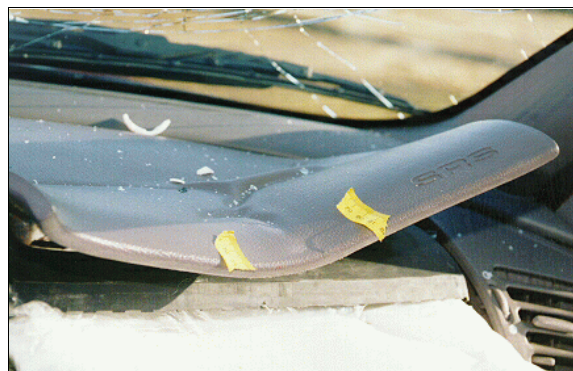
leading edge indicating direct contact with the front right passenger's neck and lower face (**Figure 14**). The skin and blood transfer was 8 centimeters (3.1 inches) wide and was approximately 15 centimeters (5.9 inches) in from the left edge and 14 centimeters (5.5 inches) in from the right edge. The evidence started at the leading edge of the cover flap extended back 6 centimeters (2.4 inches).

**Figure 14:** Close-up of blood/skin evidence on case vehicle's deformed front right air bag module's cover flap from contact with front right passenger's neck and chin (case photo #44)

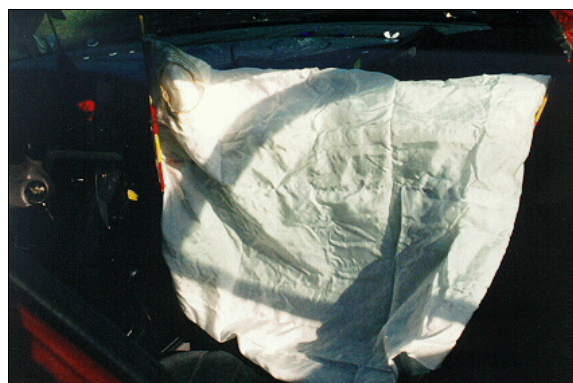
The front right air bag's fabric did not show any damage from the deployment. The front right passenger's air bag was designed with two tethers, each 7.5 centimeters (3.0 inches) in width. Both tethers were sewn to the interior face of the air bag at a point that was 23 centimeters (9.1 inches) below the top edge. The front right air bag had one vent port, approximately 7 centimeters (2.8 inches) in diameter, located at the 10 o'clock position. The deployed front right air bag was rectangular with a height of approximately 50 centimeters (19.7 inches) and a width of approximately 73 centimeters (28.7 inches). An inspection of the front right air bag revealed a large transfer of skin to the top and upper front left portions of the air bag. The examination also revealed a large area of dark skin and what looked like unknown dried bodily fluids to the bottom left portion of the air bag. On the top left surface there was an area of blood with dark skin. The skin transfer started approximately 17 centimeters (6.7 inches) down from the top edge of the air bag and extended forwards [towards the front right seat, 24 centimeters (9.4 inches)], angling right to the left towards the corner and air vent port. The skin transfer was 8 centimeters (3.2 inches) wide and started 13 centimeters (5.1 inches) in from the left edge. The skin and blood transfer continued down onto the front left surface a distance of 25 centimeters (9.8 inches) and extended inwards 12 centimeters (4.7 inches) towards the center of the front surface (**Figure 15**). The other large skin and fluid transfer was to the bottom left portion of the air bag and started 15 centimeters (5.9 inches) rearward from the bottom edge of the front surface and was approximately 20 x 10 centimeters (7.9 x 3.9 inches) in area.

**Figure 15:** Front surface of case vehicle's deployed front right passenger air bag showing bloody and oily area around vent port in upper left quadrant and no other obvious evidence of contact (case photo #37)

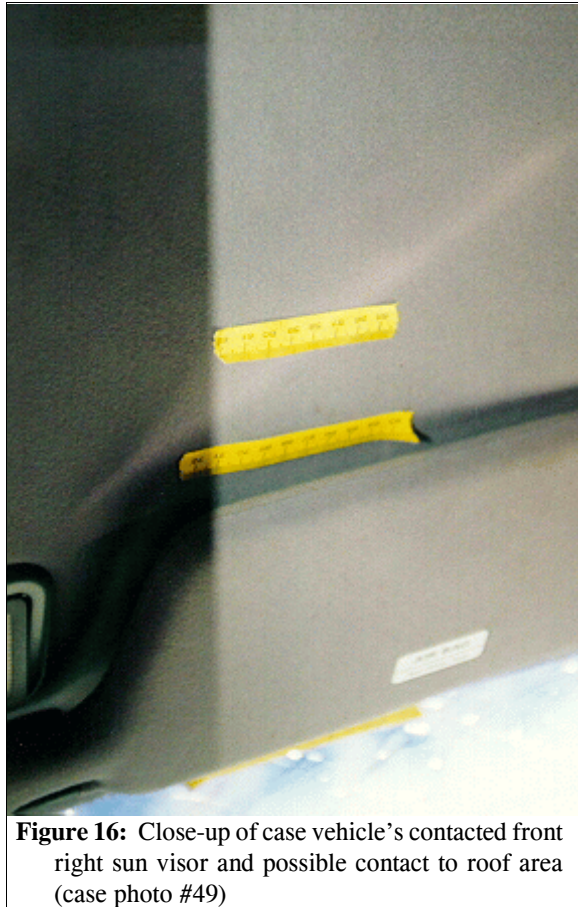
**Figure 16:** Close-up of case vehicle's contacted front right sun visor and possible contact to roof area (case photo #49)

addition, the front right passenger struck the forward edge of the sun visor and front right header, depositing strands of hair (Figures 16 and 17). This sequence of head contacts initiating with the cover flap strike, were responsible for this occupants fatal injuries. Presumably, her left foot may have struck the center instrument panel knocking off the air flow control knob and her right knee scraped the glove compartment door as her body was being lifted upwards. After striking the sun visor and header, the passenger may have contacted the roof above the right instrument panel and front right floor area before rebounding backwards against the seat back and falling into her seat where she came to rest on the seat cushion, on her left side, with her head towards the driver. This occupant’s final rest position is based on the blood evidence on the seat cushion and air bag fabric.

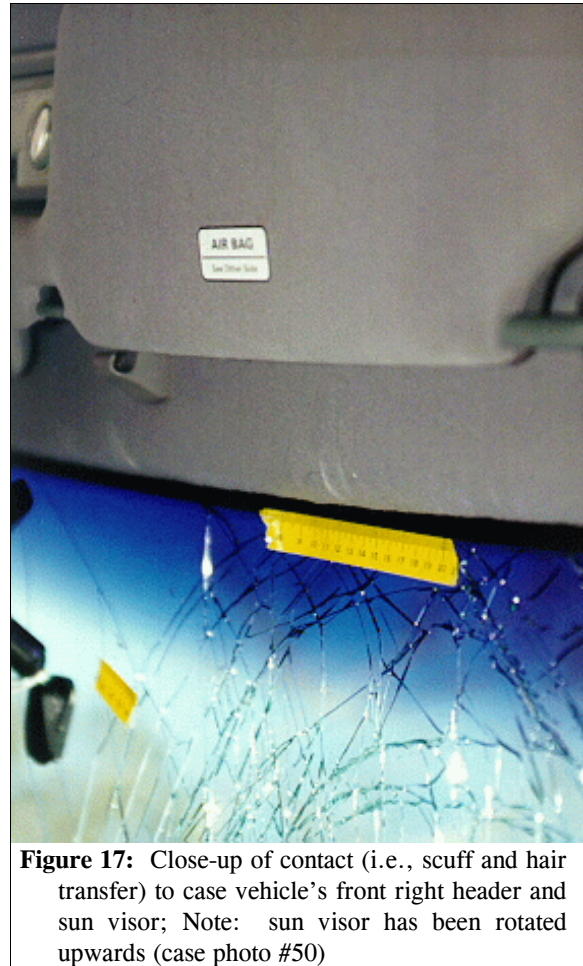
**Figure 17:** Close-up of contact (i.e., scuff and hair transfer) to case vehicle's front right header and sun visor; Note: sun visor has been rotated upwards (case photo #50)

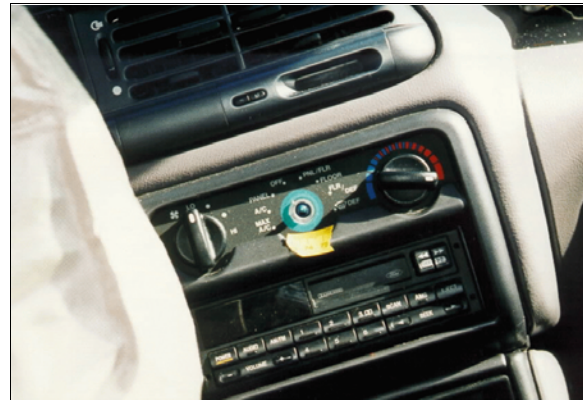
into the center instrument panel, knocking off the air flow control knob and lacerating her right thumb (Figure 18). As the deploying air bag continued to expand, it also struck the driver in the chest driving her upwards and back into her seat back. In addition, her scalp possibly contacted the roof as she moved rearward. At final rest the driver was close to the same seating position as prior to the crash. Following the crash the driver exited the case vehicle, without any assistance, and removed the front right passenger and the back left passenger, placing them into the Ford pickup where they were transported directly to the hospital.

**Figure 18:** Case vehicle’s center instrument panel showing missing air flow knob most likely knocked off by right hand of case vehicle’s driver (case photo #36)

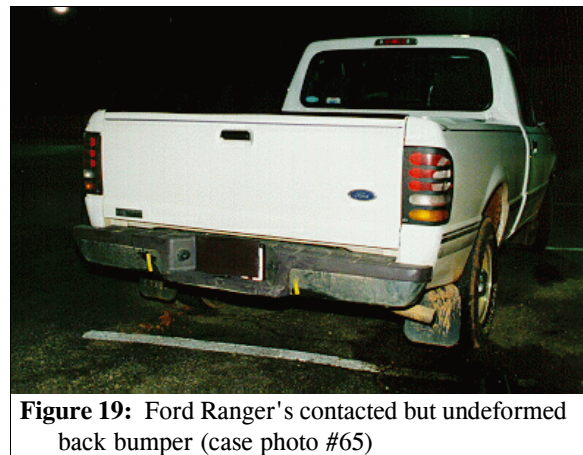
The Ford pickup's contact with the case vehicle involved its back step-up bumper (**Figure 19**). The back step-up bumper showed no visible deformation, only cracking and deep scratches to the plastic bumper cover (**Figure 20** below). Direct damage was concentrated to the center third of the vehicle and began 35 centimeters (13.8 inches) to the left of center and extended, a measured distance of 62 centimeters (24.4 inches) to the right (passenger side). Maximum crush was estimated as less than 0.5 centimeter (0.2 inches)--**Figure 5** above and **Figure 20** below]. The underside of the bumper showed approximately

**Figure 19:** Ford Ranger's contacted but undeformed back bumper (case photo #65)
