TRANSPORTATION RESEARCH CENTER

**REMOTE DEPOWERED AIR BAG REPORT**

CASE NUMBER - IN97-043  
LOCATION - TEXAS  
VEHICLE - 1998 CHEVROLET MALIBU LS  
CRASH DATE - November, 1997

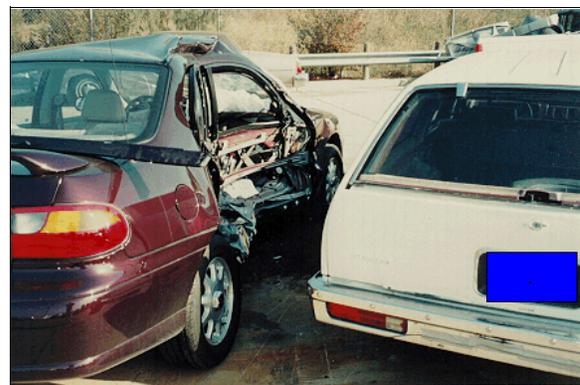
The center of the case vehicle's right side (Figure 1 and Figures 2 and 3 below) was impacted by the front of vehicle #2, causing the case vehicle's driver and front right passenger supplemental restraints (air bags) to deploy. The crash severity to the case vehicle is moderate [24-40 km.p.h. (15 to 25 m.p.h.)]. Vehicle #2 was also equipped with driver and front right passenger supplemental restraints (air bags) but, reportedly, they did not deploy.

**Figure 1:** Case vehicle's right side damage viewed from approximately 20 degrees right of back

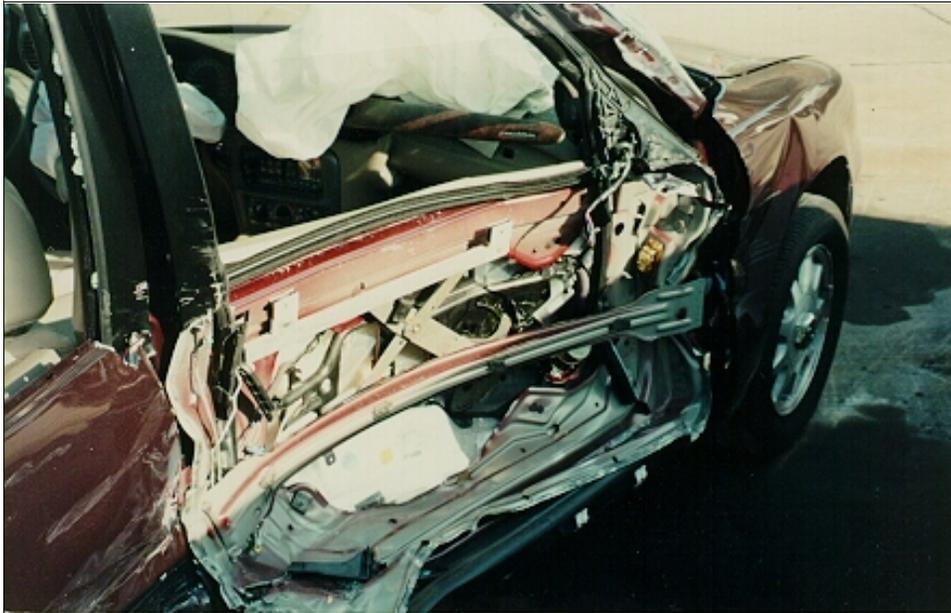
**Figure 2:** Close-up of case vehicle's right passenger compartment damage viewed from rear

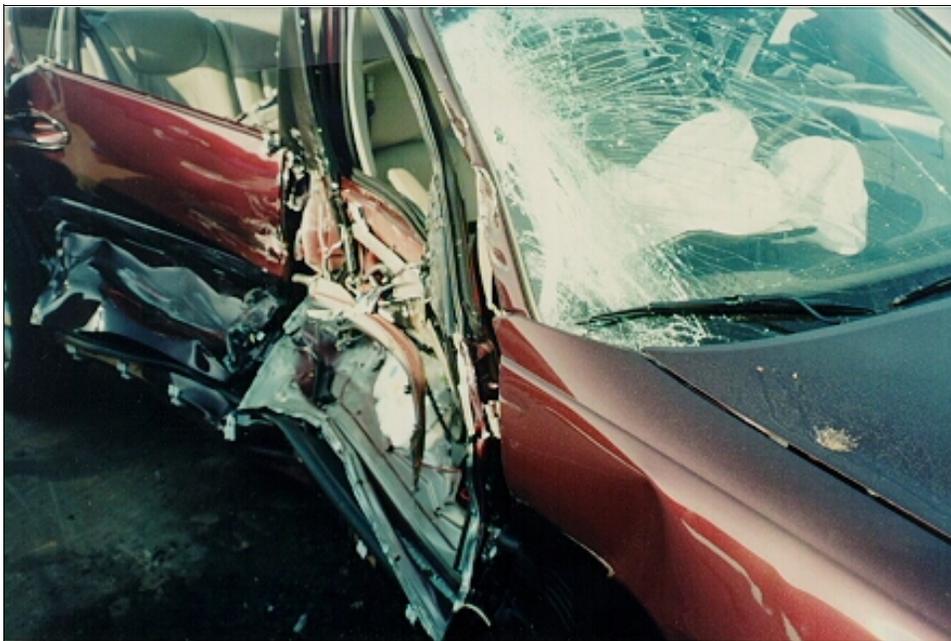
**Figure 3:** Close-up of case vehicle's right passenger compartment damage viewed from front
