# INDIANA UNIVERSITY

### ON-SITE ADULT AIR BAG-RELATED FATALITY INVESTIGATION

CASE NUMBER - IN97-044  
LOCATION - TEXAS  
VEHICLE - 1996 FORD CONTOUR GL  
CRASH DATE - May, 1997

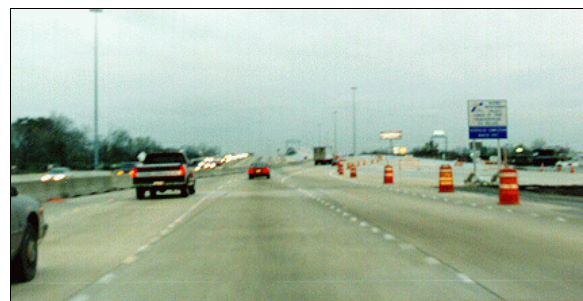
**Figure 1:** Case vehicle's southward travel path viewed from center lane of southbound roadway; Note: neither the farthest right (west) lane nor the road construction were present at the time of the crash (case photo #51)

The case vehicle was traveling south in the outside lane of a six-lane, divided, U.S. Freeway (**Figure 1**) and intended to continue traveling southward (i.e., both the north and southbound

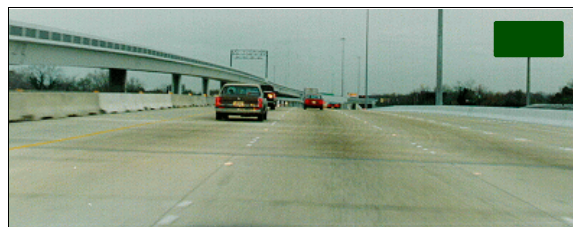
**Figure 2:** Approximate area of case vehicle's crash viewed from center lane of southbound roadway; Note: impacted concrete longitudinal barriers were located off both east (left) and west (right) sides of road and the farthest right (west) lane did not exist at the time of the crash (case photo #03)

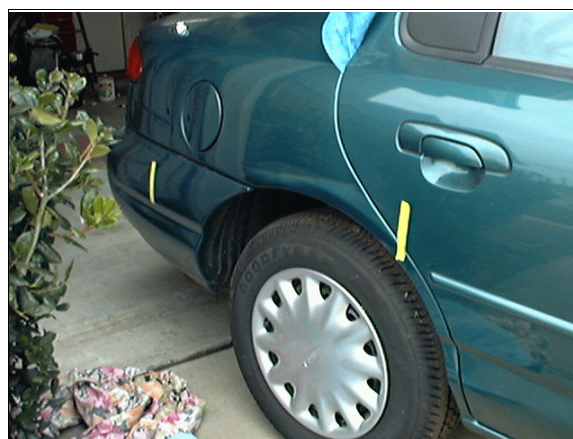
The case vehicle's right quarter panel, just above the wheel well (**Figure 3**), impacted a concrete barrier. As a result of the impact, the case vehicle's driver over steered back to the left, causing the case vehicle to veer across all three southbound lanes and go into a counterclockwise yaw. Besides the case vehicle's driver over correcting to the left, it is unknown whether the driver made any other avoidance maneuvers prior to departing the east (left) edge of the southbound roadway. The primary impact occurred when the case vehicle struck, in an end swiping fashion (**Figure 4** below), a concrete median barrier. The case vehicle's frontal end swipe impact (**Figures 5 and 6** below) with the concrete barrier caused

**Figure 3:** Sideswipe damage to case vehicle's right quarter panel above the right rear wheel well; Note: contact resulted from initial impact with concrete longitudinal barrier (case photo #16)

The case vehicle's initial contact with the concrete longitudinal barrier located off the right (west) side of the road involved a sideswipe type impact to the right quarter panel, just above the right rear wheel well area. The direct damage can be described as scuffing with minor deformation. The direct damage was 77 centimeters (30.3 inches) long and started 25 centimeters (9.8 inches) forward of the right rear axle and extended rearwards (**Figure 3** above). Maximum crush was only 0.5 centimeters (0.2 inches). The case vehicle's frontal impact with the concrete barrier caused minimal deformation (**Figure 6** above) and was primarily heavy abrasions across the case vehicle's front bumper fascia from right to left (passenger side to driver side–**Figure 5** above). There was heavier abrading on the front left bumper corner (**Figure 4** above). The direct damage was 125 centimeters (49.2 inches) in width and started 51 centimeters (20.1 inches) right

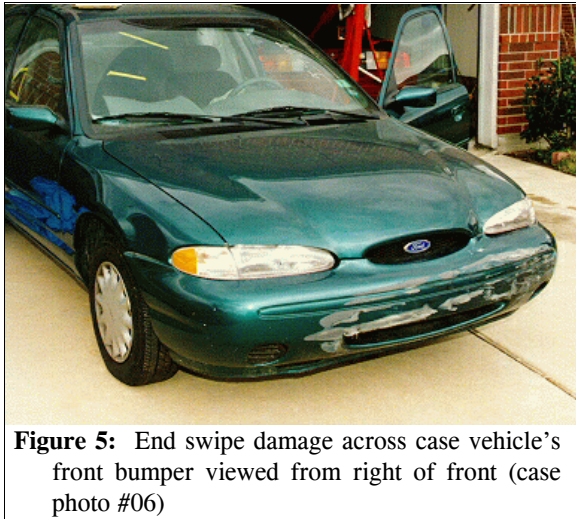
**Figure 5:** End swipe damage across case vehicle's front bumper viewed from right of front (case photo #06)

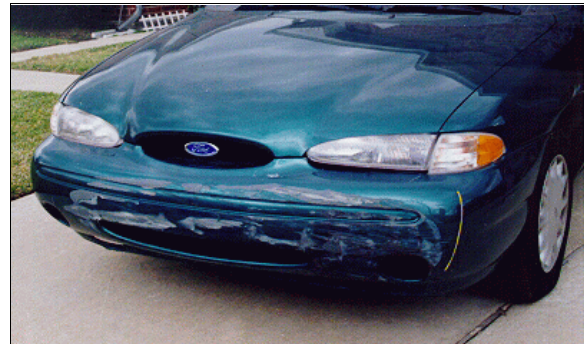
**Figure 4:** End swipe damage to case vehicle's front bumper fascia from concrete median barrier viewed from left of front (case photo #05)

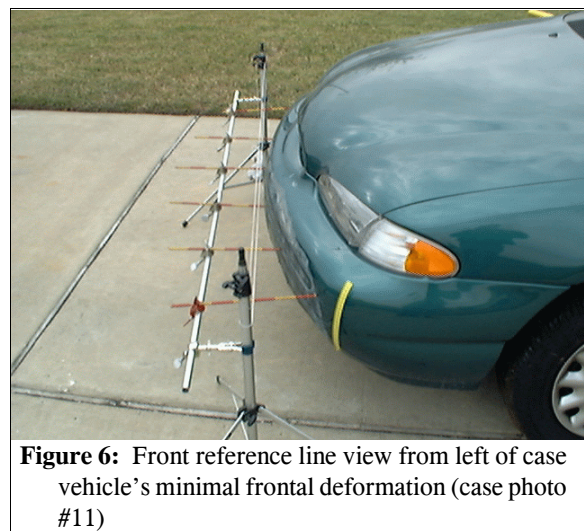
**Figure 6:** Front reference line view from left of case vehicle's minimal frontal deformation (case photo #11)

Based on the vehicle inspection, the CDC was determined to be: **02-FDEW-1 (50)**, for the case vehicle. The WinSMASH reconstruction program, barrier algorithm, was used on the case vehicle's highest severity impact. The Total, Longitudinal, and Lateral Delta Vs are, respectively: 7.3 km.p.h. (4.5 m.p.h.), -4.7 km.p.h. (-2.9 m.p.h.), and -5.6 km.p.h. (-3.5 m.p.h.). This contractor believes that while this collision fits the model, the Delta Vs are low. The low Delta Vs are a result of the minimal deformation to the case vehicle's front bumper, which sustained nothing more than scrapes with some slight shifting to the left, and the counterclockwise rotational trajectory of the case vehicle just prior to its impact with the barrier. The case vehicle was towed but not due to damage.

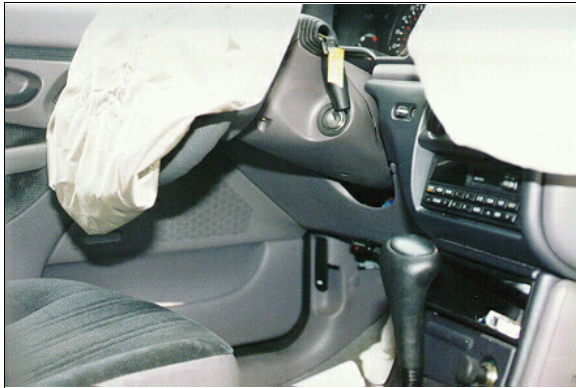
**Figure 7:** Case vehicle's steering column showing deployed driver air bag and broken windshield wiper lever (case photo #25)

The inspection of the case vehicle's interior revealed the windshield wiper lever on the steering column to be broken and hanging down (**Figure 7** above). The energy absorbing steering column showed no evidence of compression. The glove compartment door directly in front of the front right seating area showed no evidence of direct contact (**Figure 8** above). There was an area of unknown body fluid sprayed on the right windshield (**Figure 9** above) above the passenger side air bag module's cover flap. There was contact (i.e., hair with blood smear) on the front right sun visor (**Figure 10** above), a small blood smear on the roof over the front right seating position, and a head sized grease smear with blood on the base of the right front door's glazing (**Figures 11 and 12**). In addition, there was a blood trail on the right front door panel with a large area of blood on the lateral (outside) portion of the front right passenger seat cushion (**Figures 11 and 13**).

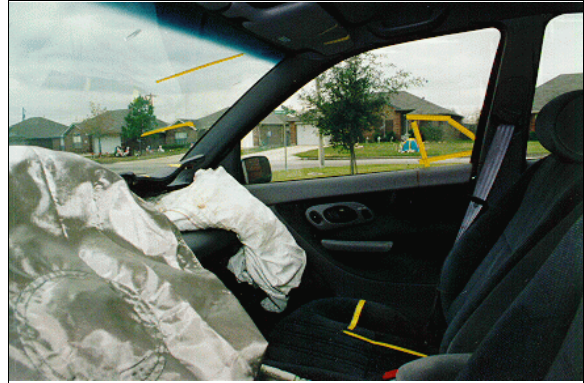
**Figure 8:** Case vehicle's front seating area showing deployed front air bags and driver's travel path within interior; Note: sequentially driver struck and deposited evidence on the front right passenger air bag module's cover flap, air bag, front right sun visor, and right front glazing (case photo #28)

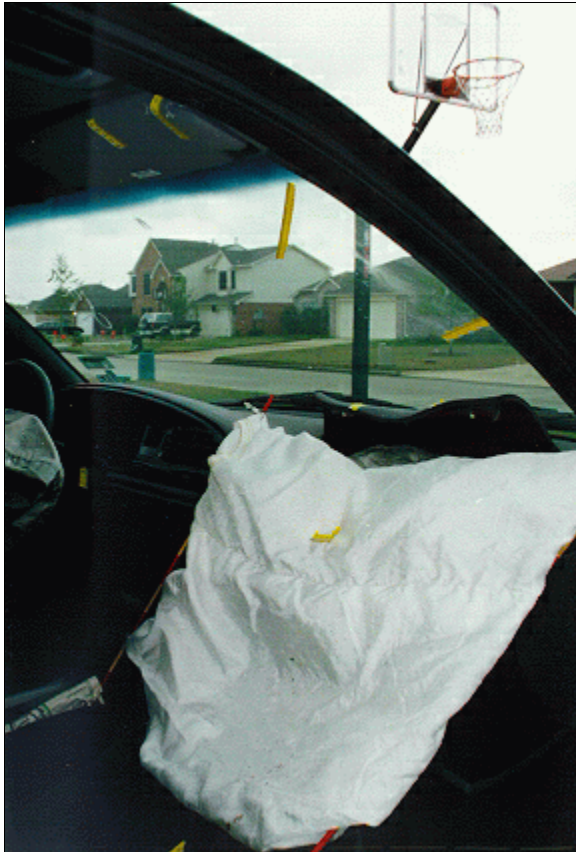
**Figure 9:** Vertical view of case vehicle's deployed front right passenger air bag showing evidence of driver contact to front surface of air bag, front right sun visor; and spray on the right windshield (case photo #40)

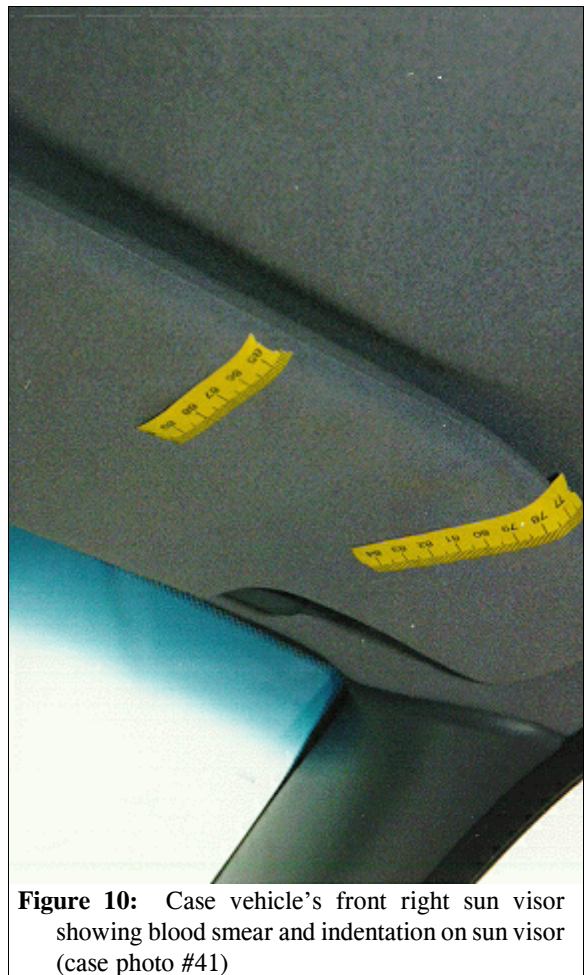
**Figure 10:** Case vehicle's front right sun visor showing blood smear and indentation on sun visor (case photo #41)

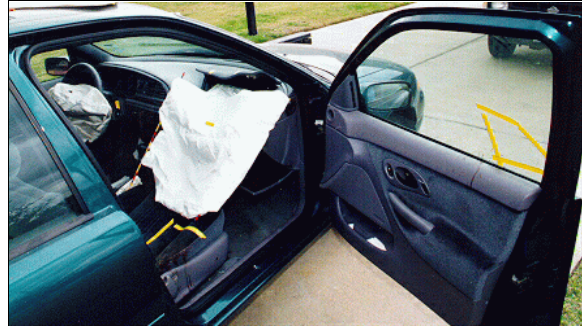
**Figure 11:** Interior surface of case vehicle's right front door and deployed front right passenger's air bag showing occupant contact on air bag, right front glazing, and lateral surface of front right seat (case photo #43)

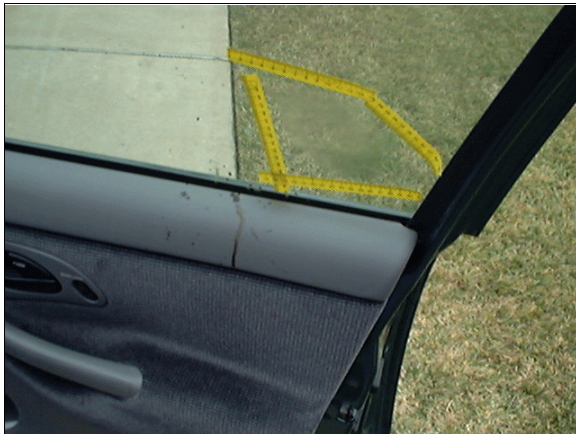
**Figure 12:** Case vehicle's right front door glazing showing oil and blood smear from contact by driver's head (case photo #50)

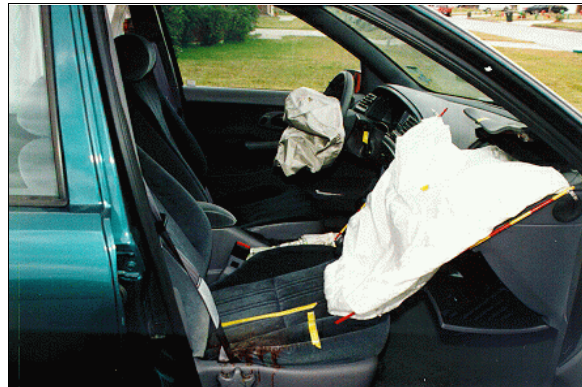
**Figure 13:** Case vehicle's front seating area showing deployed driver and front right passenger air bags and blood evidence on lateral side of front right seat (case photo #46)

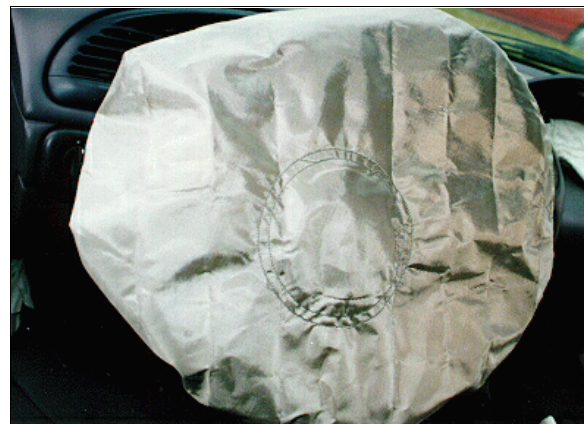
The case vehicle was equipped with a Supplemental Restraint System (SRS) that contained frontal air bags at the driver and front right passenger positions. Both air bags deployed as a result of the case vehicle's frontal end swipe with concrete median barrier. The case vehicle's driver air bag was located in the steering wheel hub. The module cover consisted of asymmetrical "H"-configuration cover flaps made of thick vinyl. The overall dimensions of the top flap were 26 centimeters (10.2 inches) at the top, 20 centimeters (7.9 inches) across the center seam and 8 centimeters (3.1 inches) vertically. The overall dimensions of the bottom flap were 21 centimeters (8.3 inches) at the bottom, 19 centimeters (7.5 inches) across the center seam, and 8 centimeters (3.1 inches) vertically. An inspection of the air bag module's cover flaps and air bag revealed that the cover flaps opened at the designated tear points, and there was no evidence of damage during the deployment to the air bag or the cover flaps. The driver's air bag was designed with four tethers, sewn interiorly to the center of the air bag, each 6 centimeters (2.4 inches) in width. The driver's air bag had two vent ports, approximately 2 centimeters (0.8 inches) in diameter, located at the 11 and 1 o'clock positions. The deployed driver's air bag was elliptical with a height of approximately 57 centimeters (22.4 inches) and a width of approximately 59 centimeters (23.2 inches). There was no contact evidence readily apparent on the driver's air bag (**Figure 14**).

**Figure 14:** Case vehicle's deployed driver air bag showing no visible evidence of contact (case photo #22)

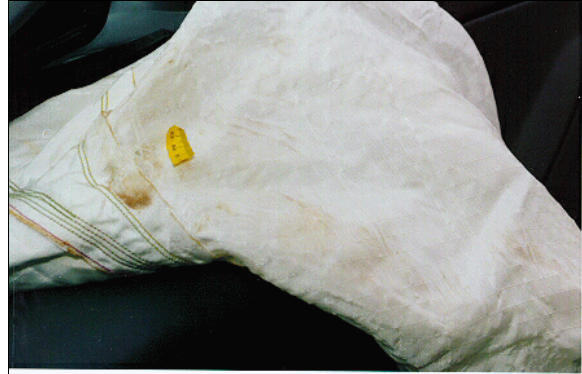
An inspection of the front right air bag module's cover flaps and air bag revealed that the cover flaps opened at the designated tear points, and there was a snag on the underneath surface towards the driver's side of the air bag (**Figures 15 and 16**). A 2 centimeter (0.8 inch) snag resulted during the air bag's altered deployment path as it caught on the metal frame of the cover flap. Furthermore, there was deformation, teeth marks, and skin on the front right air bag module's cover flap (**Figure 17 and Figure 18** below). The deformation was located 9 centimeters (3.5 inches) in from the left side edge of the cover flap and 13 centimeters (5.1 inches) in from the right edge. The skin transfer was approximately 15 centimeters (5.9 inches) wide and was 7 centimeters (2.8 inches) high starting from the forward-most edge of the cover flap. The teeth scratches started 14 centimeters (5.5 inches) in from the left side edge and extended 2 centimeters (0.8 inches) up from the forward-most edge of the cover flap downward. The cover flap did not contact the windshield.

**Figure 15:** Underneath surface of case vehicle's deployed front right passenger air bag showing driver contact area near snag which occurred during air bag's deployment (case photo #33)

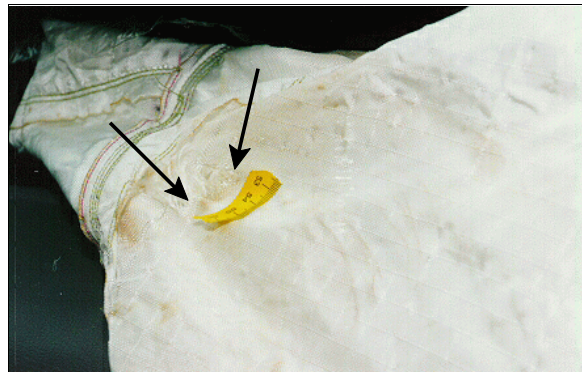
**Figure 16:** Close-up of snag on underneath surface of case vehicle's deployed front right passenger air bag; Note: snag (arrows) near area of skin, oil, and fluid stains from contact by driver (case photo #34)

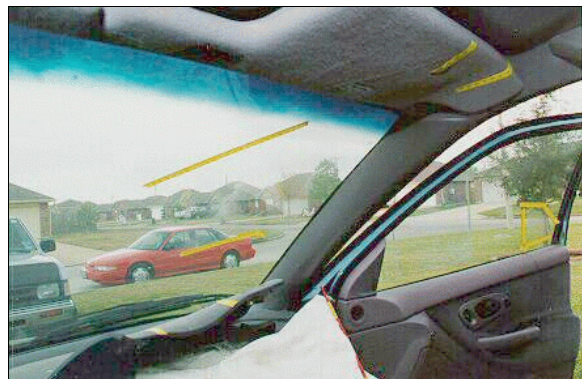
**Figure 17:** Case vehicle's front right seating area showing driver's direction of movement and contacts to air bag module's cover flap, sun visor, and right front door glazing; Note: spray on right windshield (case photo #30)

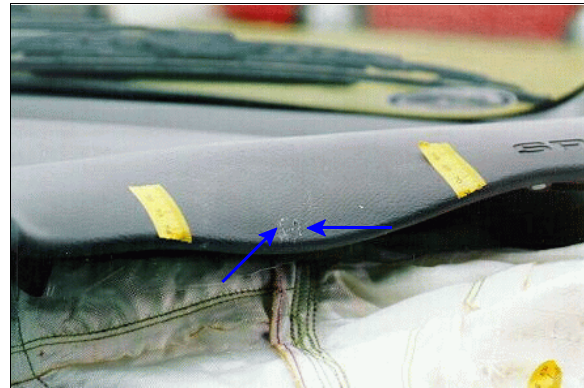
**Figure 18:** Close-up of deformation and teeth marks (arrow) on case vehicle front right passenger air bag module's cover flap from contact with face of case vehicle's driver (case photo #37)

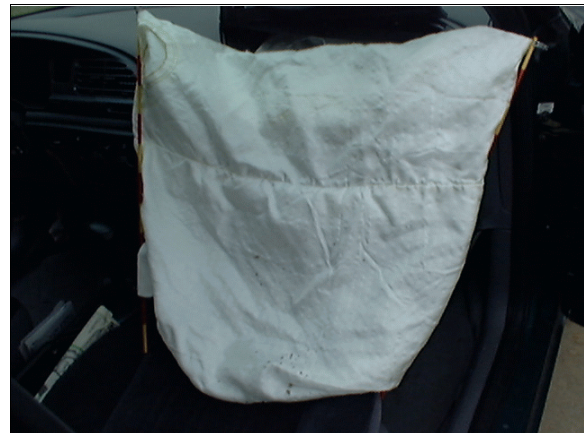
**Figure 19:** Case vehicle's deployed front right air bag showing evidence of occupant contact to lower right quadrant (case photo #39)
