**CALSPAN ON-SITE AIR BAG/CHILD PASSENGER FATALITY INVESTIGATION
CALSPAN CASE NO. CA97-045
VEHICLE: 1997 GEO METRO
LOCATION: FLORIDA
CRASH DATE: OCTOBER, 1997**

CALSPAN ON-SITE AIR BAG/CHILD PASSENGER FATALITY INVESTIGATION

CALSPAN CASE NO. CA97-045

VEHICLE: 1997 GEO METRO

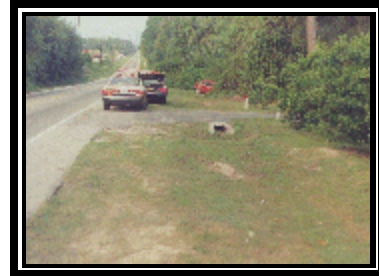
Figure 1. On-scene view of the crash site and final rest position of the Geo Metro.

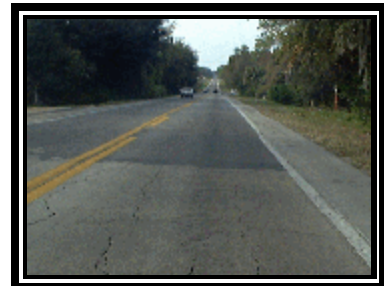
Figure 2. Overall view of the crash site.

broken yellow centerline with raised reflectors which allowed passing in the southbound direction of travel. The edgelines were solid white lines with no tactile warning devices present on the shoulder of the road. Private residential driveways intersected the travel lanes. The posted speed limit was 72 km/h (45 mph). A shallow drainage ditch paralleled the west (right) road edge and was located 5.2 m (17.0') outboard of the edgeline. A concrete drainage culvert for a private driveway was located 4.6-5.6 m (15'2"-18'4") west of the edgeline.

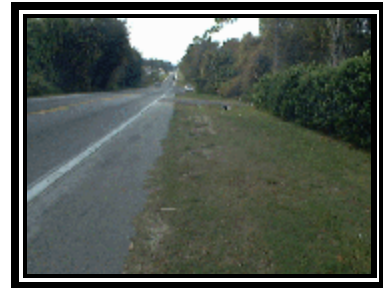
Figure 3. Trajectory of the Geo Metro across the lawn area.

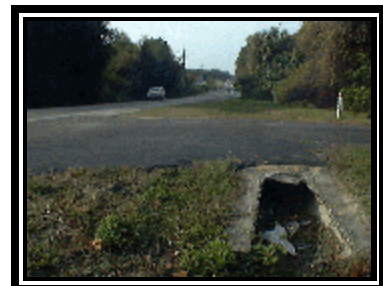
Figure 4. Struck driveway culvert.

hook, and the right front tire and wheel assembly impacted the exposed edge of the driveway culvert (**Figure 4**). The impact resulted in a 12 o'clock direction of force. The vehicle's damage pattern was outside the scope of the WinSMASH reconstruction program, therefore the velocity change was estimated at 13-16 km/h (8-10 mph). As a result of this impact sequence, the frontal air bag system deployed. It was probable the undercarriage contact produced an elongated crash pulse which delayed the deployment of the frontal air bag system.

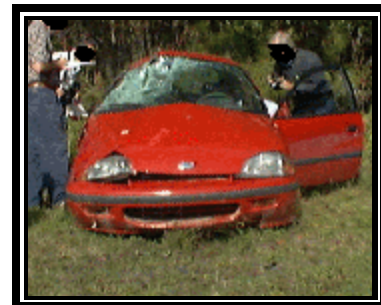
The driveway/culvert impact initially involved the lower aspect of the front bumper fascia. This flexible component was abraded from the culvert contact with the direct contact damage beginning 31.8 cm (12.25") right of center and extending 25.4 cm (10.0") to the right (**Figure 5**). The deformation was below the level of the bumper reinforcement bar, therefore no residual crush occurred at bumper level. The impact with the driveway/culvert edge resulted in a 6.2 cm (2.4") longitudinal displacement of the lower radiator support located 36.0 cm (14.2") right of center and deformation of the tie-down hook. The right front tire and wheel subsequently impacted the culvert which dented the steel wheel and reduced the right wheelbase by 2.0 cm (0.8"). The Collision Deformation Classification (CDC) for this impact sequence was 12-FRLW-1.

Figure 5. Frontal view of the Geo Metro.

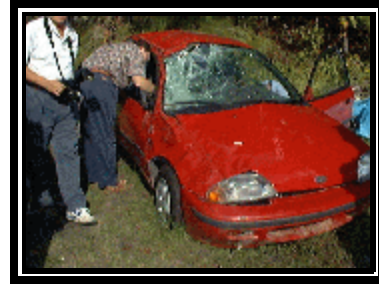
The rollover event resulted in vertically oriented abrasions to the left rear quarter panel, lateral abrasions to the roof and hood, and vertical abrasions to the right side of the Geo. The right A-pillar and adjacent side rail area sustained 7.0 cm (2.75") of lateral displacement and approximately 5 cm (2") of vertical displacement. The leading edge of the right front fender and hood at the headlamp area was displaced 7.6 cm (3.0") in both the vertical and lateral directions (**Figure 6**). The rollover damage resulted in a CDC of 00-TDDO-3.

Figure 6. Rollover damage.

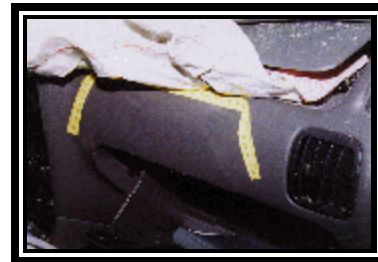
The lower aspect of the improperly restrained child safety seat moved forward during the crash sequence and contacted the lower mid instrument panel evidenced by a scuff mark with plastic transfers (**Figure 7**). The contact point was located 10.2-38.1 cm (4.0-15.0") right of center and was 7.0 cm (2.75") in height. The transfer was located 3.2-10.8 cm (1.25-4.25") below the leading edge of the front right air bag module cover flap. Additional transfers from the base of the CSS were noted to the front right seat cushion. These transfers resulted from the forward movement of the CSS during the crash sequence.

Figure 7. CSS contact to the mid instrument panel.

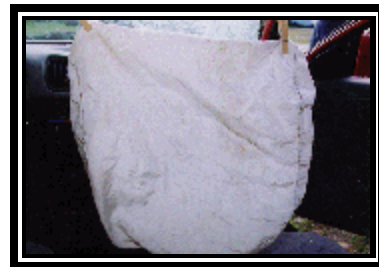
The maximum rearward excursion of the non-tethered passenger side air bag was 64.8 cm (25.5") from the leading edge of the module assembly, or 60.3 cm (23.75") rearward of the mid panel. Vertically oriented black vinyl transfers were present on the top panel of the bag located 8.9-14.0 cm (3.5-5.5") rearward of the cover flap. These transfers resulted from bag expansion against the inside surface of the module cover flap. Faint tissue transfers were noted to the face of the bag, located slightly right of the bags center line (**Figure 8**). The vertically oriented transfers consisted of tissue fragments from bag expansion against the face of the child passenger.

Figure 8. Tissue and vinyl transfers on the face of the front right air bag.

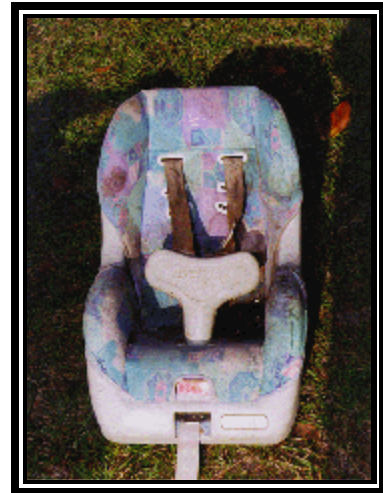
The 17 month old female passenger was seated in a forward facing Evenflo Scout convertible child safety seat (CSS) that was positioned in the front right of the vehicle. The CSS was manufactured on September 26, 1995, and was identified by Model No. 225117 J1 (**Figure 9**). The restraint consisted of a molded plastic shell with an adjustable strut on the base of the CSS. This strut was folded up into the shell which is the proper position when used in a rear facing mode. The strut should have been extended to the down position to maintain a vertical profile to the seat in the forward facing position. The harness system consisted of a three-point belt system with an abdominal shield with an integral latchplate. The shoulder harness straps were properly routed through the upper slots for this forward facing position. The chest positioning clip was affixed to the left shoulder harness strap. This model did not utilize a fold-up tray shield. The history of this CSS was unknown.

Figure 9. Overall view of the Evenflo Scout CSS.

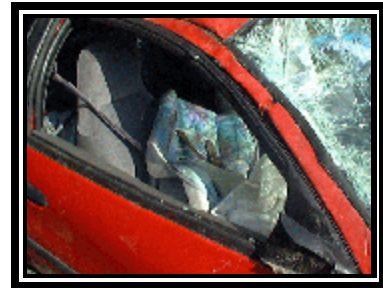
Although not in violation of manufacturers recommendations, the forward facing CSS was positioned in the front right seat of the Geo Metro. The manufacturers label on the front right belt webbing advised that the seat track must be adjusted to the full rear position when using a forward facing CSS. The seat track was positioned in a mid track position, set 10.4 cm (4.1") forward of the full rear position. The CSS was improperly restrained by the vehicle's manual 3-point lap and shoulder belt system. The belt webbing was routed through the proper belt path of the shell, however, the retractor was not placed in the switchable mode, therefore the CSS was not properly secured to the vehicle. In this position, the emergency locking retractor allowed the CSS to move free within the front right position (**Figure 10**). The investigating police officer indicated that the child safety seat after the crash could be lifted approximately 30 cm (12") above the seat cushion while secured by the manual belt system.

Figure 10. Loose position of the CSS in the front right seated area.

Damage to the CSS was limited to superficial abrasions to the lower front aspect of the shell from contact against the lower/mid instrument panel. Blood stains were noted to the harness straps and front shield.

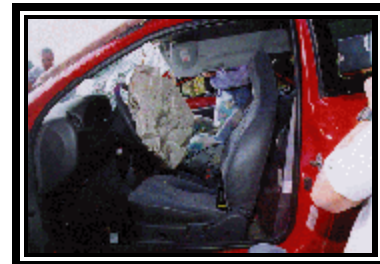
The manually operated driver’s seat track was adjusted to a mid track position, 9.7 cm (3.8") rearward of the full forward position (**Figure 11**). The seat back support was adjusted to the most vertical position at the time of inspection. Contact evidence within the driver’s compartment of the vehicle consisted of two abrasions/scuff marks to the knee bolster.

Figure 11. Adjusted seat rack position and the deployed front left air bag.

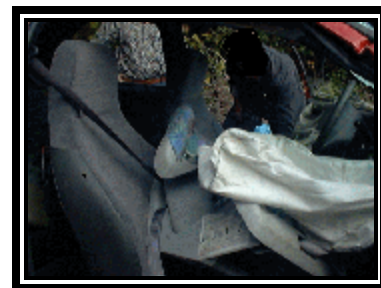
At the time of air SIR deployment, the child was within the deployment path of the front right air bag (**Figure 12**) with her head slightly to the right. The child sustained extensive facial abrasions that extended vertically from the underside of the chin to the mid forehead and laterally from the left ear to the outboard aspect of the right eye (refer to SENSITIVE IMAGES, **Figures 14 and 15**, Page 14). Tissue transfers on the bag evidence her interaction with the deploying membrane. The head was accelerated by the deploying air bag which resulted in a frontal scalpular hemorrhage, cerebral edema, and leptomenigeal hemorrhage over the left superior temporo-parietal region with left subarachnoid hemorrhage. In addition to the face and closed head injuries, the child sustained abrasions of the lower legs from air bag deployment. Her feet impacted the mid right instrument panel as the lower aspect of the child restraint contacted and scuffed the mid instrument panel.

Figure 12. Excursion of the front right air bag into the CSS.

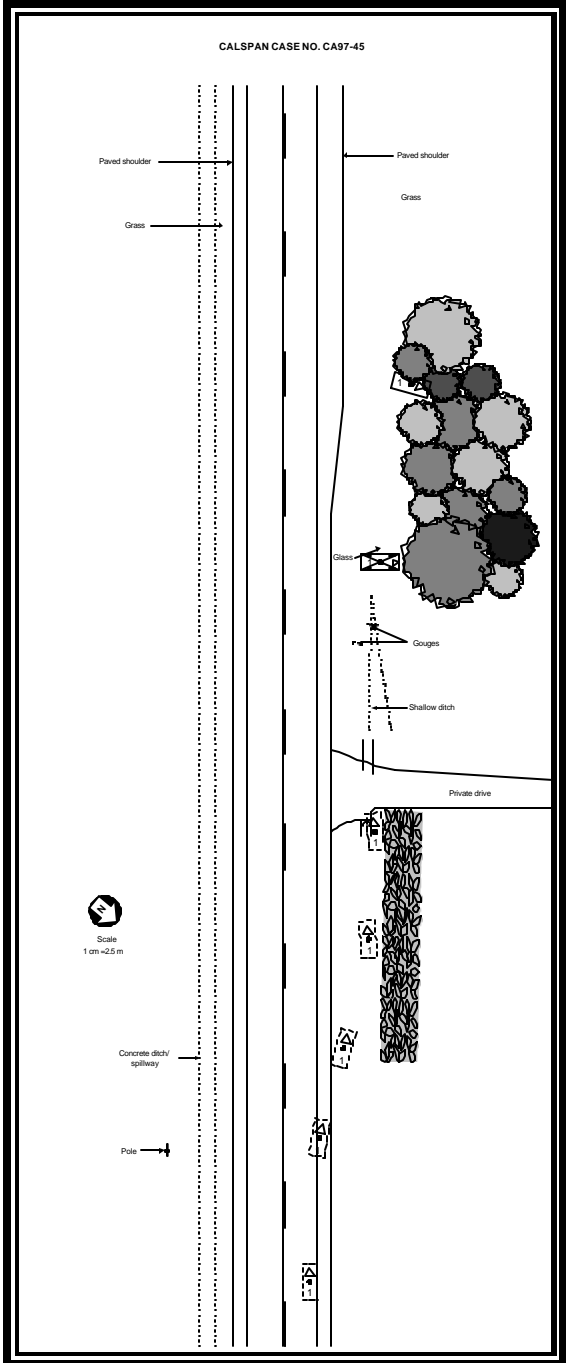
Figure 13. Crash Schematic

The front right impact sequence induced a clockwise (CW) rotation to the Geo Metro as its center of gravity (CG) continued in a southerly trajectory. The Geo traveled a police reported distance of approximately 11 m (36') across the driveway and adjacent lawn area where the left side tires dug in to the sandy surface which tripped the Metro into a lateral rollover sequence, leading with its left side. The Metro completed four quarter turns over a longitudinal distance of approximately 33 m (109') before coming to rest in an upright attitude. At final rest, the vehicle was facing in a westerly direction approximately 6.7 m (22.0') off-road. The crash schematic is attached as **Figure 13**, Page 12.
