REDESIGNED AIR BAG REPORT

CASE NUMBER - IN97-046
LOCATION - TEXAS
VEHICLE - 1998 DODGE DAKOTA PICKUP TRUCK
CRASH DATE - November, 1997

| 4. <i>Title and Subtitle</i> On-Site Redesigned Air Bag Investigation Vehicle - 1998 Dodge Dakota Pickup Truck Location - Texas | | | 5. <i>Report Date:</i> January 19, 1999 | | |

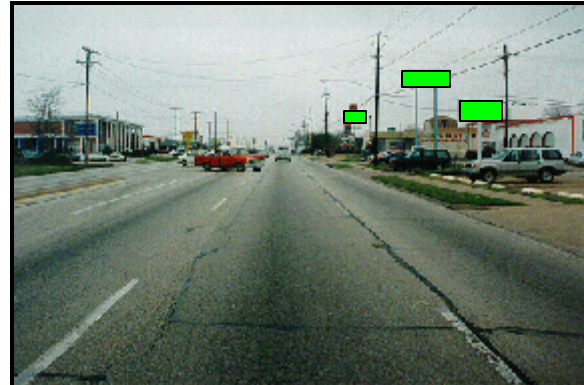
The case vehicle was traveling north in the center northbound through lane (**Figure 1**) of a seven-lane, divided, city trafficway and intended to continue its northerly travel path through a "Tee" intersection (i.e., both the north and south roadways had three through lanes and a left-hand turn lane). Vehicle #2 had been traveling west in the westbound lane of a two-lane, undivided, intersecting city street and was entering the "Tee" intersection, intending to cross the northbound roadway and turn left and travel south on the southbound roadway. Vehicle #3 was traveling north in the inside (westernmost) through lane of the northbound roadway and also intended to continue its northerly travel path. The case vehicle's driver locked-up his brakes, attempting to avoid the crash. His pre-impact travel speed was estimated at 66-80 km.p.h.(41-50 m.p.h.), the same speed he estimated for his vehicle at-impact. The posted speed limit for this location was 56 km.p.h. (35 m.p.h.). The crash occurred in the center through lane of the northbound roadway, in the "Tee" intersection of the two trafficways.

Figure 1: Case vehicle's northward travel path from center northbound through lane (case photo #02)

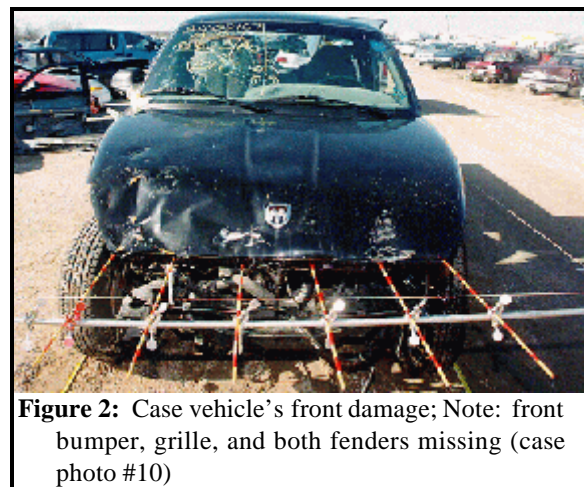
Figure 2: Case vehicle's front damage; Note: front bumper, grille, and both fenders missing (case photo #10)

reading (i.e., an electronic odometer) was approximately 4,023 kilometers (2,500 miles). The case vehicle was towed due to disabling damage. Direct damage from the first (deployment) impact was corner-to-corner to the front bumper, with other damaged components including: grille, radiator and brackets, front splash guard, both right and left headlight and turn signal assemblies, both right and left fenders, and the hood. Maximum crush was 13 centimeters (5.1 inches) at the front right hood corner. No intrusion from the case vehicle's first impact was detected. Based on the vehicle inspection, the CDC was determined to be: **12-FDEW-1** (Figure 2 above) for the case vehicle's deployment impact. The WinSMASH reconstruction program, damage only algorithm, was used on the case vehicle's highest severity (first) impact. The Total, Longitudinal, and Lateral Delta Vs are, respectively: 24.1 km.p.h. (15.0 m.p.h.), -23.7 km.p.h. (-14.7 m.p.h.), and -4.2 km.p.h. (-2.6 m.p.h.). Direct damage from the case vehicle's second impact, involving vehicle #3, included: the forward portion of the left quarter panel, the lower left "B" pillar, the left front door panel, and the left rocker panel under the door panel (Figure 7). At the time of inspection, the backlite glazing was missing; it is unknown if crash forces were responsible for the missing glazing. Intrusion from the second impact to the driver's seating area measured 11 centimeters (4.3 inches) at both the left front door and rocker panel and 12 centimeters (4.7 inches) at the lower "B" pillar. A CDC for the case vehicle's second impact was estimated to be: **08-LZEW-01**. WinSMASH was not attempted on the second impact because vehicle #3 was not inspected and part of the outer metal covering of the case vehicle's left front door was missing.

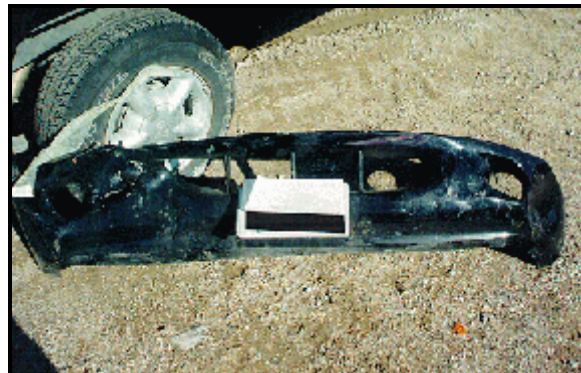
Figure 3: Case vehicle's front bumper; Note: corner to corner direct damage (case photo #12)

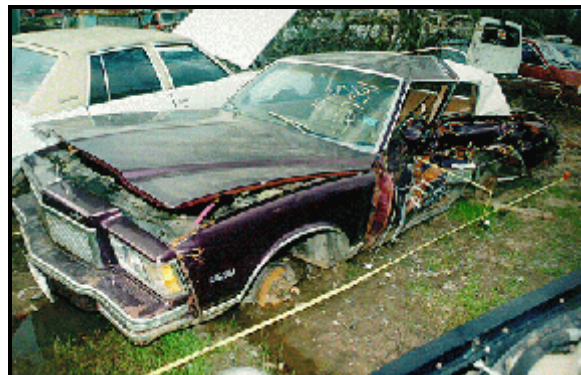
Figure 4: Vehicle #2's left-side damage; Note: direct contact to "D" pillar and "C" pillar (case photo #13)

Vehicle #2 was a rear wheel drive 1979 Chevrolet Monte Carlo “S” (“Sport”), six-passenger, two-door coupe (VIN: 1Z37H9R-----) equipped with a 5.0L, 4 Bbl, V-8 engine. The case vehicle’s wheel base was 275 centimeters (108.1 inches). Direct damage extended from the middle of the left front door to the forward portion of the left rear wheel well (**Figure 4** above), with an averaged maximum crush of 41 centimeters (16.1 inches) near the back edge of the left front door panel. Based on the vehicle

inspection, the CDC was determined to be: **10-LZAW-04**. The WinSMASH reconstruction program, damage only algorithm, was used on vehicle #2's highest severity impact. The Total, Longitudinal, and lateral Delta Vs are, respectively: 25.9 km.p.h. (16.1 m.p.h.), -12.9 km.p.h. (-8.0 m.p.h.), and 22.4 km.p.h. (13.9 m.p.h.).

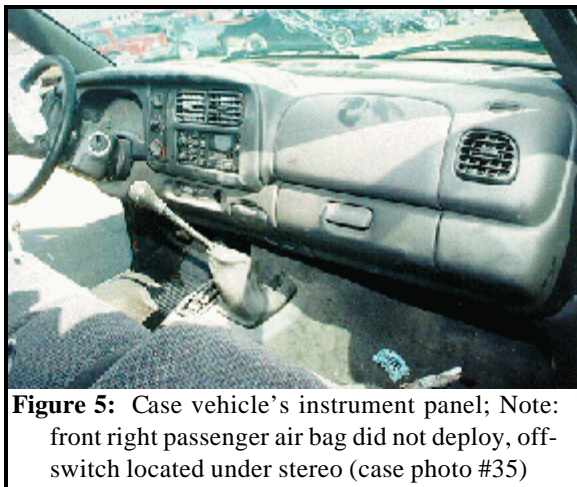
Figure 5: Case vehicle's instrument panel; Note: front right passenger air bag did not deploy, off-switch located under stereo (case photo #35)

The case vehicle's nondeployed, front right passenger air bag, which had been disabled, was located in the middle of the instrument panel (Figure 5 above). The dimensions of its single cover flap were not measured. An inspection of the nondeployed passenger air bag module's cover flap did not reveal any occupant contacts; however, the front right passenger impacted the windshield directly above that cover flap.

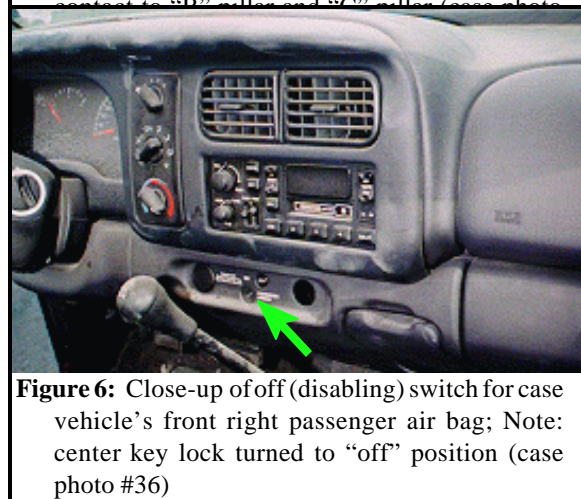
Figure 6: Close-up of off (disabling) switch for case vehicle's front right passenger air bag; Note: center key lock turned to "off" position (case photo #36)

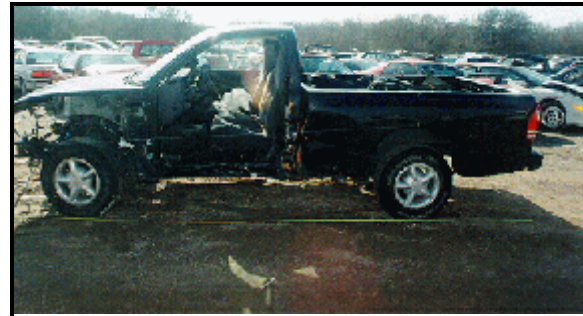
5 and 6). After the initial impact, the case vehicle rotated approximately 30 degrees counterclockwise and was, subsequently, impacted in the left side (Figure 7 below) by the front right corner of vehicle #3. The second impact to the case vehicle involved the left front corner of its cargo bed and the left front door panel. The second impact of the crash sequence arrested the case vehicle's counterclockwise rotation and caused it to rotate approximately 260 degrees clockwise while moving northeastward toward the east edge of the northbound roadway. The case vehicle came to rest straddling the east curblin, heading southwestward. After the initial impact with the case vehicle, vehicle #2 was pushed northwestward and rotated approximately 45 degrees counterclockwise before coming to rest atop the raised concrete median separating the roadways on the north leg of the intersection. Vehicle #3 continued northward in its lane and came to rest in the inside (westernmost) lane of the northbound roadway, north of vehicle #2's final rest location.

Figure 7: Case vehicle's left-side damage from impact (2nd event) with vehicle #3 (case photo #17)

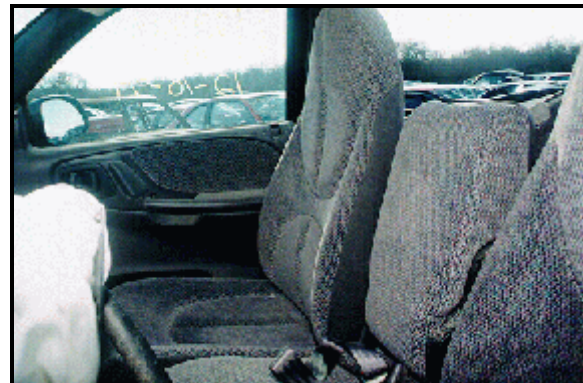
The front right passenger's seat track was found to be at its middle position and the driver's at its rearmost position during the vehicle inspection (Figure 8). Both seat track positions were reported by the driver to have been in their rearmost positions. Both seat backs were slightly reclined. No evidence of seat or track failure was detected. The tilt steering wheel was found to be in its upmost position during the vehicle inspection, but the driver reported it to be adjusted to its center position. No evidence of steering wheel deformity or steering column movement was detected.

Figure 8: Case vehicle's front right passenger seating area (case photo #37)

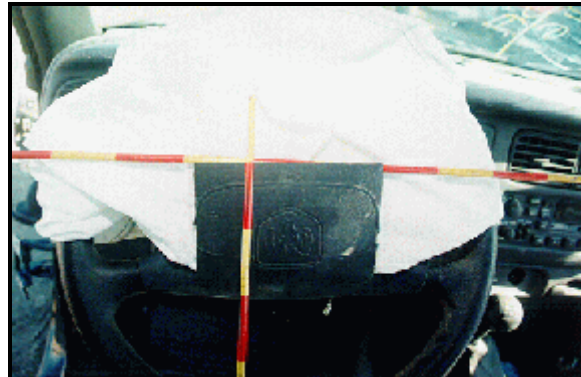
At the time of inspection, this contractor's investigative consultant discovered the case vehicle's driver air bag module, which was originally located in the steering wheel hub, had been removed. The module was found in the cargo area. Inspection of the air bag module's single cover flap revealed that the flap opened at the designated tear points (**Figure 9**), and there was no evidence of damage to the air bag or the cover flap. No evidence of occupant contact to the air bag (**Figure 10**) or cover flap was discerned, possibly because of the accumulated mud and dirt. The driver's deployed air bag was designed with: two, 2 centimeter (0.8 inch) tethers, no vent ports, and shaped round--with a diameter of 62 centimeters (24.4 inches). The single cover flap measured 15 centimeters (5.9 inches) along its top seam, 10 centimeters (3.9 inches) along its bottom seam, and 14 centimeters (5.5 inches) in height.

Figure 9: Close-up of case vehicle driver air bag module's cover flap; Note: steering wheel is rotated 180 degrees (case photo #45)

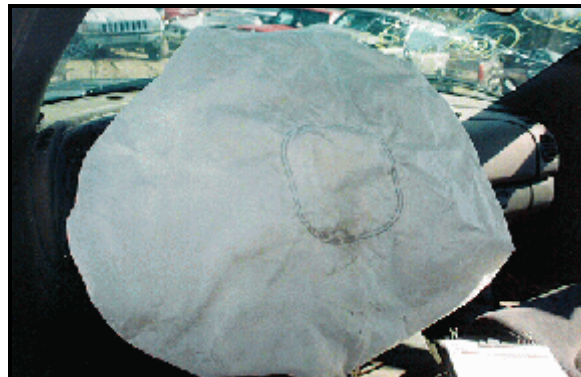
Figure 10: Case vehicle's deployed driver air bag; Note: air bag module had been removed post-crash and thrown into cargo area (case photo #40)
