**VERIDIAN REMOTE FRONT RIGHT AIR BAG DEPLOYMENT/INFANT
INVESTIGATION
VERIDIAN CASE NO. CA97-048
SUBJECT VEHICLE - 1994 TOYOTA CAMRY
LOCATION - STATE OF FLORIDA
CRASH DATE - SEPTEMBER, 1997**

Contract No.
DTNH22-94-D-07058

1. <i>Report No.</i> CA97-048	2. <i>Government Accession No.</i>	3. <i>Recipient's Catalog No.</i>	
4. <i>Title and Subtitle</i> Veridian Remote Front Right Air Bag Deployment/Infant Investigation Vehicle: 1994 Toyota Camry Location: State of Florida		5. <i>Report Date:</i> March, 1998

**VERIDIAN REMOTE FRONT RIGHT AIR BAG DEPLOYMENT/INFANT INJURY
INVESTIGATION
CALSPAN CASE NO. CA97-048
LOCATION: STATE OF FLORIDA
CRASH DATE: SEPTEMBER, 1997**

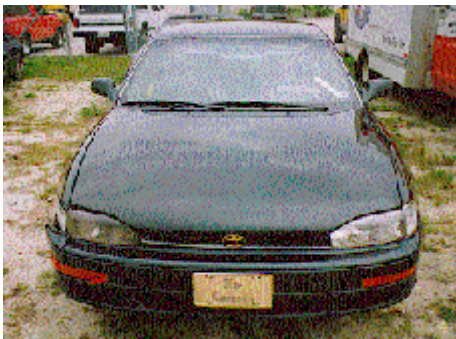
Figure 1. Frontal view of the Toyota Camry.

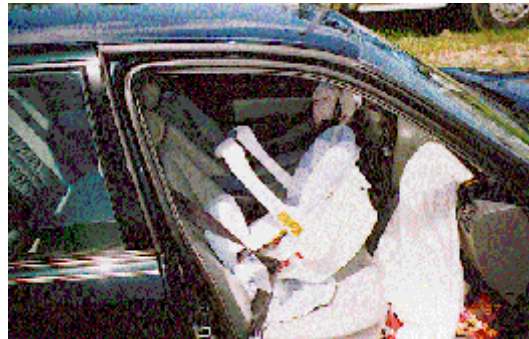
Figure 2. Right lateral view of the Camry's passenger compartment and post-crash positioned infant seat.

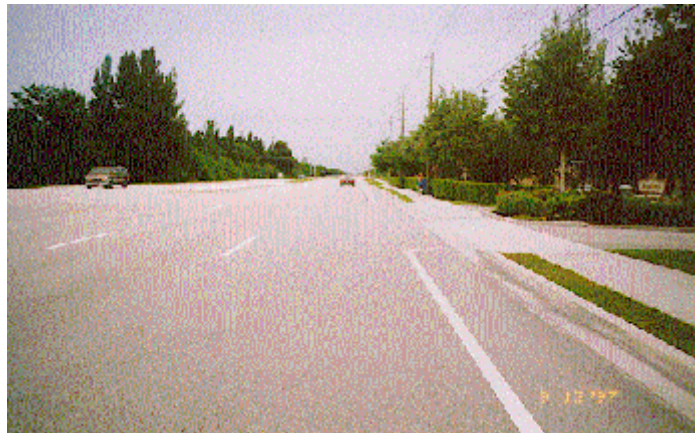
This crash occurred during the daylight hours in the southbound lanes of a divided state route with a posted speed limit of 72 km/h (45 mph). There were four lanes of northbound travel, one of which was designated as a left turn lane for a private driveway that created a T-type junction. Three southbound travel lanes were divided from the northbound lanes by a grass median and were bordered by a bicycle lane and a sidewalk adjacent to the outboard travel lane. The private driveway intersected the southbound lanes of the north/southbound roadway. Traffic exiting the driveway was controlled by a stop sign. There were no traffic controls for north/southbound travel. The asphalt road surface was dry and atmospheric conditions were clear at the time of the crash.

Figure 3. Pre-impact approach of the Camry.

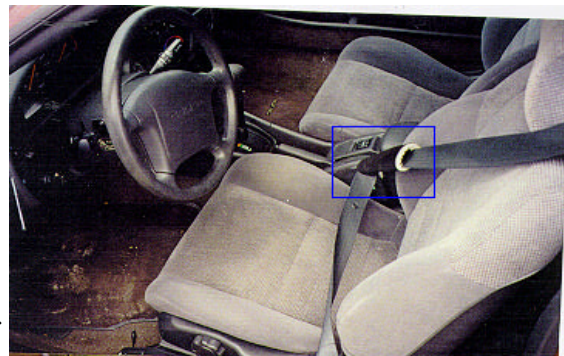
Figure 4. Driver side passenger compartment of the Toyota Celica with highlighted comfort sleeve.

positions. The front left belt's torso webbing was equipped with an adjustable aftermarket comfort sleeve (Figure 4). The Celica was not equipped with ABS.

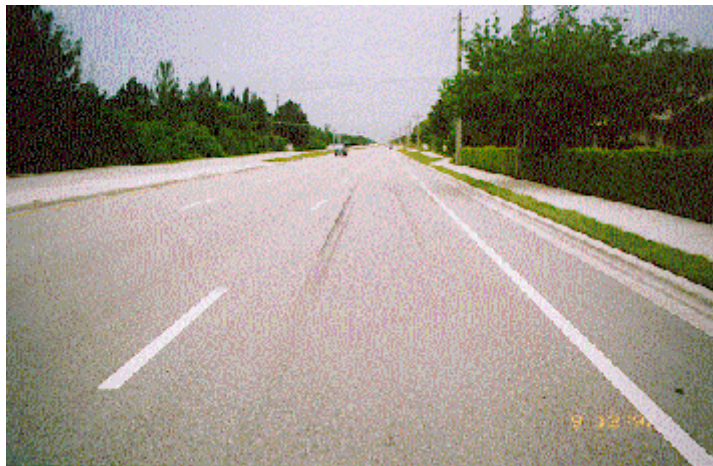
The Celica was traveling eastbound on the private driveway approaching the junction of the north/southbound roadway. The Camry was traveling southbound in the outboard lane of traffic at a police estimated speed of 89 km/h (55 mph). The driver of the Celica initiated a right turn onto the southbound roadway prior to the Camry's encroachment into the intersection. The driver of the Camry reportedly noticed the Celica when it emerged from the eastbound private driveway, however, avoidance actions to the impending crash were not evidenced until 20.7 meters (68 feet) south of the intersection. The police accident report identified pre-impact skid marks that measured 21.3 meters (70 feet) and evidenced that the driver of the Camry applied the vehicle's brakes in an attempt to avoid an impact with the Celica. The front left, front right, and left rear wheels locked on the dry asphalt surface. The front right bumper of the Camry impacted with the back left bumper of the Celica in a 12 o'clock/6 o'clock impact configuration and resulted in minor damage to both vehicles. The estimated 11-16 km/h (7-10 mph) delta V sustained by the Camry was sufficient to deploy the front left and front right air bags. Estimated delta V for the back plane impact to the Celica was 16-19 km/h (10-12 mph). Delta V's for both vehicles were estimated from police and insurance photographs. Post-impact, the front tires of the Camry remained locked and an additional 17.7 meters (58.0 feet) of post-impact skidding was police reported. Yawing evidence from the left rear and right rear tires present at the crash scene indicated that the Camry rotated approximately 20 degrees clockwise and came to final rest in the outboard lane headed southwest. Skid to stop speed was calculated at 85.8 km/h (53.3 mph) assuming a friction coefficient of .75.

Figure 5. Pre-impact skid marks from the Toyota Camry.

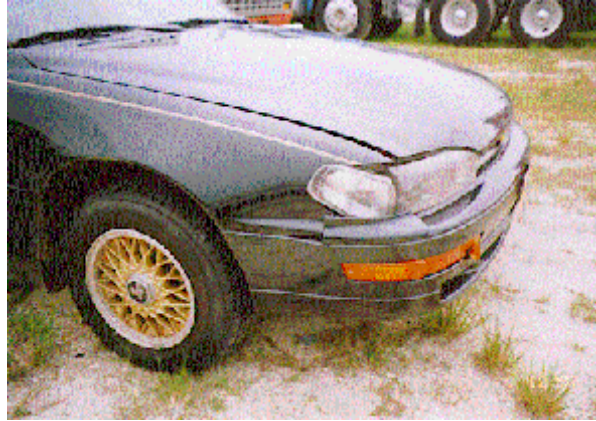
This impact sequence resulted in direct contact damage to the Camry that began at the front right bumper corner and extended an estimated 30 cm (12 in) left. Crush was minimal and was estimated at a maximum

of 5 cm (2 in) at the front right bumper corner. The crush under represented the energy absorbed by the Camry due to rebound of the bumper fascia and the front bumper's energy absorption system. The damage resulted in a 12 o'clock direction of force with an estimated Collision Deformation Classification (CDC) of 12-FRLW-1 from police and insurance photographs. Estimated delta V for this impact was 11-16 km/h (7-10 mph). Exterior damaged components consisted of the front bumper fascia, grille assembly, hood, radiator support, and right fender.

Figure 6. Crush damage sustained by the Camry.

Interior damage to the Camry consisted of a displaced rearview mirror, fractured windshield, and unspecified damage to the right sunvisor resultant of contact with the front right air bag. The normal deployment path of the air bag was restricted by the infant seat positioned in the front right seated position and the air bag subsequently deployed upward which displaced the rearview mirror and fractured the windshield.

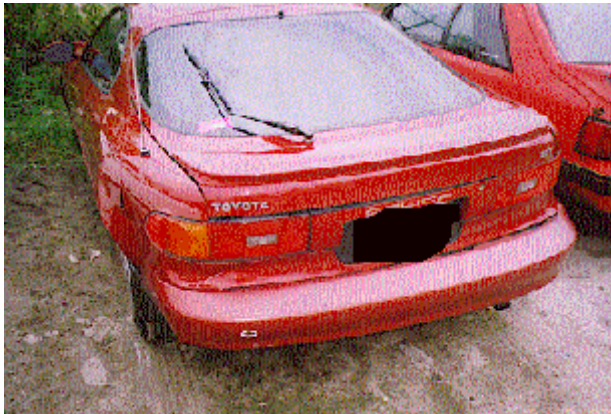
Figure 7. Crush damage sustained by the back left bumper of the Celica.

The Celica sustained direct damage from its impact with the frontal plane of the Camry that began at the back left bumper corner and extended approximately 30 cm (12 in) right. Maximum crush was located at the back left bumper corner and was estimated at 10 cm (4 in). The damage resulted in a 6 o'clock direction of force and an estimated CDC of 06-BLLW-1 from police and insurance photographs. Estimated Delta V for this impact was 16-19 km/h(10-12 mph). Exterior damaged components consisted of the back bumper fascia, left rear quarter panel, and liftback.

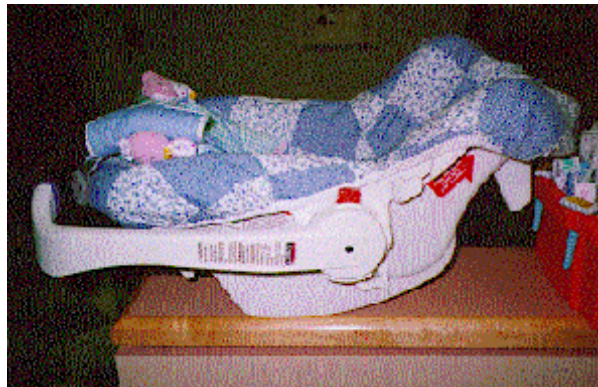
The infant seat was a SmartFIT model manufactured by Century Products Company. The infant seat was designed for independent use in the vehicle or fitted into a base that was designed to be stationary in the vehicle. The infant seat was equipped with a level indicator on its right side which indicated the maximum safe recline position of the infant seat. The infant seat was also equipped with a canopy and pivoting carrying handle. Warning labels on the infant seat and an exemplar base identified the risks associated with rear

Figure 8. SmartFIT infant seat without the base.

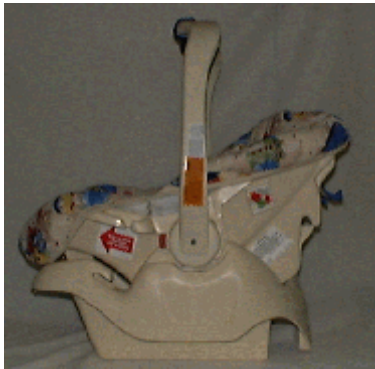
Figure 9. Exemplar SmartFIT infant seat with base.

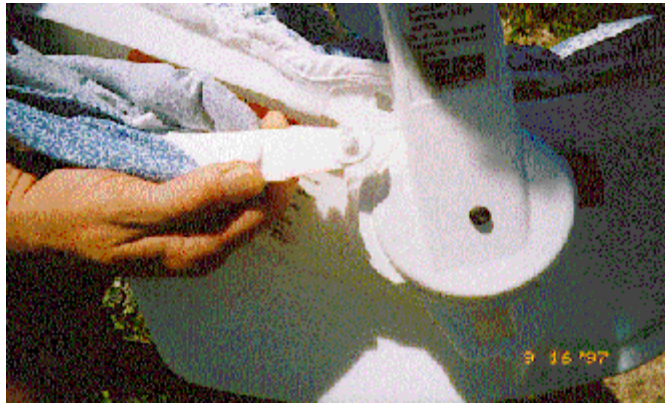
facing infant seats and air bags. The driver of the Camry indicated that the infant seat did not sustain damage from the crash events with exception for the canopy which was displaced from the infant seat. Police photographs confirmed the driver's recollection of infant seat damage and showed a dislodged metal locking clip on the front right seat cushion. The driver also noted that the canopy was stowed against the back of the infant seat at the time of the crash and that its fabric was not torn, abraded, or burned. Police photographs identified that there were no abrasions to the shell of the infant seat.

Figure 10. Attachment point of the dislodged infant seat canopy.

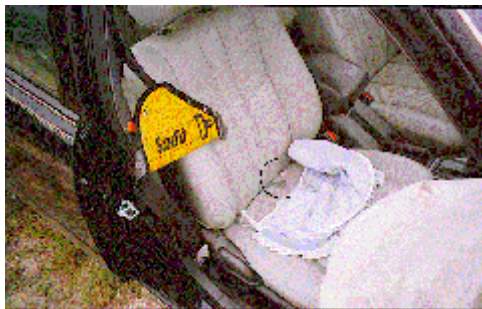
A police photograph (Figure 11) indicated that the available front right 3-point manual lap and shoulder belt was equipped with an aftermarket shoulder belt webbing adjuster. It was yellow in color and displayed the word SAFEFIT. The driver of the vehicle indicated that it was used to comfortably adjust the 3-point manual lap and shoulder belt for a five year old child. The belt was equipped with the device at the time it was looped through the infant seat.

Figure 11. View of the right front seat with the webbing's SAFEFIT device, displaced infant seat canopy, and metal locking clip.

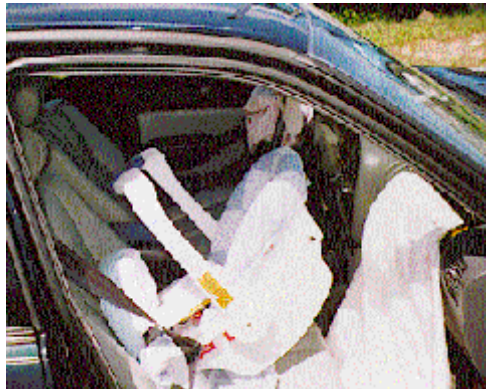
The driver of the vehicle stated that the male infant was consistently placed in the infant seat when traveling in the vehicle and that it was normally positioned in the rear seat, however, the infant had been upset on the day of the crash and the driver subsequently positioned the child with the infant seat in the front right position. Although the driver indicated that the infant seat's base was utilized with the infant seat in the front right seated position on the crash date, the investigating police officer recalled that the base was not available in the vehicle or at the crash scene prior to departure of the driver and male infant passenger. It was, therefore, determined that the base was not used during this crash. The infant seat's belt slots were located on both sides of the seat adjacent to the junction of its carrying handle and shell. The lap and torso belt webbing was maneuvered into the belt slots and the SAFEFIT device positioned over the infant's lower body. The child was restrained in the infant seat by the 3-point harness system. The harness webbing was woven through the upper slots in the foam padding and shell of the infant seat.

Figure 13. Right lateral view of the Camry's passenger compartment and post-crash positioned infant seat.

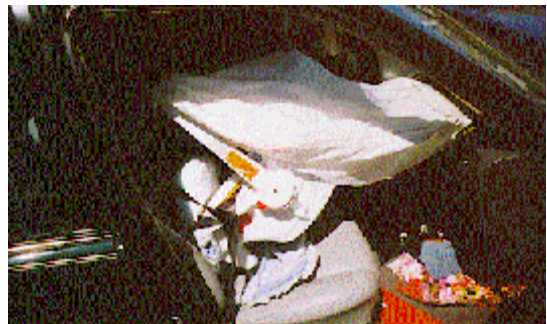
The Supplemental Restraint System of the Camry consisted of a front left and front right air bag. The front left air bag was concealed within a four-spoke steering wheel rim and deployed from H-configuration module cover flaps. It was unknown if the air bag was tethered or was equipped with vent ports. The front right air bag deployed from a mid mount module assembly that was incorporated in the right instrument panel. Insurance and police photographs show that there was at least one vent port located on the left side of the bag (with respect to the vehicle). It was unknown if the air bag consisted of other vent ports. A police photograph (Figure 14) that illustrated the rearward excursion of the front right air bag indicated the lack of tethers.

Figure 14. Right lateral view of the Camry's passenger compartment with rear facing infant seat and front right air bag excursion.
