ON-SITE ASYMMETRICAL AIR BAG DEPLOYMENT INVESTIGATION

CALSPAN CASE NO. CA97-049

VEHICLE - 1993 MERCURY SABLE

CRASH DATE - AUGUST, 1997

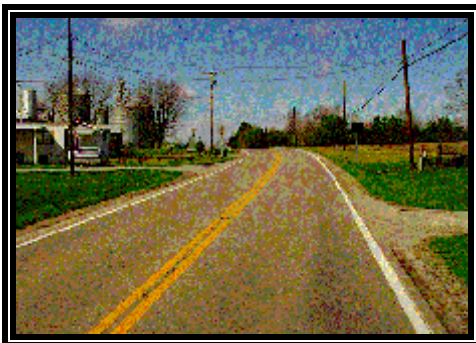
Figure 2: Westbound view 30 m (100 ft) from the POI.

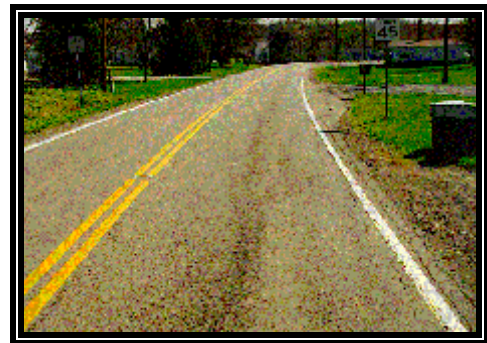
Figure 1: Eastbound view 30 m (100 ft) from the POI.

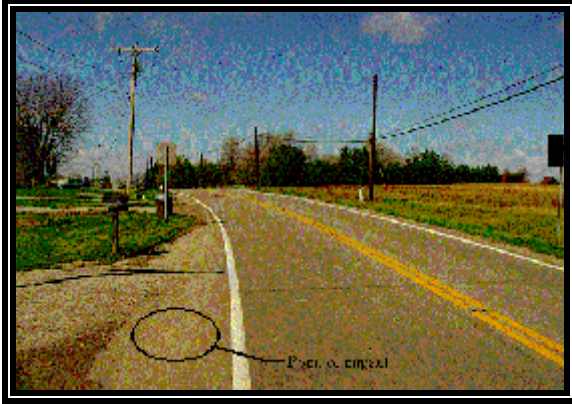
Figure 3: Point of impact.

The female driver of the Mercury recognizing the impending collision, steered right prior to the crash in an attempt to avoid the collision. The crash occurred outboard of the south road edge line referenced in Figure 3 above. The center and left frontal area of the Oldsmobile impacted the center and left frontal area of the Mercury in an offset frontal collision. The 12 o'clock direction of the impact force initiated the deployment sequence of the Mercury's SRS, however, only the vehicle's front passenger air bag deployed. The impact caused the Mercury to reverse its travel direction and rotate counterclockwise (CCW). The Mercury came to rest facing north in a driveway, approximately 4.0 m (13.0 ft) west of the point of impact and 5.8 m (19.0 ft) south of the road edge. The Oldsmobile rotated CCW and came to rest facing east on the roadway centerline, approximately 8 m (26 ft) west of the point of impact.

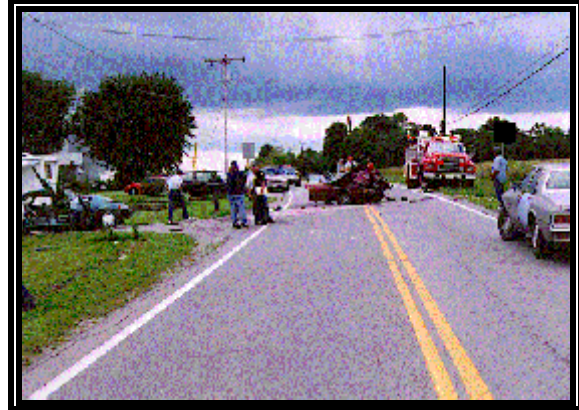
Figure 4: Westbound view of the crash scene.

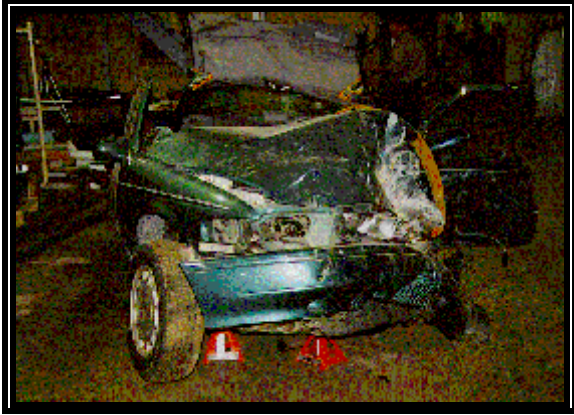
The Mercury Sable sustained 86 cm (34 in) of direct contact damage across the frontal width of the vehicle. The direct damage began 10 cm (4 in) right of center and extended to the left front corner. The measured crush profile was as follows: C1=118.9 cm (46.8 in), C2=105.1 cm (41.4 in), C3=85.1 cm (33.5 in), C4=62.2 cm (24.5 in), C5=40.9 cm (16.1 in), C6=3.3 cm (1.3 in). The right front corner of the vehicle was displaced laterally to the left 91.4 cm (36.0 in). The windshield was fractured and the left side window glazings shattered in the impact. The left front suspension deformed rearward foreshortening the left wheelbase 74 cm (29 in). Rearward deformation of the left A-pillar buckled the roof. The left front door was buckled and opened due to deformation of the latch mechanism. The left rear door was buckled and jammed shut by deformation. In order to attain access to the driver, the vehicle's left and right A-pillars were cut and the roof was pulled back. Additionally, the right B-pillar was cut and removed with the right rear door in the extrication process. The right front seat back and center console were removed as well. The Collision Deformation Classification (CDC) of the Mercury was 12-FYEW-5. The delta V calculated

Figure 6: Front view of the Mercury Sable.

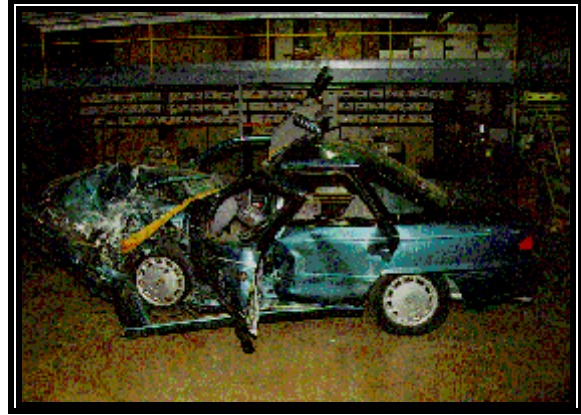
Figure 5: Left side view of the Mercury Sable.

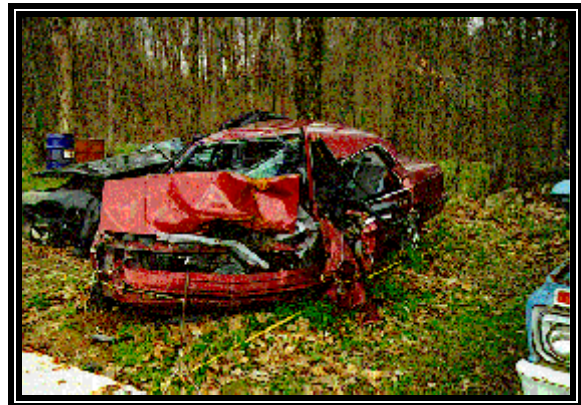
The Oldsmobile Cutlass Ciera (**Figure 7**) sustained 112 cm (44 in) of direct contact damage across the frontal width of the vehicle. The direct damage began 26.7 cm (10.5 in) right of center and extended to the left front bumper corner. The crush profile measured across the front plane of the vehicle was as follows. C1=157.5 cm (62.0 in), C2=143.3 cm (56.4 in), C3=124.0 cm (48.8 in), C4=99.6 cm (39.2 in), C5=70.1 cm (27.6 in), C6=35.6 cm (14.0 in). The right front corner was displaced laterally 86 cm (34 in) to the left. The deformation extended rearward along the left side of the vehicle to the C-pillar causing both left side doors to be buckled and jammed. The windshield was fractured and the left side window glazings were shattered. The left front suspension deformed rearward foreshortening the left wheelbase 88.6 cm (34.9 in). The left A-pillar was displaced rearward 57.9 cm (22.8 in) causing the roof to buckle. The left floor pan deformed rearward to the driver's seat cushion. The roof was cut at all the pillars and removed during the extrication of the driver. The CDC of the vehicle was 12-FYEW-6. The delta V calculated by the Damage Algorithm of the WINSMASH model was 92.0 km/h (57.2 mph). Forensic analysis of the Oldsmobile's damage and SCI experience indicated the delta V calculated by the SMASH program was overestimated. The Oldsmobile's damage appeared to be more consistent with a delta V of approximately 72 km/h (45 mph).

Figure 7: Left front three-quarter view of the Oldsmobile Cutlass Ciera.

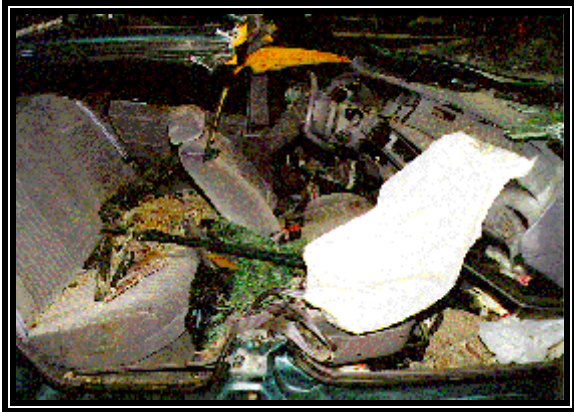
The Mercury's left front interior sustained significant impact damage as a result of the external forces generated in the crash (**Figure 8**). The left A-pillar and left corner of the instrument panel were displaced longitudinally approximately 51 cm (20 in). The steering column was displaced 38 cm (15 in) rearward and 28 cm (11 in) laterally to the right. The floor pan in the driver's foot well deformed rearward to the seat cushion.

Figure 8: Right interior view.

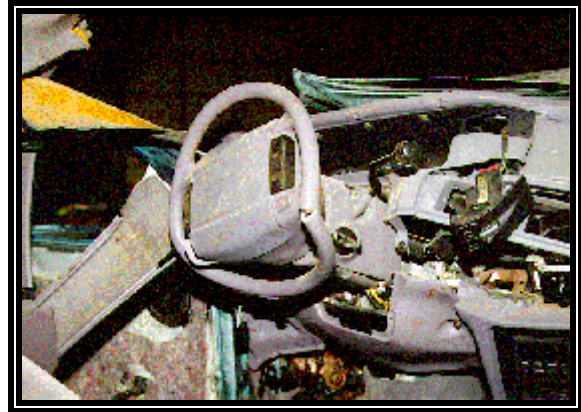
The tilt mechanism of the steering wheel was fractured by occupant contact. The post-crash position of the steering wheel was rotated 180 degrees. The upper half (12 o'clock sector) of the rim was deformed approximately 15 cm (6 in) due to contact with the driver's abdomen/lower extremities (**Figure 9**). Due to the occupant loading, there was complete separation of the left side steering column shear capsule and the right aspect of the steering column's mount was fractured above the right shear capsule (**Figures 10 and 11**).

Figure 9: Steering wheel rim and steering column.

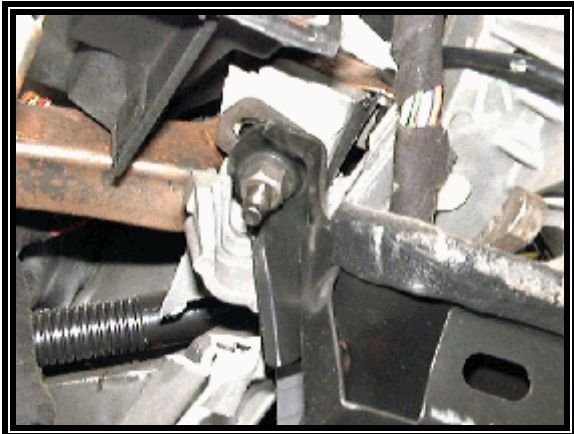
Figure 10: Left shear capsule complete separation.

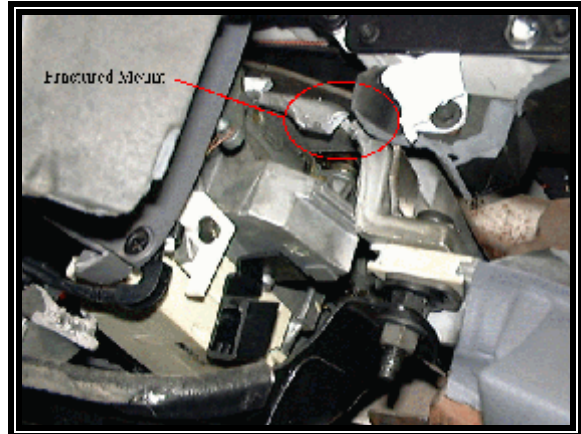
Figure 11: Fractured steering column mount.

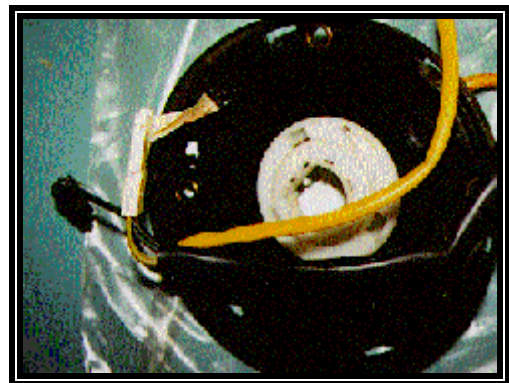
The summation of the resistance readings taken during the Steps (1-6) of the inspection indicated that passenger air bag circuitry was intact and functioning properly. A fault was detected in the driver air bag circuitry Steps (8-9) and confirmed by the flash code (32) reading in Steps (10-11). During the check of the flash code (Step 11), upon ignition the air bag indicator illuminated steady for approximately 6 seconds, as the diagnostic module monitored the air bag system readiness. The indicator then flashed three times, paused one second, flashed two times, paused three seconds and then repeated the three flash, one second pause, two flash, three second pause sequence. This indicated a flash code 32. Flash code 32 represented a Driver Air Bag High Resistance or Open condition. This open condition in the Driver Air Bag circuitry resulted in the non-deployment of the driver air bag in the crash. Removing the clock spring and replacing it with a simulated load (resistor), Steps (12-15) isolated the fault in the circuitry to the clock spring. There were no other fault codes stored in the diagnostic module.

The purpose of the clock spring was to carry the electrical current from the stationary steering column through the rotating steering wheel to the driver air bag module, horn and cruise control. **Figure 13** is a view of the clock spring taken after its removal from the vehicle. The white electrical connector in the 10 o'clock sector of the figure was displaced from its designed location. The connector normally resides in the recess on the back side of the assembly. Additionally the flat wire conductor, wound internally in clock spring, had folded onto itself and was taut. The condition of the clock spring indicated that it had been improperly installed.

Figure 13: View of the back side of the clock spring.

service. This service reportedly occurred in July, 1995. The vehicle's mileage at the time of the service was 57,396 km (35,665 miles). This service would have required the removal of the clock spring. It was probable that the clock spring was improperly reinstalled during this repair.

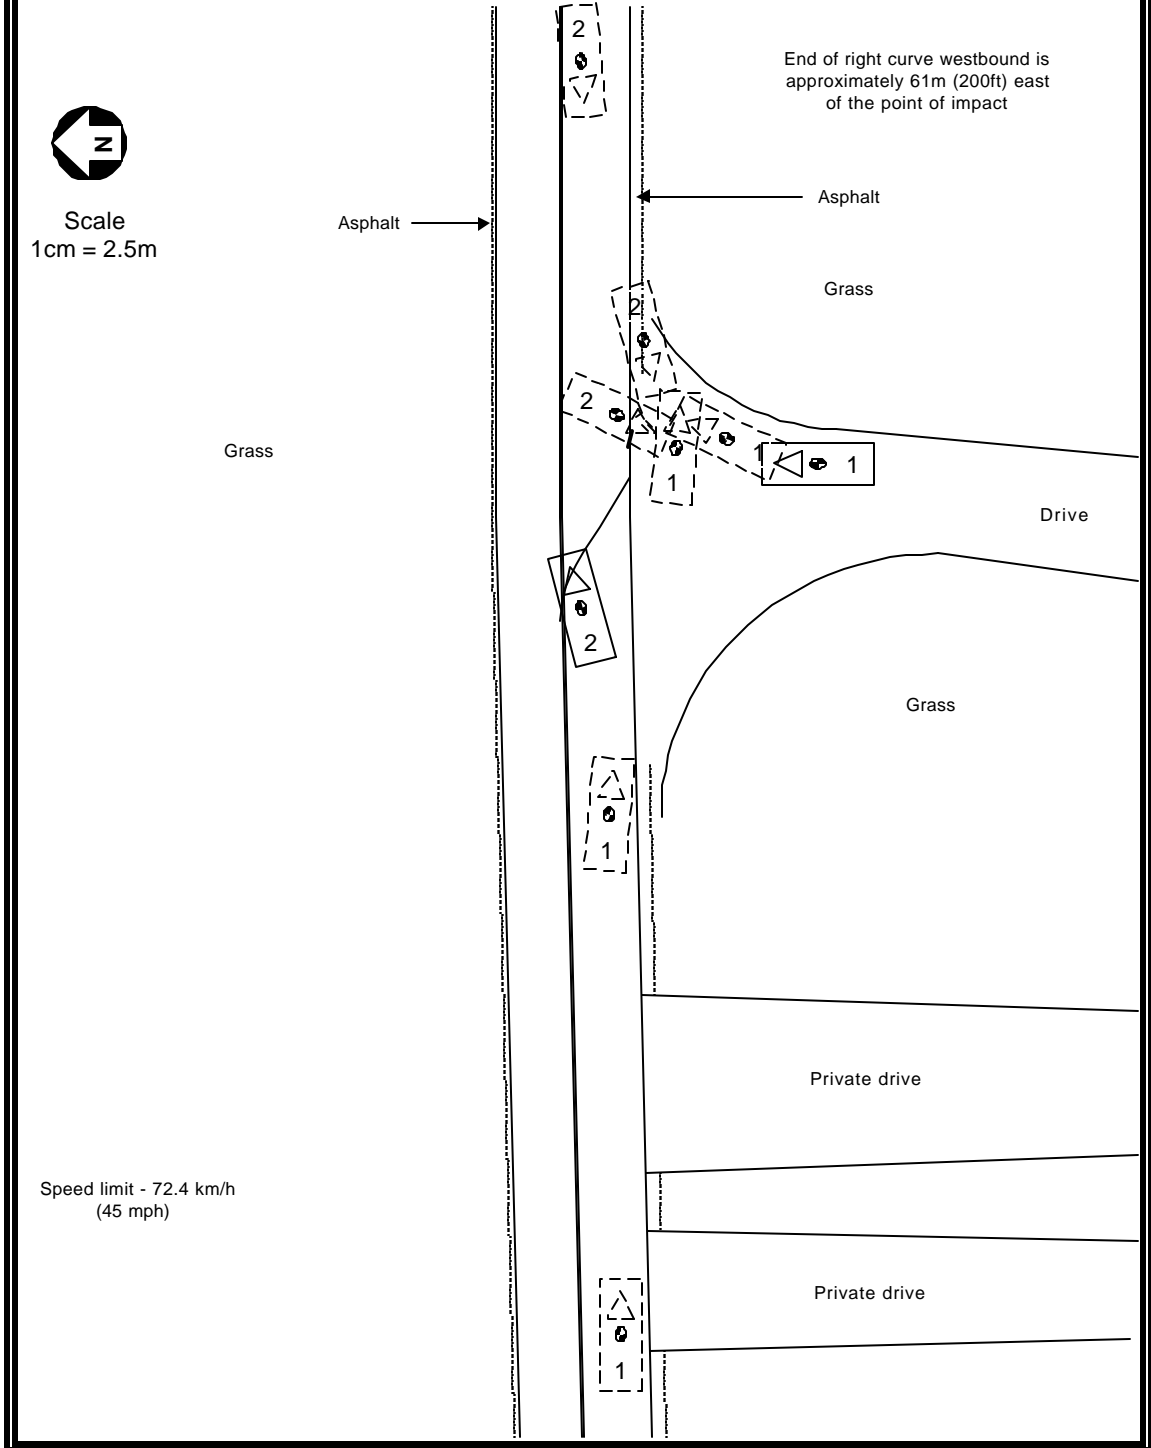
Figure 14: Crash Schematic.

The 1991 Oldsmobile Cutlass Ciera was operated westbound by a 22 year old unrestrained male driver. The 1993 Mercury Sable was operated eastbound by a 48 year old female. She was restrained by the vehicle's manual 3-point lap and shoulder harness. The crash occurred when the westbound Oldsmobile failed to properly exit the right curve and traveled left of center directly into the path of the eastbound Mercury Sable. Refer to **Figure 14**, the crash schematic at the end of this narrative report.
