ON-SITE AIR BAG INVESTIGATION

CASE NUMBER - IN97-051
LOCATION - KENTUCKY
VEHICLE - 1996 BUICK CENTURY SPECIAL
CRASH DATE - December, 1997

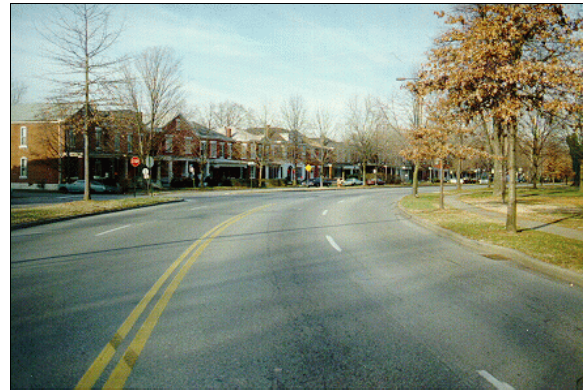
Figure 2: Plymouth’s northward travel path in inside northbound lane (case photo #07)

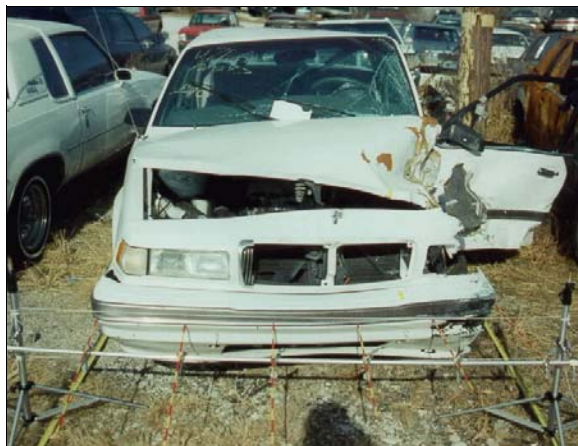
Figure 3: Case vehicle’s front left damage with contour gauge present (case photo #11)

The case vehicle's contact with the Plymouth involved its front left. Direct damage began 28.5 centimeters (11.2 inches) left of the case vehicle's center and extended, a measured distance of 50.5 centimeters (19.9 inches), to the front left bumper corner (**Figure 3** above). Maximum crush was measured as 39 centimeters (15.4 inches) at C₁. The wheelbase on the case vehicle's left side was shortened 31 centimeters (12.2 inches) while the right side remained essentially unchanged. The case vehicle's front bumper, bumper fascia, grille, hood, front left headlight and turn signal assemblies, and left fender were directly damaged and crushed rearward. The left front door was also directly damaged and crushed inward as the Plymouth rotated counterclockwise around the case vehicle's left front side. The case vehicle's left "A"-pillar sustained damage, but it was most likely induced. The case vehicle's left front tire was physically restricted and deflated from the frontal impact (**Figure 8**). The right rear tire was deflated and rotated inward from the curb impact. There was induced damage to the left "A"-pillar, the left front and rear doors, and to the right fender. Remote buckling was also found on the left front portion of the case vehicle's roof, over the driver's occupant space.

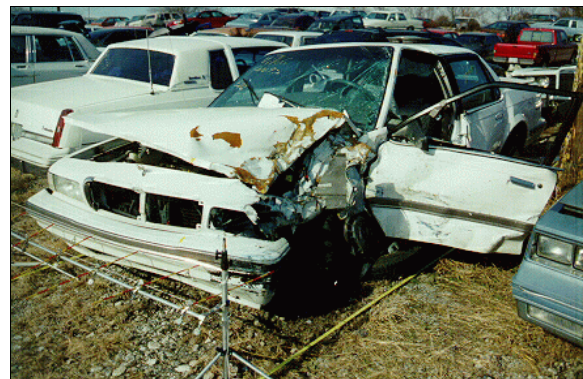
Figure 4: Case vehicle’s frontal damage viewed from left of front; Note: direct damage to left front door and induced damage to left “A”-pillar (case photo #13)

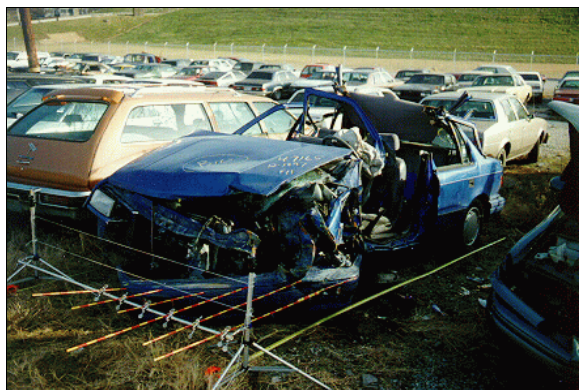
Figure 5: Plymouth's frontal damage viewed from left of front; Note: left front door and both left "A" and "B"-pillars were severed by an extrication tool (case photo #38)

The other vehicle's contact with the case vehicle involved the entire front of the vehicle. Direct damage began at the front left bumper corner and extended, a measured distance of 99 centimeters (39.0 inches), along the front bumper to the front right bumper corner. Maximum crush was measured as 92 centimeters (36.2 inches) at C₁ (**Figure 5** above). The wheelbase on the Plymouth's left side was shortened 27 centimeters (10.6 inches) while the right side was extended 2 centimeters (0.8 inches). The Plymouth's front bumper, bumper fascia, grille, hood, front left headlight and turn signal assemblies, and left fender were directly damaged and crushed rearward. The case vehicle's left front tire was physically restricted, and the two front tires and the right rear tire were deflated. The right headlight and turn signal assemblies sustained induced damage as well both the right and left fenders.

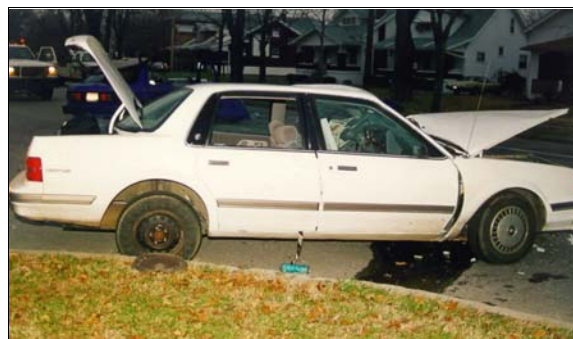
Figure 6: On-scene east-northeasterly view of case vehicle's final rest position against southern curb; Note: wheel impact to curb dislodged hub cab (case photo #50)

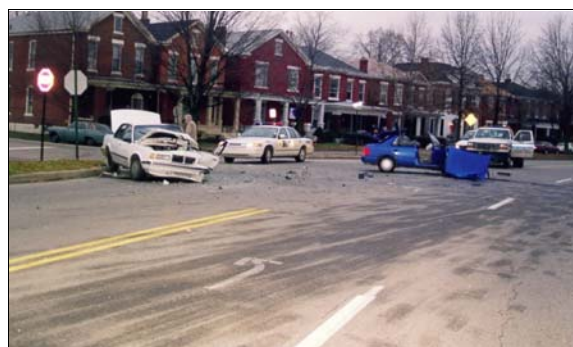
rest heading in a southeasterly direction, straddling the outside, southwestbound lane, just south of the intersection. The Plymouth rapidly rotated approximately 270 degrees counterclockwise while moving northward and came to rest near the intersection straddling the inside southwestbound lane, heading in a east-northeasterly direction (**Figure 7**).

Figure 7: On-scene north-northwesterly view of case vehicle's (against curb) and other vehicle's (straddling southwestbound lane) final rest positions (case photo #46)

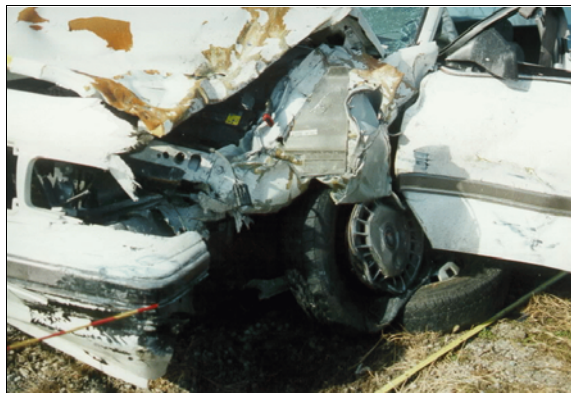
Figure 8: Close-up of case vehicle's corner impact showing damage to left front wheel assembly (case photo #14)

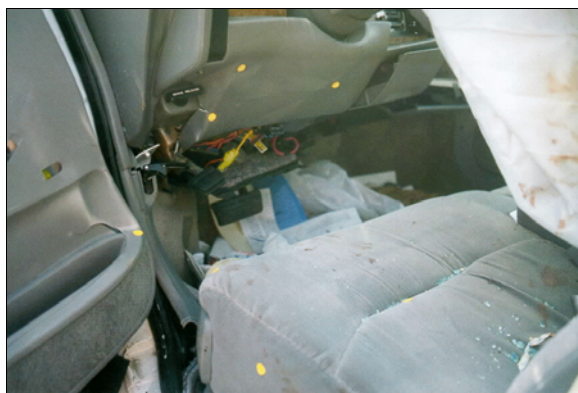
Figure 9: Contact evidence on case vehicle's driver knee bolster and left instrument panel; Note: blood splatter on driver's seat and interior surface of driver's door (case photo #25)

Simultaneous to the sun visor/header strike, the driver's right knee loaded the driver's knee bolster and/or underneath surface of the steering column (**Figure 9** above). When the case vehicle reached maximum engagement, it rotated counterclockwise and slid toward the southwest. The driver first moved backwards contacting the roof over her seating position with the top of her head and depositing contact evidence (**Figures 10 and 11** above). Next, the driver moved toward the left interior door surface and seat back. When the case vehicle's right rear tire and wheel contacted the southerly curb, the driver most likely moved towards the deflating driver's air bag and front right passenger seating area. The copious blood evidence on the air bag and on the

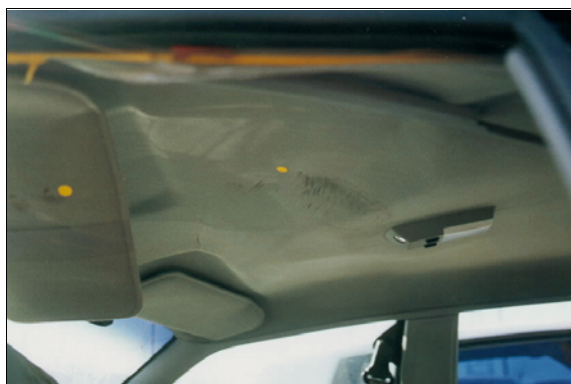
Figure 10: Sun visor and roof area on case vehicle's driver side showing contact evidence on sun visor from driver's face and roof from driver's scalp (case photo #28)

Because of a combination of factors (which included): the tilt steering wheel being located in its upmost position, the driver's upward movement, and the air bag's primary impact location on the driver's chest, the unrestrained driver continued forward, ramping over the steering wheel rim and air bag and striking the left sun visor and/or windshield's header (**Figures 10 and 11** above). Because the driver's head had been hyper extended by its interaction with the deploying air bag, the central part of her face impacted the sun visor and/or header (as opposed to her head striking the roof, hyper extending her neck, and allowing her face to impact the sun visor and/or header). The scenario preferred by this contractor is based on two factors. First, the lesion to the driver's cervical spine, although a moderate injury, was a relatively minor fracture (i.e., a review of the driver's medical records indicates that the lesion was an avulsion or "chip" type fracture of the anterior-inferior body of C₂) with good alignment of the vertebral bodies post-injury. Second, there were no reported lesions to the driver's scalp to support the contention that the top of the driver's head was the initial point of impact that forced the driver's head backward, producing the hyperextension of the driver's neck and allowing the driver's face (i.e., specifically the jaw) to rotate upwards causing the moderate to serious facial lesions.

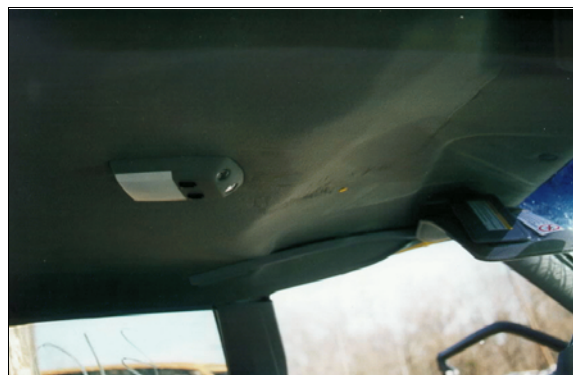
Figure 11: Sun visor on case vehicle's driver side showing deformation from impact by driver's face (case photo #33)

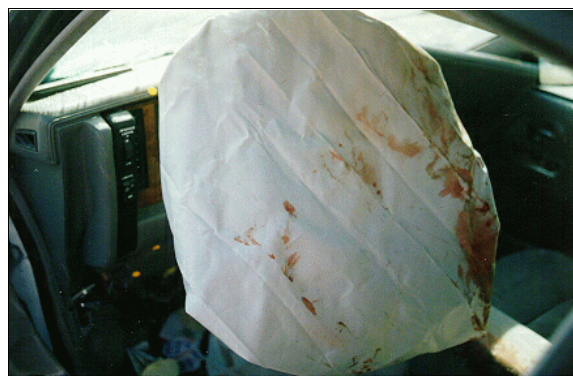
The case vehicle was equipped with a Supplemental Restraint System (SRS) that contained a front air bag at the driver (only) position. The air bag deployed as a result of the frontal impact with the Plymouth. The case vehicle's driver air bag was located in the steering wheel hub. The module cover consisted of essentially symmetrical "H"-configuration cover flaps made of thick vinyl with overall dimensions of 20 centimeters (7.9 inches) at the horizontal seam and 5.5 centimeters (2.2 inches) vertically for the upper flap and 5 centimeters (2.0 inches) vertically for the lower flap. An inspection of the air bag module's cover flaps and air bag revealed that the cover flaps opened at the designated tear points, and there was no evidence of damage during the deployment to the air bag. However, there appeared to be scrapes and cloth transfers on the driver air bag module's lower cover flap. The driver's air bag was designed with one tether. The driver's air bag had two vent ports, approximately 2 centimeters (0.8 inches) in diameter, located at the 3 and 9 o'clock positions. The deployed driver's air bag was round with a diameter of 52 centimeters (20.5 inches). An inspection of the driver's air bag revealed a copious amount of blood on the fabric, both front and back. On the front surface (**Figure 12**), there were spots in the center of the air bag's fabric and across the lower portion located between the 4 and 8 o'clock positions; although, the spots reached the 4 o'clock position, they stop short of the 8 o'clock position. On the back surface there were several blood spots near the 10:30 o'clock position and two bloody areas, one near the 1:30 o'clock position and the other, obliquely oriented, between the 4 and 5 o'clock positions. Most of the blood was found on the right half of the air bag.

Figure 12: Case vehicle's deployed driver air bag showing evidence (i.e., blood) of contact (case photo #34)

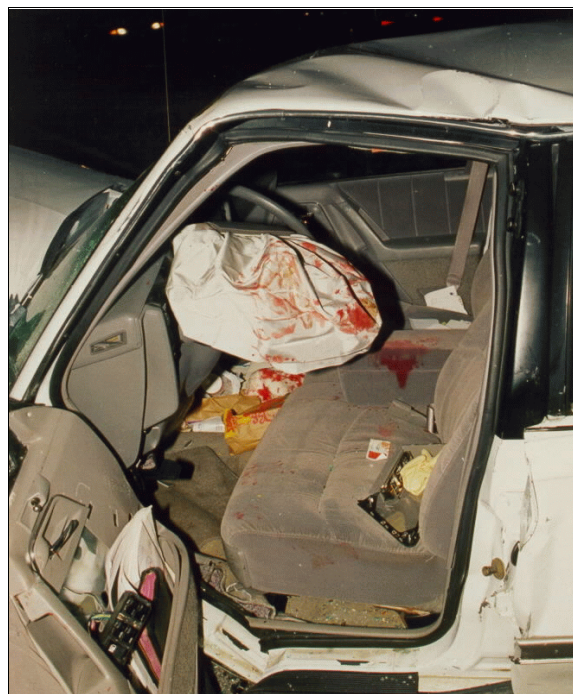
center armrest was mostly deposited as the driver was approaching her final rest position. Although the exact final rest position of the driver is unknown, the huge blood deposit on the center arm rest coupled with the preponderance of the blood on the right side of the air bag's fabric indicates that she was most likely leaning towards the front center seating position at final rest (Figure 13).

Figure 13: On-scene close-up of case vehicle's front seating area showing driver's deployed, bloodied, air bag and blood evidence on center arm rest (case photo #49)

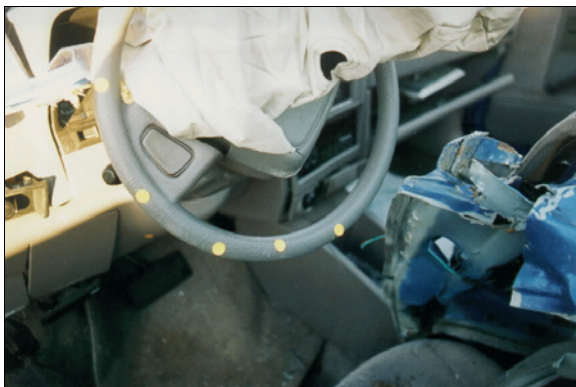
Figure 14: Contacts (i.e., scratches) along right side of Plymouth's steering wheel; Note: top of steering wheel has been rotated approximately 60 degrees clockwise in photo (case photo #53)

A limited inspection of the Plymouth's interior revealed scratching to the lower and left portions of the steering wheel rim (**Figure 14** above) as well as contact evidence on the driver's knee bolster and left instrument panel (**Figure 15** above). Furthermore, there was contact evidence on the driver's sun visor and left windshield's header (**Figures 16** and **17**).

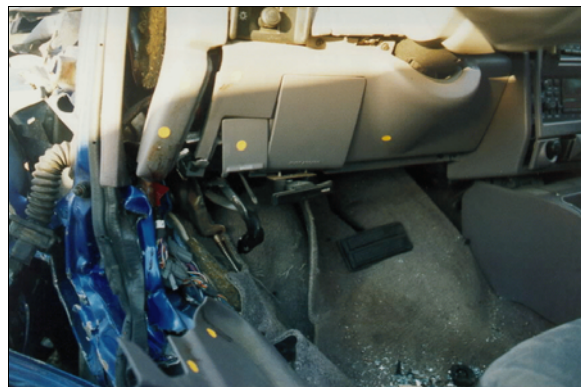
Figure 15: Contact evidence on Plymouth's driver knee bolster and left instrument panel; Note: contacts to interior surface of driver's door (case photo #52)

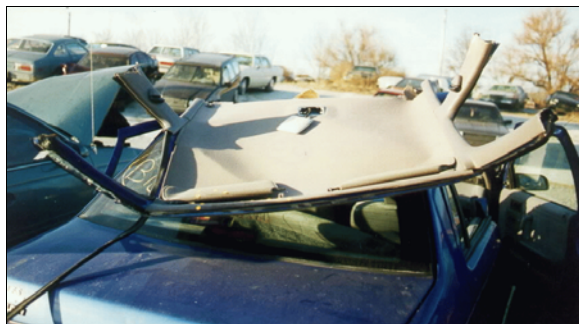
Figure 16: Interior surface of Plymouth's roof, peeled back during extrication, showing contact evidence to driver's sun visor and left windshield header (case photo #55)

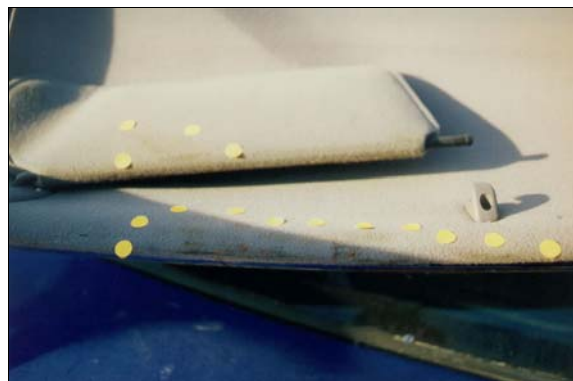
Figure 17: Close-up of contact evidence found on Plymouth's driver sun visor and left windshield header (case photo #56)

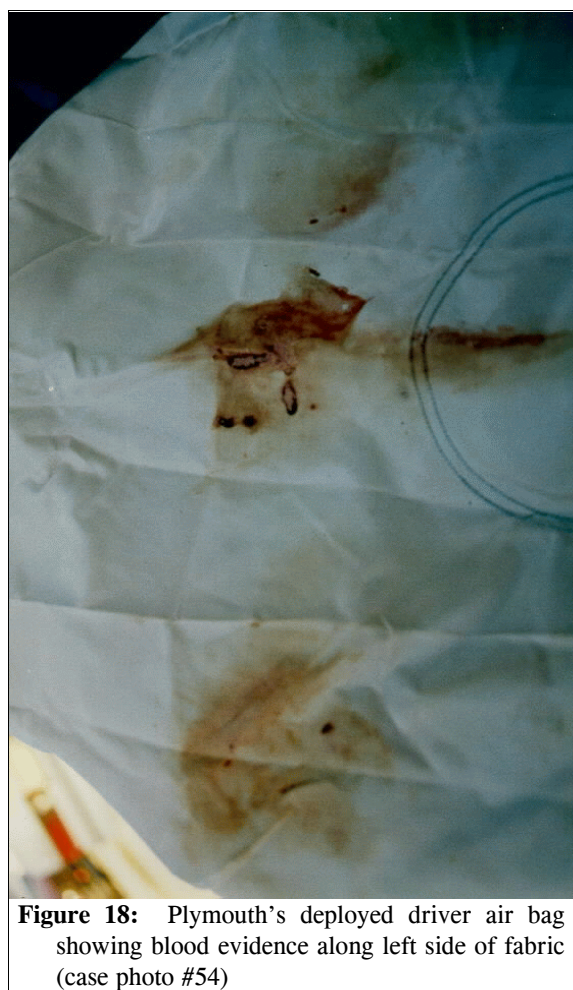
Figure 18: Plymouth's deployed driver air bag showing blood evidence along left side of fabric (case photo #54)

inspection of the air bag module's cover flaps and air bag revealed that the cover flaps opened at the designated tear points, and there was no evidence of damage during the deployment to the air bag or the cover flaps. The driver's air bag was designed with two tethers, each 7 centimeters (2.8 inches) in width. The driver's air bag had two vent ports, approximately 3 centimeters (1.2 inches) in diameter, located at the 11:30 and 12:30 o'clock positions. The deployed driver's air bag was round with a diameter of 57 centimeters (22.4 inches). An inspection of the front surface of the driver's air bag revealed large blood spots on and just to the left of the air bag's center distributed circularly between the 8 and 11 o'clock positions (**Figure 18** above). Furthermore, there was a single blood spot on the perimeter of the front surface near the 11 o'clock position. Finally, there was a large blood spot on the front surface at the perimeter located between the 5:30 and 6:30 o'clock positions. This spot extended onto the back surface of the air bag.
