## TRANSPORTATION RESEARCH CENTER

### ON-SITE AIR BAG NON- DEPLOYMENT INVESTIGATION

CASE NUMBER - IN97-052  
LOCATION - TEXAS  
VEHICLE - 1995 CHEVROLET C-1500 PICKUP  
CRASH DATE - June, 1997

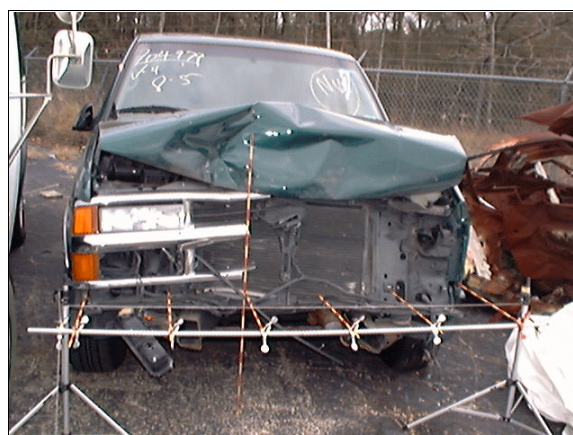
The front (**Figure 2** and **Figure 3** below) of the case vehicle impacted the right front (**Figure 4** below) of the 1992 pickup as it spun counterclockwise in the inside center lane of the

**Figure 2:** Case vehicle's frontal deformation with contour gauge present; Note: vertical rod approximates location where 1992 pickup's right front corner penetrated case vehicle's hood (case photo #03)

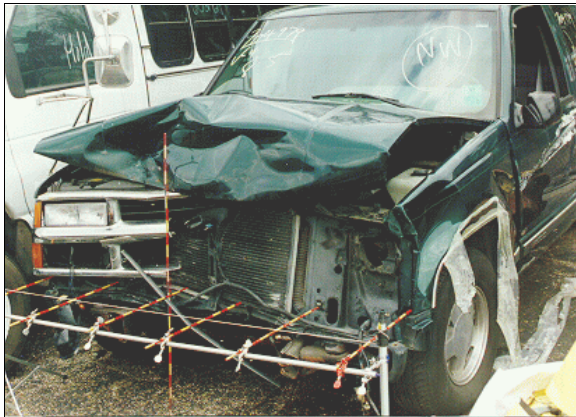
**Figure 3:** Case vehicle's frontal deformation viewed from left of front with contour gauge present (case photo #06)

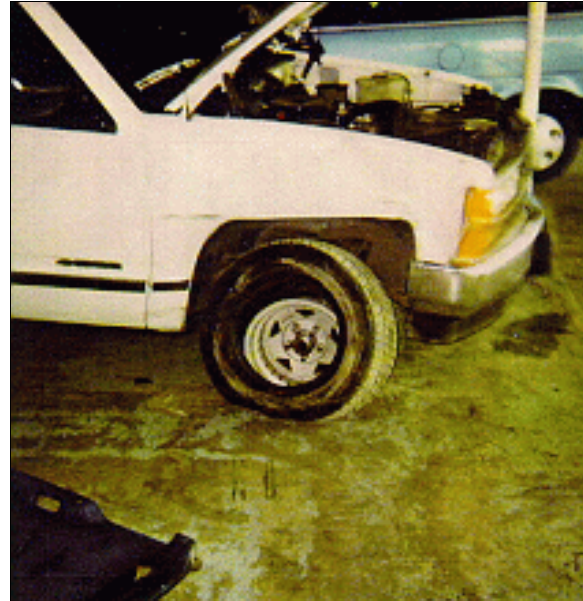
**Figure 4:** Insurance photo of damage to 1992 Chevrolet pickup's right fender and right front wheel assembly (case photo #25)

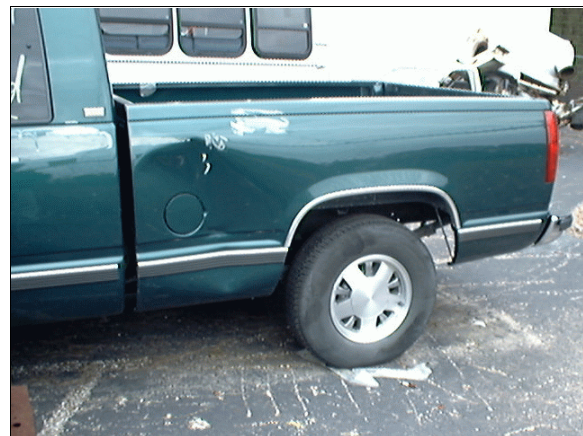
**Figure 5:** Side slap damage on left side of case vehicle's pickup bed (case photo #07)

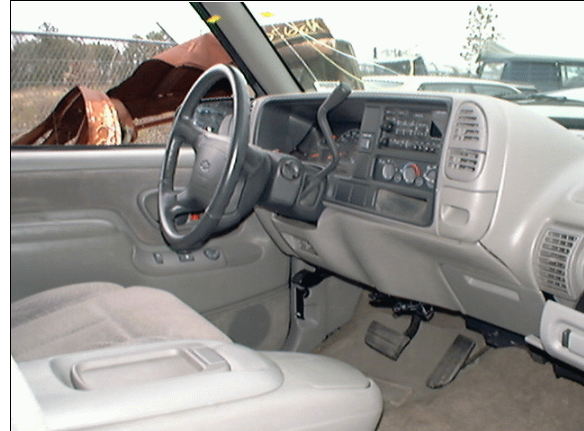
rings. The vehicle was equipped with a knee bolster for the driver's position only. The air vent on the driver's knee bolster was pushed inwards by the driver's right knee. Automatic restraint was provided by a Supplemental Restraint System (SRS) that consisted of a frontal air bag for the driver (only) position. The frontal air bag did not deploy as a result of the case vehicle's frontal impact with the 1992 pickup (**Figure 6**).

**Figure 6:** Case vehicle's driver seating area showing non-deployed driver air bag (case photo #13)

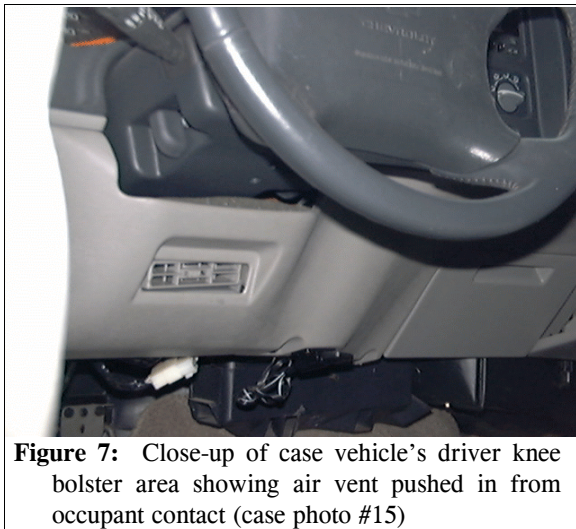
**Figure 7:** Close-up of case vehicle's driver knee bolster area showing air vent pushed in from occupant contact (case photo #15)

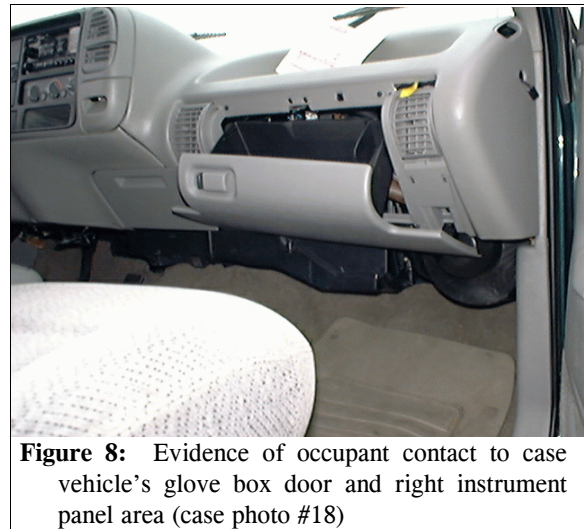
**Figure 8:** Evidence of occupant contact to case vehicle's glove box door and right instrument panel area (case photo #18)

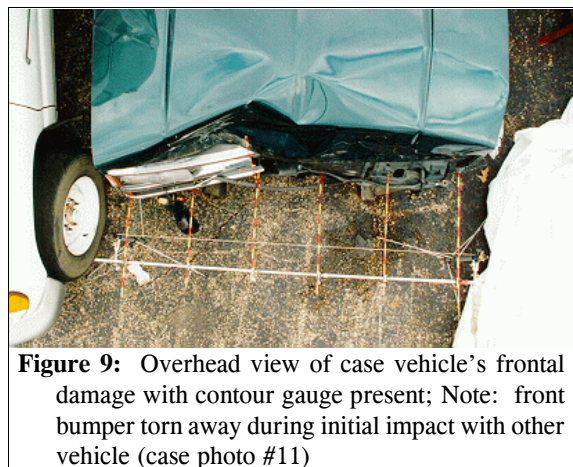
mounts (**Figure 9**). The residual crush to the two frame rails, which supported the two front bumper mounts, were measured at 13 centimeters (5.1 inches) on the left and 8 centimeters (3.1 inches) on the right. This contractor used these two points on the front to determine the case vehicle's crush profile. The resulting residual six "C"-measurements were as follows: 15 centimeters (5.9 inches) at C<sub>1</sub>, 13.5 centimeters (5.3 inches) at C<sub>2</sub>, 12 centimeters (4.7 inches) at C<sub>3</sub>, 10 centimeters (3.9 inches) at C<sub>4</sub>, 8 centimeters (3.1 inches) at C<sub>5</sub>, and 6.5 centimeters (2.6 inches) at C<sub>6</sub>. These "C"-measurements were used in the reconstruction program to determine the case vehicle's Delta V. For the side slap impact, direct damage began 75 centimeters (29.5 inches) forward of the right rear axle and extended rearward, a measured distance of 21 centimeters (8.3 inches), above the sill along the side of the truck bed. The case vehicle's wheelbase was neither shortened nor extended on either side. The case vehicle's front bumper, bumper fascia, grille, and left headlight assembly were torn off. The case vehicle's hood and radiator were directly damaged and crushed rearward. None of the case vehicle's tires were physically restricted or deflated from the front end damage. The right headlight and turn signal assemblies sustained induced damage as well as both the right and left fenders. There was no evidence of intrusion to the case vehicle's interior.

**Figure 9:** Overhead view of case vehicle's frontal damage with contour gauge present; Note: front bumper torn away during initial impact with other vehicle (case photo #11)

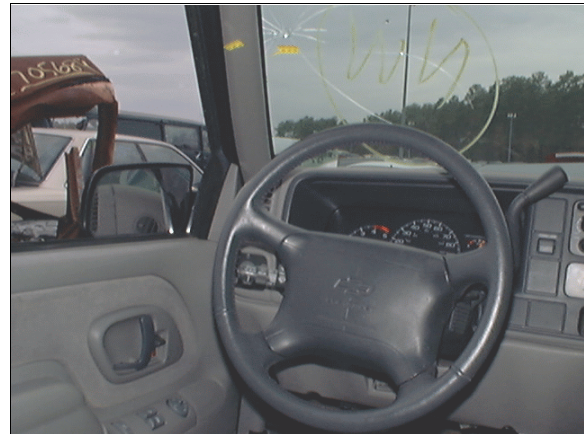
The case vehicle was equipped with a Supplemental Restraint System (SRS) that contained a frontal air bag at the driver (only) position. The driver air bag did not deploy as a result of the frontal impact with the 1992 pickup. The case vehicle's driver air bag was located in the steering wheel hub. The case vehicle was not equipped with a front right passenger air bag. There was no visible evidence of direct contact from the driver to the steering wheel hub, spokes, and/or rim (**Figure 10** below).

This contractor's best explanation for why the case vehicle's air bag did not deployed is twofold. First, this contractor determined that not all of the observed and measured damage occurred in this crash. Second, the 1992 pickup had most likely not yet come to rest (i.e., was still rotating counterclockwise and moving backwards) prior to the case vehicle striking it.

**Figure 10:** Case vehicle's non-deployed driver air bag; Note: evidence of driver contact (yellow tape) on left side of windshield's glazing and left "A"-pillar (case photo #22)

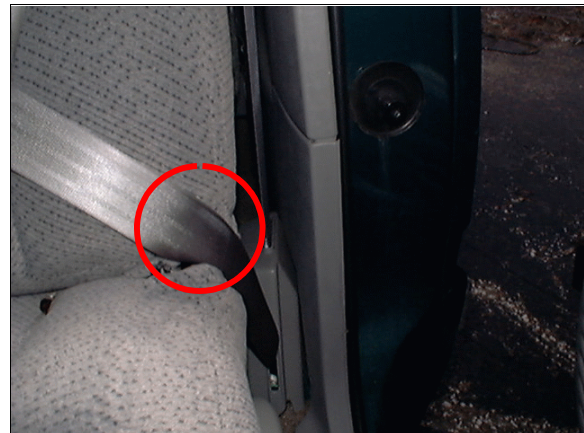
The case vehicle's driver was improperly restrained (i.e., wearing his shoulder belt behind his back) by his available, active, three-point, lap-and-shoulder, safety belt system. An inspection of the case vehicle's driver seat belt system showed evidence of loading, but only to the lap belt portion (Figure 11).

**Figure 11:** Case vehicle's driver seat belt showing heat abrasion (highlighted) on lap belt portion of webbing (case photo #19)

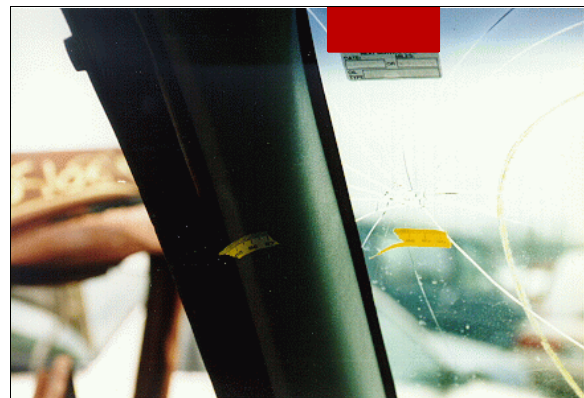
The inspection of the case vehicle's interior revealed a scuff on the left "A"-pillar and a small spider web crack on the windshield's glazing near the left "A"-pillar. As mentioned above, the air vent underneath the steering column within the driver's knee bolster was depressed inward and cracked, most likely from contact by the driver's right knee (**Figure 7**). Furthermore, there was evidence of occupant contact in the front right seating area. Specifically, the air vent on the right instrument panel was depressed inward and the hinge on the glove box door was knocked off its hinges by the front right passenger's right knee after it came open during the collision (**Figure 8**). Finally, the energy absorbing steering column showed no evidence of compression.

**Figure 12:** Close-up of scuff on case vehicle's left "A"-pillar and spider web crack on left windshield's glazing (case photo #17)

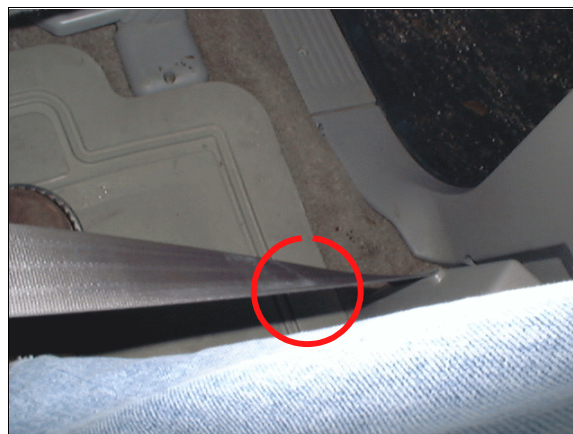
The case vehicle's front right passenger was restrained by her available, active, three-point, lap-and-shoulder, safety belt system. An inspection of the front right passenger's seat belt restraint showed evidence of loading but, once again, only to the lap belt portion (**Figure 13** below).

**Figure 13:** Overhead view of case vehicle’s front right passenger safety belt showing heat abrasion (highlighted) on lap belt portion of webbing (case photo #21)
