TRANSPORTATION RESEARCH CENTER

DEPOWERED AIR BAG REPORT

CASE NUMBER - IN97-056
LOCATION - ALABAMA
VEHICLE - 1998 CADILLAC DEVILLE CONCOURS
CRASH DATE - December 1997

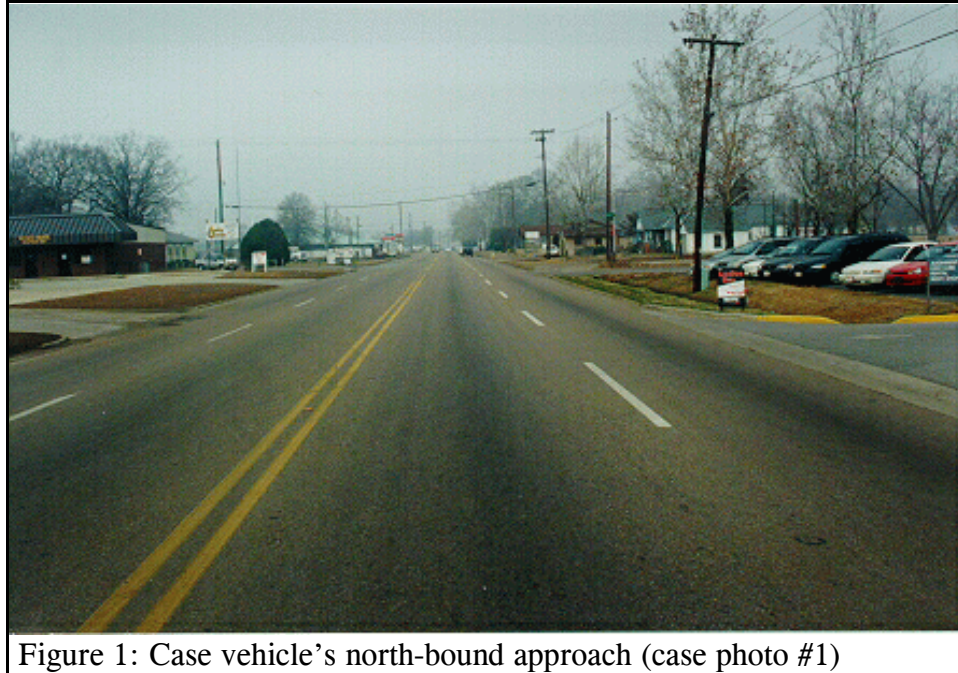
Figure 1: Case vehicle’s north-bound approach (case photo #1) 3

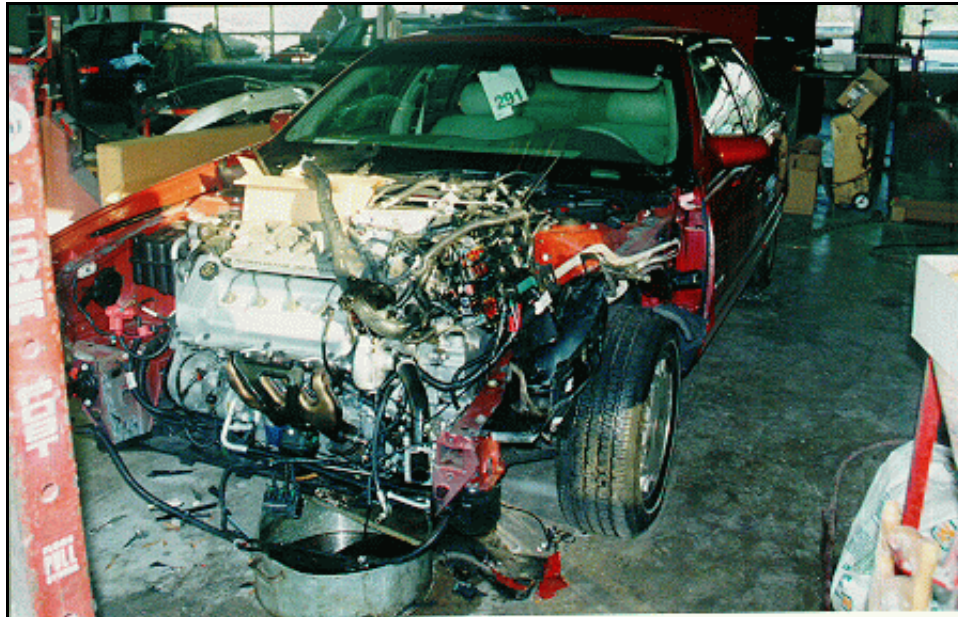
The case vehicle was a front wheel drive 1998 Cadillac DeVille Concours four-door sedan (VIN: 1G6KD54Y3W4-----) equipped with four-wheel traction control and anti-lock brakes. The case vehicle was partially dis-assembled for repair and crush measurements were not obtained, but the damaged components were inspected (see **Figures 2 - 6**). The damage was located at the front left corner, with direct contact to the bumper, headlight area, hood and left front fender. There was no passenger compartment integrity loss, nor any intrusion. All doors remained closed and operational. The CDC for the case vehicle is **12-FYEW-2**. The ROLDMIS reconstruction algorithm was used to compute delta v based on vehicle #2's crush profile (discussed below). The calculations for the case vehicle indicate total delta v of 22 km.p.h. [14 m.p.h.], with -22 km.p.h. [-14 m.p.h.] longitudinal and 0 lateral.

Figure 2: Case vehicle with damaged components removed (case photo #6)

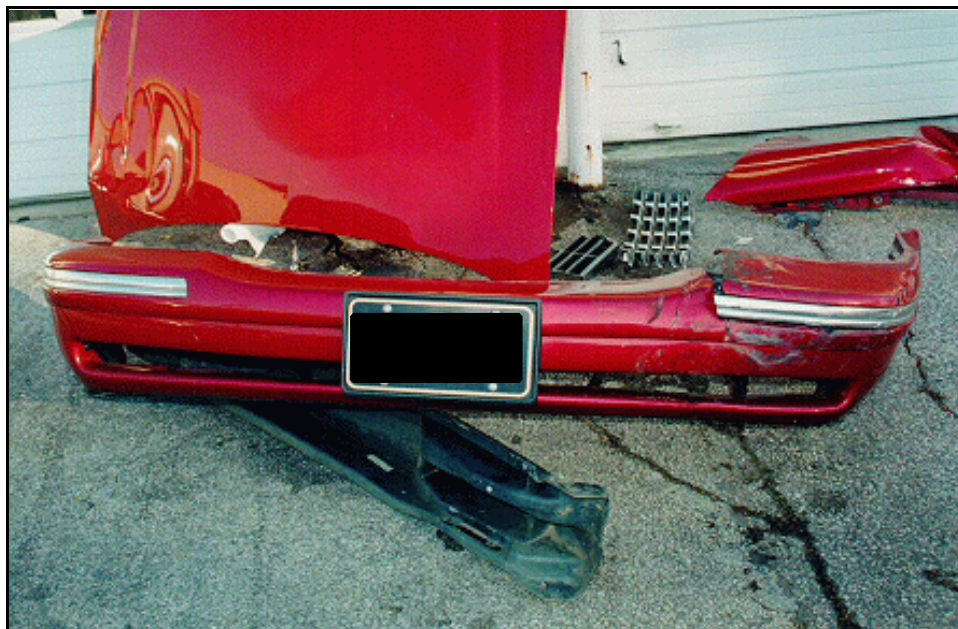
Figure 3: Case vehicle's damaged components (case photo #12)

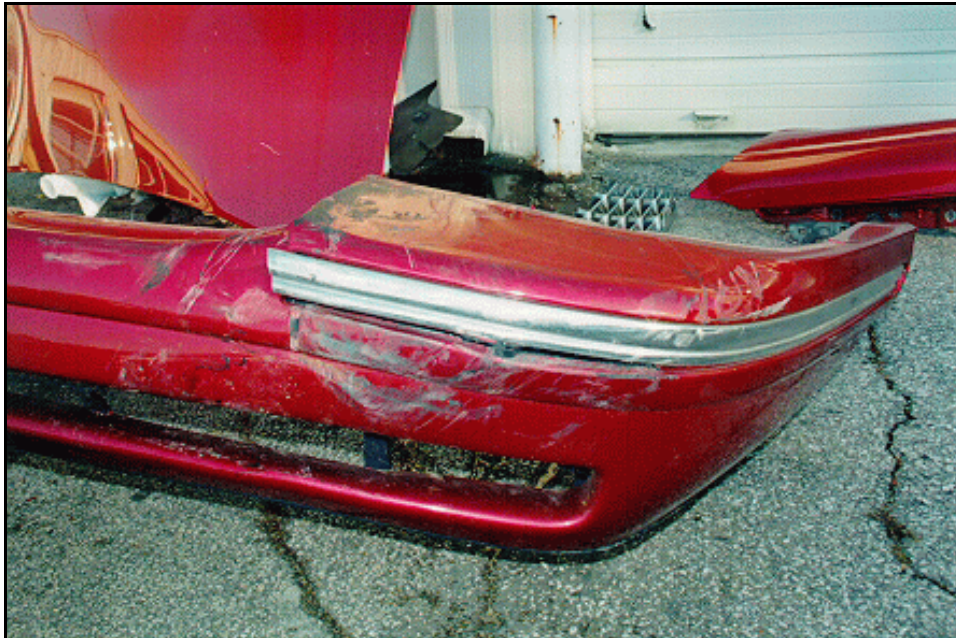
Figure 4: Front left corner of case vehicle's bumper cowl (case photo #13)

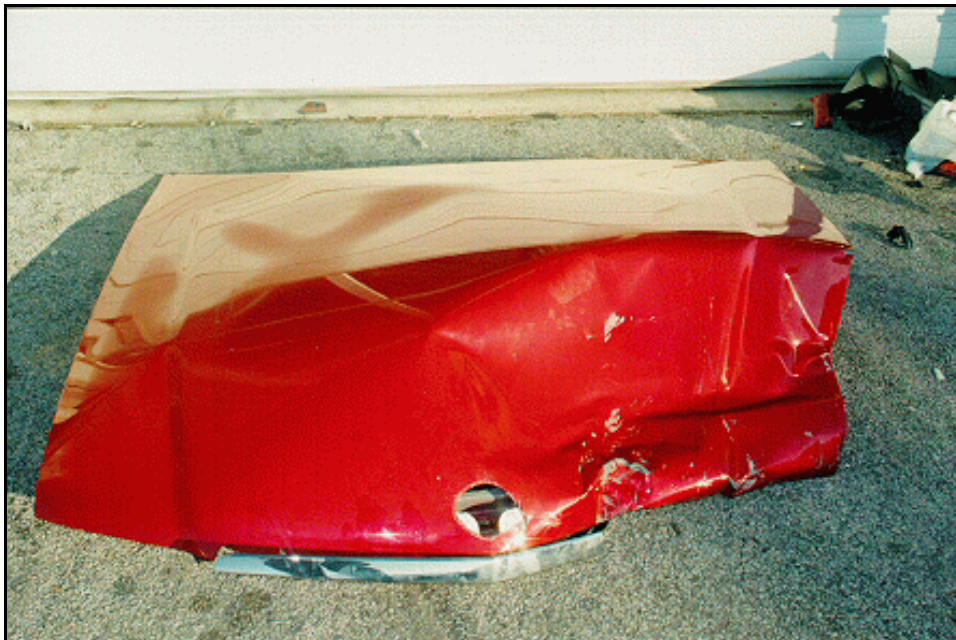
Figure 5: Case vehicle's hood (case photo #14)

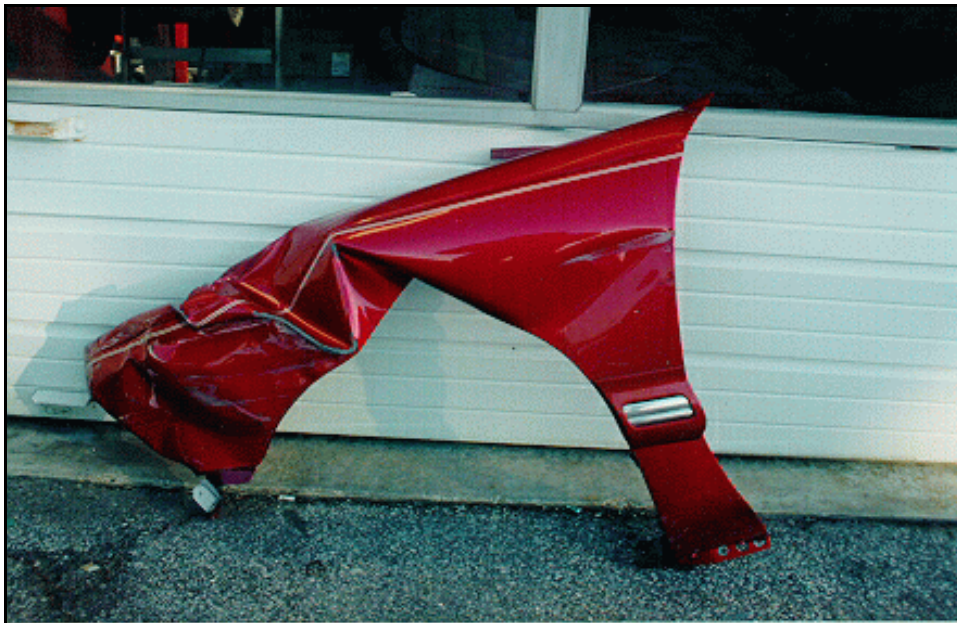
Figure 6: Case vehicle's left front fender (case photo # 15)

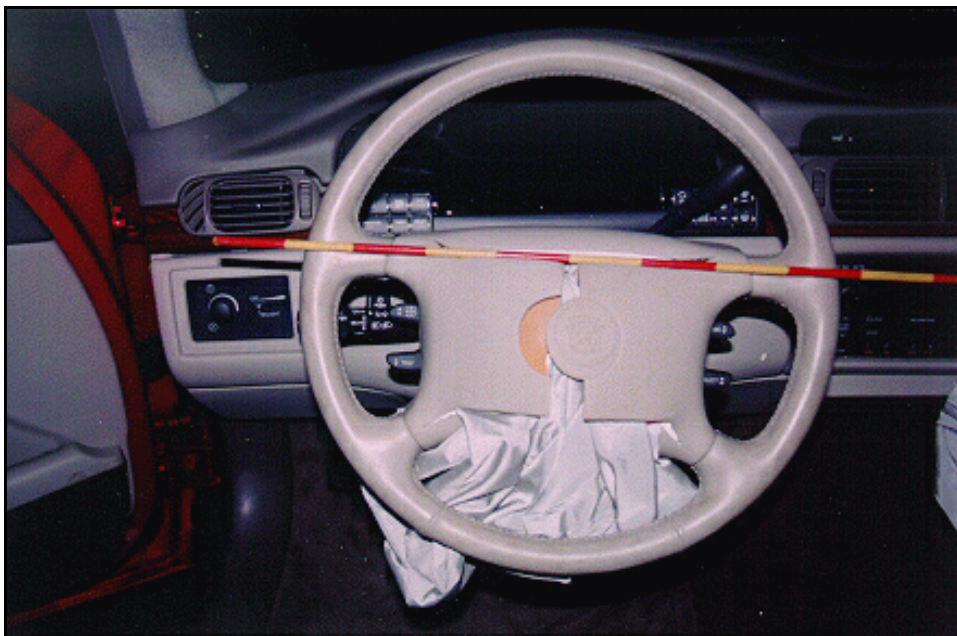
Figure 7: Case vehicle's steering wheel with cover flaps (case photo #22)

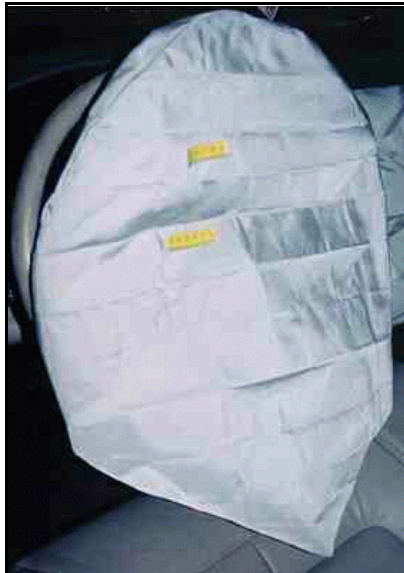
The case vehicle's driver was female, 74 years, 168 centimeters, 73 kilograms [66 inches, 160 pounds]. There was no other occupant in the case vehicle. The driver was restrained by the available manual 3-point lap-and-shoulder safety belt system with the upper anchorage adjustment in the full down position. She did not sustain any specific injuries and did not seek any medical attention, but did suffer general soreness. She exited the vehicle under her own power and was driven from the scene by friends in a private car. The driver was seated in an upright posture with her back against the seatback, both hands on the steering wheel and her feet on the floor and foot controls. Inspection of the driver's air bag revealed a smudge of lipstick slightly above and left of center (see **Figures 8 - 9**). There was no other evidence of occupant contact anywhere in the car, nor any other marks on the driver's air bag.

Figure 8: Case vehicle's driver air bag with contact evidence marked (case photo #24)

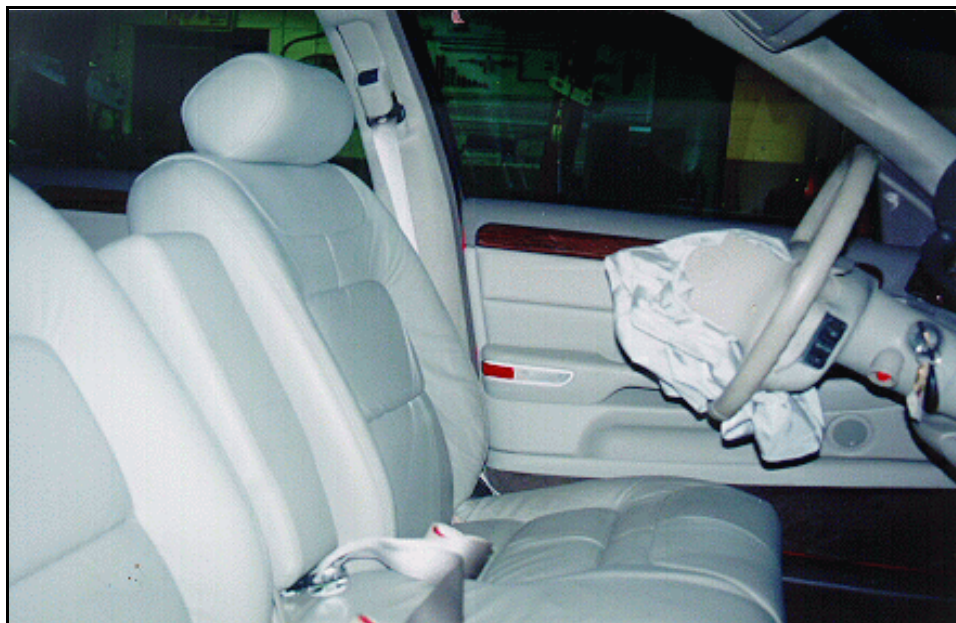
The case vehicle was fitted with a split bench seat in the front row, with the seat track adjusted in the middle position and the seatback slightly reclined. There was no evidence of any seat or track failure and the seatback retained its pre-crash adjustment. The second seat row was fitted with a non-adjustable bench seat. The vehicle was equipped with manual three-point lap-and-shoulder safety belts in the four outboard seat positions, with manual lap-only belts in the two center positions. The driver's safety belt was the only belt system that showed any signs of use in this nearly-new vehicle. The tilt steering wheel was adjusted between the middle and down-most position. The driver's front air bag was located in the steering wheel hub with cover flaps in the I-configuration (see **Figure 7**). The cover flaps opened along the seams and there was no evidence of damage to the flaps or the air bag. The deployed driver's air bag was round, with diameter 51 centimeters [20 inches], no tether strap and two vent ports located at 3 and 9 o'clock positions. The steering wheel rim was not deformed and there was no evidence that the steering column had moved. The right front passenger front air bag was located in the top of the instrument panel. The single flap opened along the seams, with no evidence of damage to the flaps or the air bag. The deployed passenger air bag was a rectangle 46 centimeters [18 inches] wide and 76 centimeters [30 inches] high with two tether straps and no vent ports. The passenger air bag cover flap impacted the windshield, causing an area of spider web cracking low on the windshield and directly above the air bag module. This vehicle was also equipped with side air bags in the front seat outboard positions. These were mounted in the front door panels and did not deploy.

Figure 9: Case vehicle's non-deployed driver's side air bag above arm rest (case photo #31)

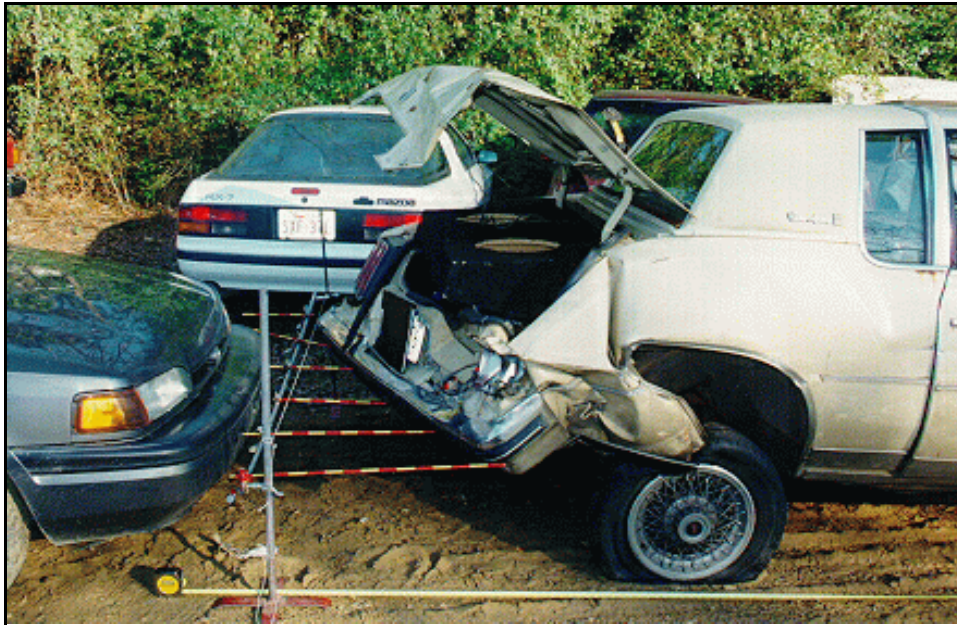
Vehicle #2 was a rear wheel drive 1979 Oldsmobile Cutlass Supreme two-door sedan (VIN: 3M47H9D-----). The damage was located at the back right corner, with direct contact to the bumper, tail light area, trunk lid and right rear quarter panel. The wheelbase was shortened by 8 centimeters [3 inches] on the right and maximum crush was 59 centimeters [23 inches] at the back right corner (see **Figures 10 - 12**). The CDC for vehicle #2 is **06-BZEW-3**. The ROLDMIS reconstruction algorithm was used to compute delta v because the case vehicle was dis-assembled and a crush profile could not be measured. The calculations for vehicle #2 indicate total delta v of 25 km.p.h. [15 m.p.h.], with +25 km.p.h. [+15 m.p.h.] longitudinal and +2 km.p.h. [+1 m.p.h.] lateral. There were three occupants in vehicle #2, none of whom sustained any police reported injury.

Figure 10: Vehicle #2's back damage (case photo #28)

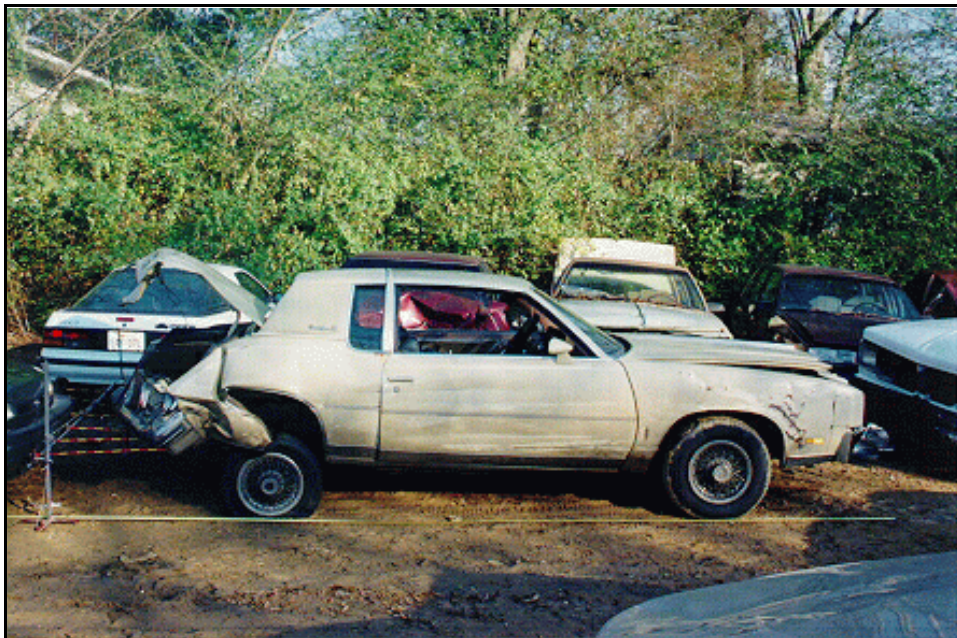
Figure 11: Right side of vehicle #2 (case photo #40)
