TRANSPORTATION RESEARCH CENTER

DEPOWERED AIR BAG REPORT

CASE NUMBER - IN97-064
LOCATION - TEXAS
VEHICLE - 1998 SATURN SL1
CRASH DATE - December, 1997

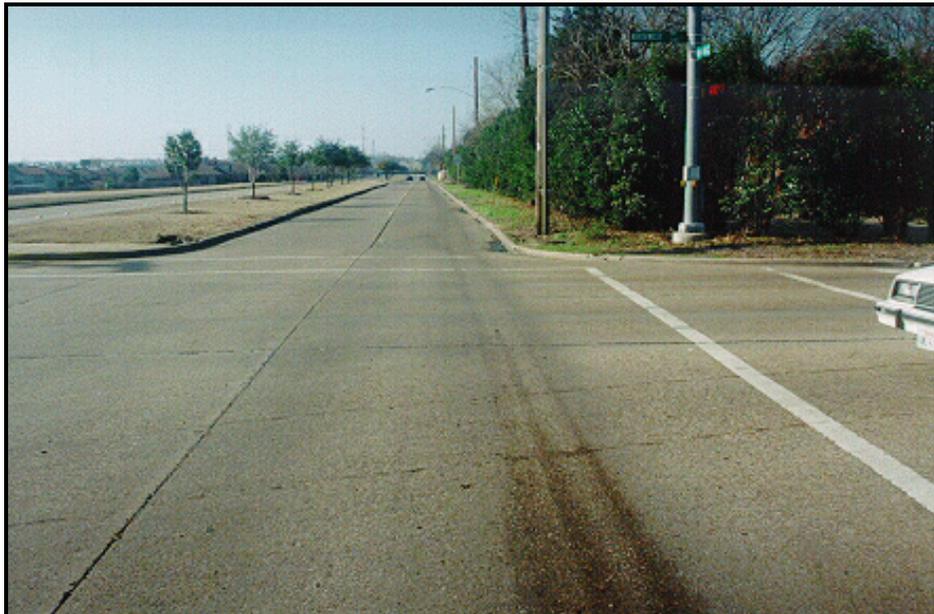
Figure 1: Vehicle #2's west-bound approach with point of impact for first harmful event at middle foreground (case photo #5)

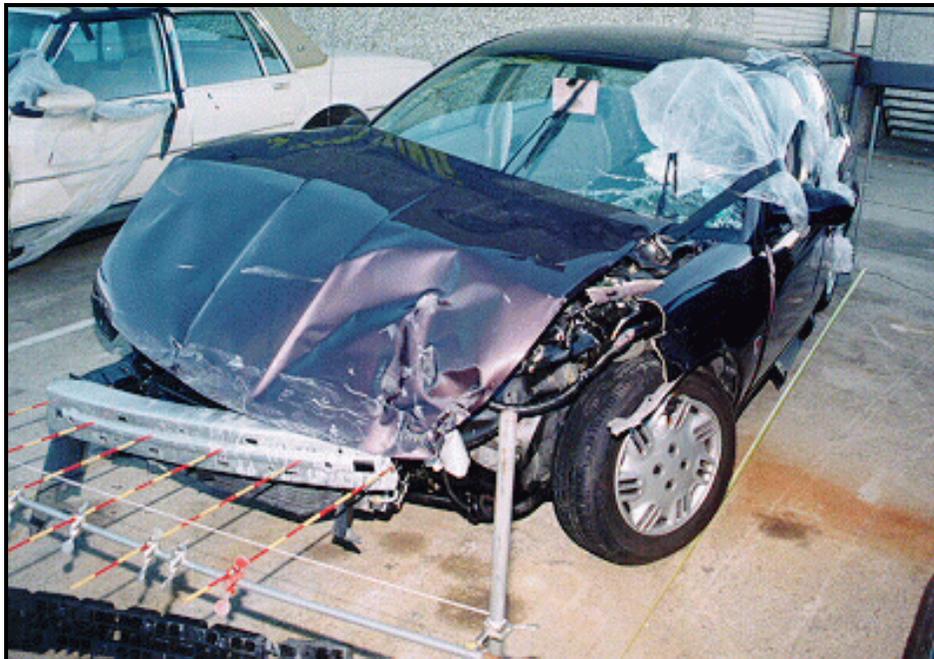
The case vehicle was a front wheel drive 1998 Saturn SL1, four-door sedan (VIN: 1G8ZH5288WZ-----) equipped with anti-lock brakes. Direct contact damage extended across the entire front end. The hood was forced rearward into the windshield and caused two distinct areas of cracking, at the lower left and lower right corners. The left front window disintegrated from impact forces. The driver's door was jammed shut, with all

other doors remaining closed and operational. The CDC for the case vehicle was determined to be 11-FDEW-2, with maximum crush 27 centimeters (10.6 inches) at the front left corner. The SMASH reconstruction program, damage only algorithm, was used on the case vehicle's highest severity impact. The Total, Longitudinal, and Lateral Delta Vs were, respectively, 23 kmph (14 m.p.h.), -17 kmph (-11 m.p.h.), and +15 kmph (+9 m.p.h.). The case vehicle was traveling approximately 56-64 kmph (35-40 mph) prior to impact.

Figure 2: Front and left side of case vehicle (case photo #12)

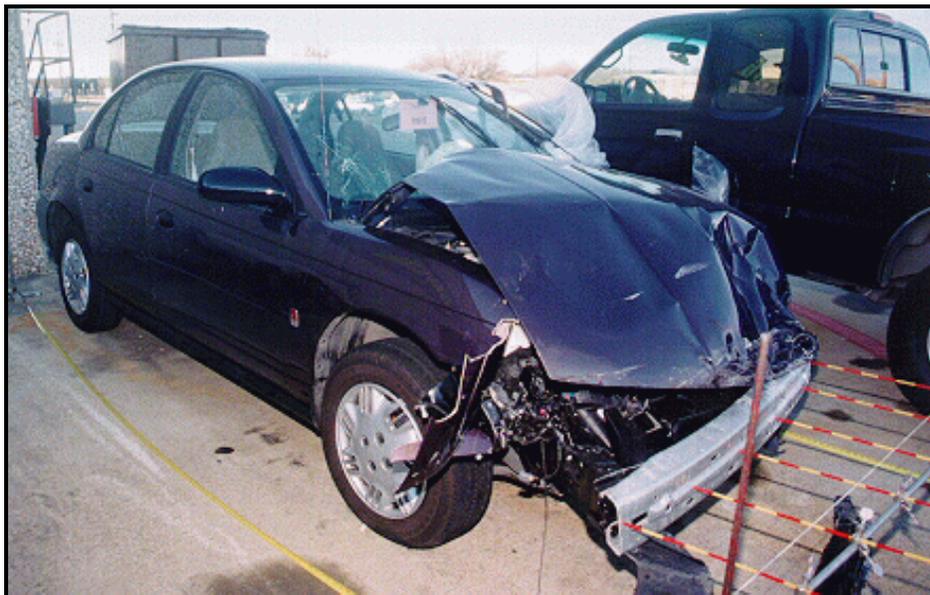
Figure 3: Front and right side of case vehicle (case photo #20)

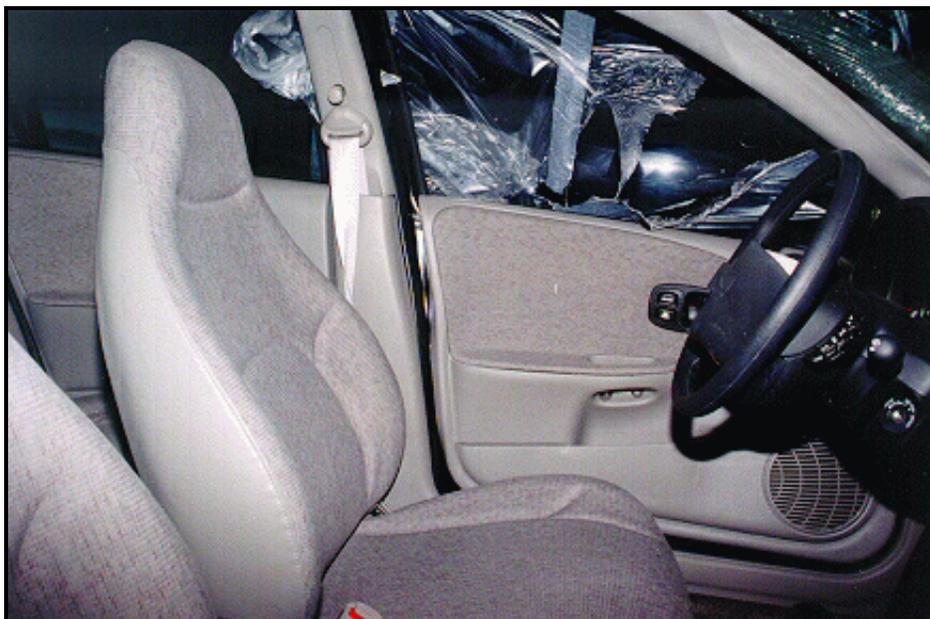
The case vehicle's driver braked, attempting to avoid the crash. As a result of this attempted avoidance maneuver and the use of his available safety belts, he moved slightly forward just prior to impact. The case vehicle's impact with vehicle #2 caused the driver and front right air bags to deploy and thrust the driver forward and leftward. The case vehicle's clockwise rotation forced the driver against the front left door panel, but due to his weight and low center of gravity, he remained in his seated posture and leaned to his left. The driver's interaction with the deploying air bag caused the air bag to be deflected forward, resulting in the minor steering wheel rim deformation. Because the driver was wearing his safety belt, his forward motion was restricted and

he did not engage the air bag with the full force of his inertial motion. The steering wheel would probably have been more seriously deformed had he not been wearing his restraints. As the vehicle came to rest the driver rebounded back to his right away from the driver door panel. The case vehicle's driver did not sustain any specific injuries, but did claim to be sore. The driver did not seek any medical treatment as a result of this crash.

Figure 4: Case vehicle's driver seat area -- note deformed steering wheel rim and shattered side glass (case photo #21)

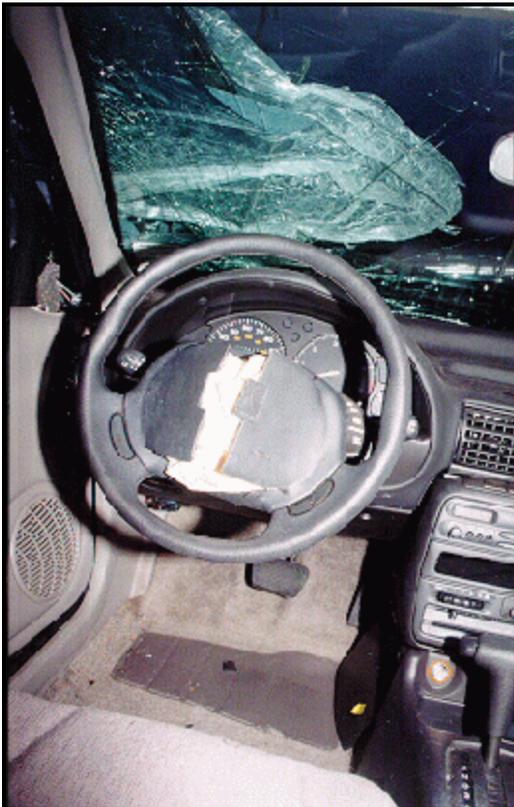
Figure 5: Front view of case vehicle's steering wheel (case photo #32)

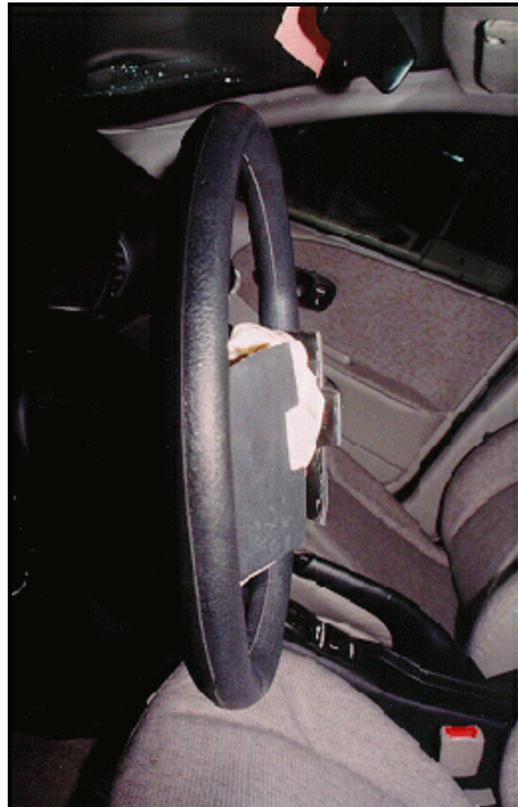
Figure 6: Side view of case vehicle's steering wheel (case photo #23)

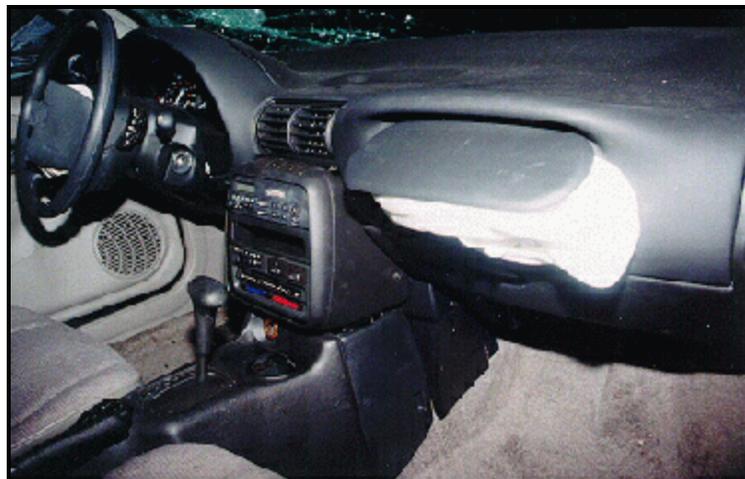
Figure 7: Case vehicle's front right air bag module (case photo #29)

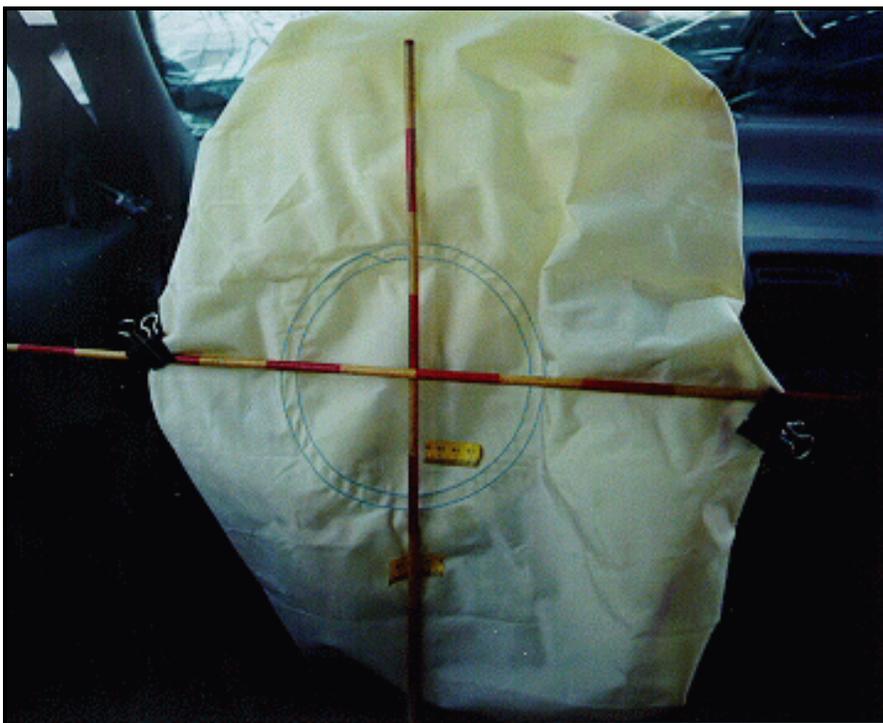
Figure 8: Front of case vehicle's driver air bag -- tape indicates area of scuffs and discoloration (case photo #25)

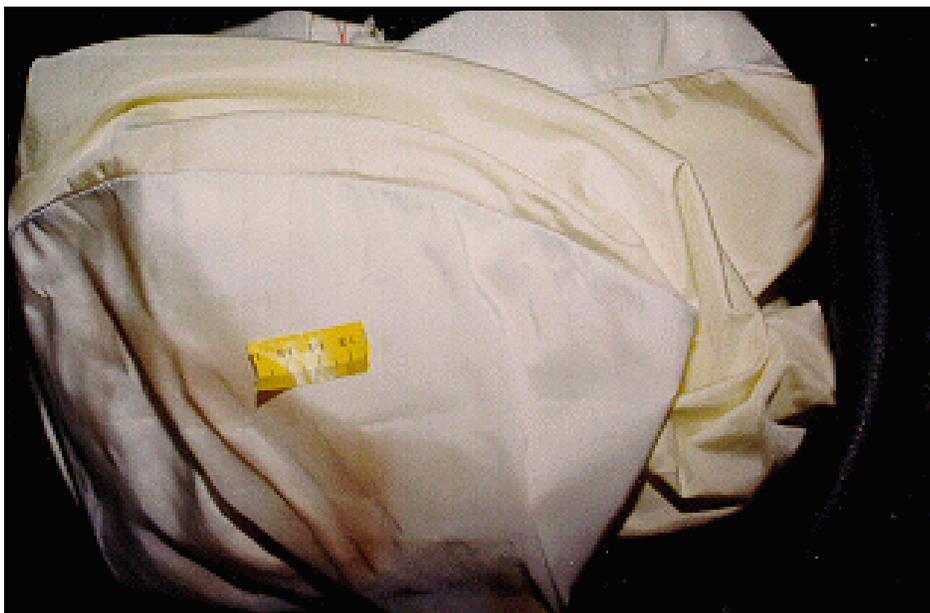
Figure 9: Back bottom half of case vehicle's driver's air bag -- tape indicates area of scorching (case photo #28)

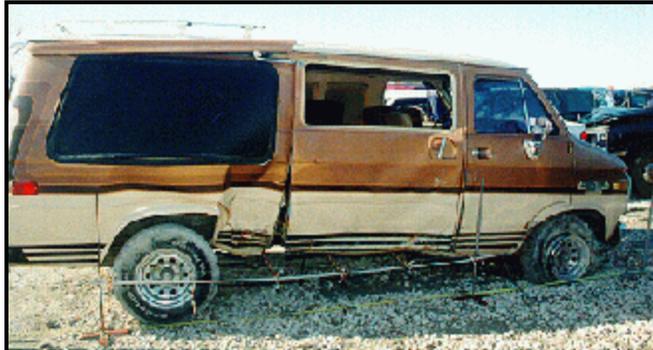
Vehicle #2 was a rear wheel drive 1983 Chevrolet G-20 conversion van (VIN: 2GBEG25H0D4-----). The damage from event #1 (the case vehicle impact) was at the sill level with the crush profile centered approximately on the right side C-pillar. Maximum crush was 17 centimeters (6.7 inches), slightly forward of the C-pillar. The CDC for this impact was 02-RZEW-2. The SMASH damage only reconstruction algorithm indicated total delta v 13 kmph (8 mph), with longitudinal delta v -9 kmph (-5 mph) and lateral delta v -10 kmph (-6 mph). The damage from event #2 (rollover) was distributed along the entire left side and was limited to scratching and minor crushing. The CDC for the rollover event was determined to be 00-LDAO-1. The left front corner of vehicle #2 impacted the median barrier curb while the van was on its left side, causing it to bounce back onto its wheels. The curb impact resulted in maximum crush of 12 centimeters (4.7 inches) on the left front fender. The CDC for this third event was 00-LFMW-2. Vehicle #2 was towed due to damage. The driver (male, 29 years, unknown height and weight) was restrained by his available, active, three-point lap-and-shoulder safety belt and sustained unknown police-reported "C" (possible) injuries. There was no other occupant in vehicle #2. The driver was transported from the scene via ambulance directly to a hospital for treatment.

Figure 10: Vehicle #2 right side damage from impact with case vehicle (case photo #42)

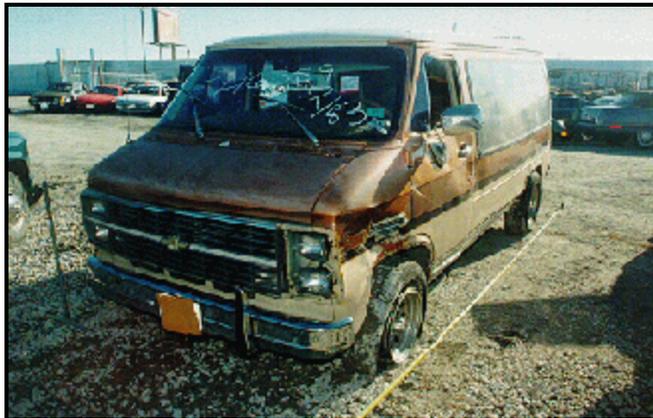
Figure 11: Vehicle #2 left side rollover damage (case photo #35)

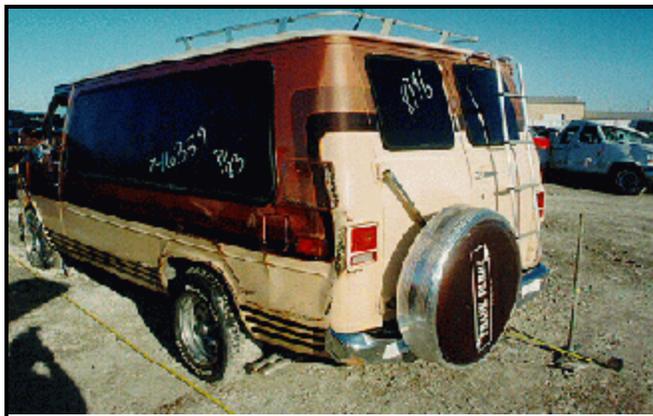
Figure 12: Vehicle #2 left side rollover damage (case photo #37)
