INDIANA UNIVERSITY

TRANSPORTATION RESEARCH CENTER

ON-SITE REDESIGNED AIR BAG REPORT

CASE NUMBER - IN97-065
LOCATION - TEXAS
VEHICLE - 1998 HONDA ACCORD EX
CRASH DATE - December, 1997

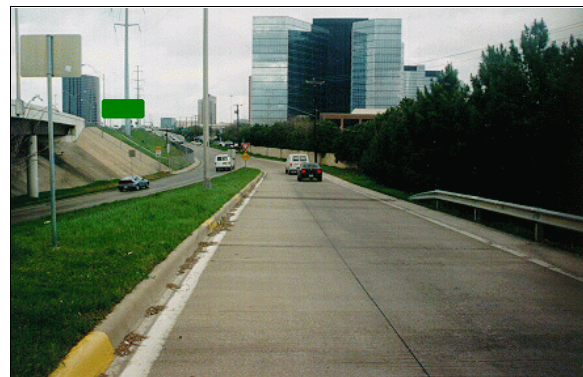
Figure 1: Case vehicle's northbound travel path on exit ramp; Note: white van on right is near crash scene (case photo #01)

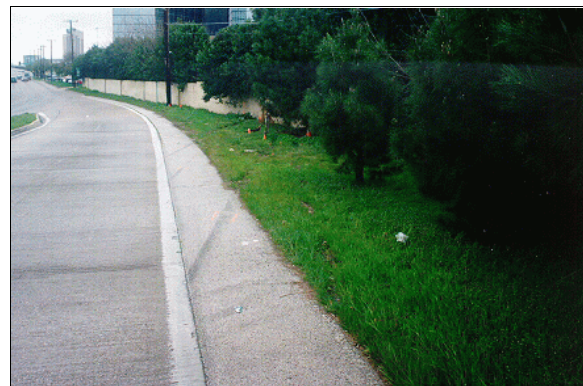
Figure 2: Case vehicle deposited clockwise yaw marks leaving roadway; Note: center cone shows first impact, right cone shows second impact, and left cone shows third impact (case photo #04)

As the case vehicle entered the exit ramp from the tollway, the ramp curved to the right. The case vehicle's driver reportedly has no memory of the crash sequence and is unsure if he made any avoidance maneuvers prior to the crash. Available evidence suggests that the case vehicle most likely came close to or struck the barrier curb along the ramp's west side; either way, the driver over corrected to the right, steering the case vehicle into a clockwise yaw (**Figure 2** above). The yaw increased as the case vehicle diagonally crossed the ramp's entire width and exited the east side of the roadway. The crash occurred on the east roadside of the tollway exit ramp.

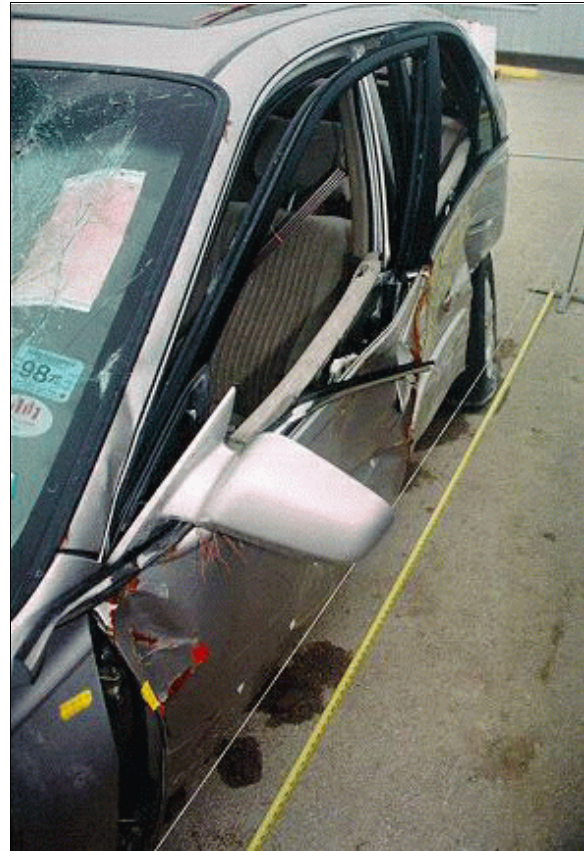
The case vehicle had rotated approximately 75 degrees clockwise when the left side impacted a 9 centimeter (3.5 inch) diameter tree immediately rearward of the left front door's forward door seam (impact #1, **Figure 3**). As a result of the initial impact, the case vehicle's rotation was likely unaffected prior to impacting a second tree, but its side-to-side stability was disrupted as the overridden trunk of the first tree caused the case vehicle to tilt slightly—with the leading left side marginally lower than the right side.

Figure 3: Case vehicle's damaged left front door from first impact; Note: contact near forward seam of door panel and on "A" pillar (case photo #25)

The first of five impacts involved contact with a 9 centimeter (3.5 inch) diameter tree that creased the forward seam of the left front door from the left rocker panel to the lower third of the left "A" pillar. There was also a small 15.2 centimeter (6.0 inch) splintering of the windshield's left seam with the left "A" pillar and contact to the left outside rearview mirror (see **Figure 3** above). The second impact (air bag deployment, **Figure 4** above) occurred with a 27 centimeter (10.6 inch) diameter tree, largest of the three trees contacted. The second impact caused direct damage to the case vehicle's front bumper,

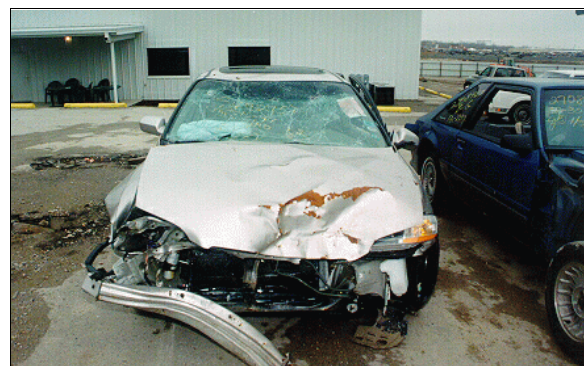
The second tree, with a 27 centimeter (10.6 inch) diameter, was impacted by the front of the case vehicle (impact #2, **Figure 4**), causing the case vehicle's driver and front right passenger supplemental restraints (air bags) to deploy. This contact with the largest of the three impacted trees (i.e., second impact) resulted in the case vehicle continuing its clockwise rotation, with the degree of clockwise rotation increasing. Almost instantaneously, a third tree, with a 10 centimeter (3.9 inch) diameter, was impacted by the center of the case vehicle's left front door (impact #3, see **SELECTED PHOTOGRAPHS, Figure 13** below). The case vehicle continued its clockwise rotation until it struck the brick, noise abatement wall (impact #4, see **SELECTED PHOTOGRAPHS, Figures 14** and **15** below) with the rear portion of its left quarter panel and, almost simultaneously, it began traveling backwards (i.e., the case vehicle had rotated approximately 165 degrees from its initial path of travel down the exit ramp), scraping the wall for approximately 6 meters (19.7 feet). The case vehicle's left side scraping damage extended forward from the back of the left quarter

Figure 4: Case vehicle's frontal damage from the second tree (deployment) impact (case photo #18)

front splash guard, front grille, radiator and brackets, front right headlight/turn signal assembly, and the left half of the front hood. Direct damage began 30 centimeters (11.8 inches) right of the front left corner and extended right 58 centimeters (22.8 inches). The third impact occurred with a 10 centimeter (3.9 inch) diameter tree and dented the left rocker panel, the middle of the left front door, the top of the left front door window glass frame, and the left roof rail above the middle of the left front door (see **SELECTED PHOTOGRAPHS, Figure 13** below). Impact four involved a brick, noise abatement wall. The rear of the case vehicle's left quarter panel contacted the wall, and the vehicle began sliding backwards along the wall, damaging the left quarter panel, the back left taillight assembly, the left seam of the trunk lid, the rear seam of the left rear door, the rear seam of the left front door, the left rocker panel, and the left rear wheel and tire (see **SELECTED PHOTOGRAPHS, Figure 14** below). The highest Delta V impact (see **Figure 5** above) was the fifth, and last, of the five crash sequence impacts. The back of the case vehicle struck a wooden utility pole. Direct damaged components include the back bumper, the back left taillight assembly, the trunk lid, the trunk floor, the back deck rearward of the backlite, the lower frame of the backlite, and the back glazing (see **Figure 6** above). In addition, there was direct damage to the forward roof rail and front right corner of the roof from contact with tree limbs; it is unknown which of the three tree impacts caused this damage. Also, the window glazing from both left side doors was missing post-crash. Tree limbs or contact with the wall by the rear door seams of the left side doors are possible causes of the missing glazing. Indirect damage included the front corners of both front fenders and the back corners of both quarter panels. No undercarriage damage was documented by this contractor's investigative consultant.

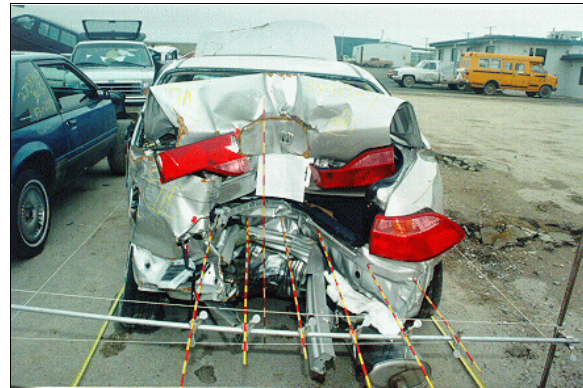
panel to the rear seam of the left front door (impact #4, see **SELECTED PHOTOGRAPHS, Figure 14** below). The case vehicle continued its backwards trajectory for another 11 meters (36.1 feet) and struck a 30 centimeter (11.8 inch), wooden utility pole with its back bumper (impact #5--the highest Delta V impact, **Figure 5**).

Figure 5: Case vehicle's back damage from utility pole (fifth impact; Note: pole was highest Delta V impact (case photo #32)

Based on the vehicle inspection, the CDC for the highest severity impact (impact #5, wooden utility pole) was determined to be: **06-BCEW-6 (180)** [maximum crush was 87 centimeters (34.3 inches)]. A CDC for the second highest impact (impact #2, deployment impact and largest tree) was determined to be: **10-FDEW-2 (305)** [maximum crush was 27 centimeters (10.6 inches)]. The CDCs for the case vehicle's first, third, and fourth impacts were determined to be, respectively: **09-LPAN-2 (280)**, **09-LPAN-2 (270)**, and **07-LZEW-1 (220)**. The WinSMASH reconstruction program, barrier algorithm, was used for the highest and the second highest severity impacts sustained by the case vehicle during this five-impact crash sequence. The Total, Longitudinal, and Lateral Delta Vs for the highest severity impact are, respectively: 53.3 km.p.h. (33.1 m.p.h.), +53.3 km.p.h. (+33.1 m.p.h.), and 0 km.p.h. (0 m.p.h.); similarly, the totals for the second highest severity impact are, respectively: 18.7 km.p.h. (11.6 m.p.h.), -10.7 km.p.h. (-6.6 m.p.h.), and +15.4 km.p.h. (+9.6 m.p.h.). This contractor believes that the determined results for the deployment impact are low.

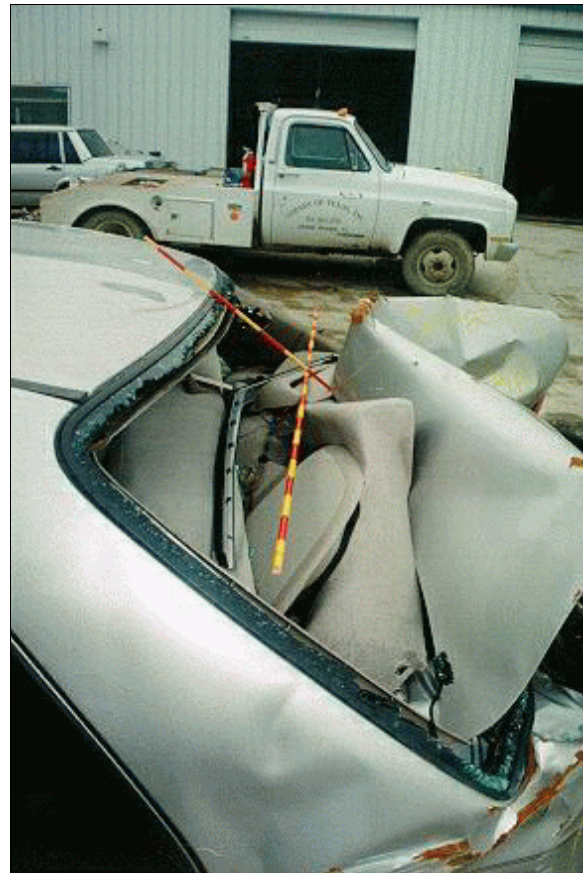
Figure 6: Case Vehicle's backlite and deck damage; Note: trunk lid intrusion into lower glazing (case photo #31)

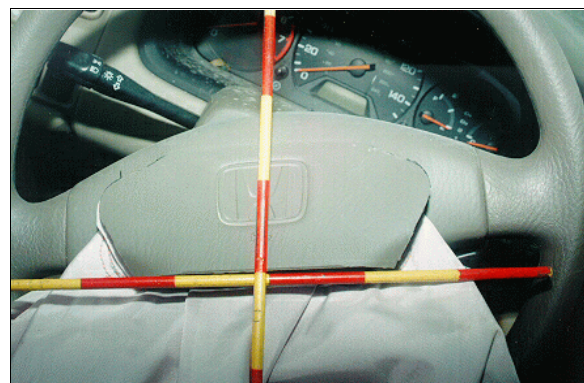
Figure 7: Case vehicle driver air bag module's top cover flap; Note: absence of occupant contact evidence (case photo 46)

second of five crash sequence impact). The case vehicle's driver air bag was located in the steering wheel hub. The module's seams were in an asymmetrical, "H" configuration, with the larger, top cover flap measuring 13 centimeters (5.1 inches) along the horizontal seam, 19 centimeters (7.5 inches) at its maximum width, and 7.6 centimeters (3.0 inches) at its maximum height (see **Figure 7** above). The smaller, lower cover flap measured 10 centimeters (3.9 inches) along the horizontal seam, 14 centimeters (5.5 inches) at its maximum width, and 4 centimeters (1.6 inches) at its maximum height (see **Figure 8**).

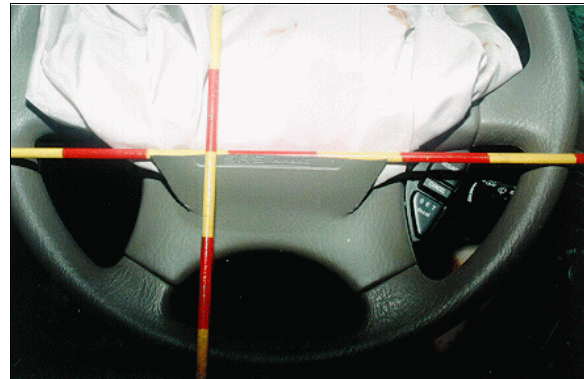
Figure 8: Case vehicle driver air bag module's bottom cover flap; Note: absence of occupant contact evidence (case photo #47)

An inspection of the air bag module's cover flaps and air bag revealed that the cover flaps opened at the designated tear points, and there was no evidence of damage during the deployment to the air bag or the cover flaps. The driver's air bag was designed with two cloth tethers, each 3 centimeters (1.2 inches) wide. The driver's air bag had two vent ports, approximately 4 centimeters (1.6 inches) in diameter, located at the 3 and 9 o'clock positions. The deployed driver's air bag was round with a diameter of 64 centimeters (25.2 inches). On the upper right quadrant of the air bag fabric (**Figure 9**) there was a possible cloth transfer located approximately 10.2 centimeters (4.0 inches) right of the longitudinal axis and 12.7 centimeters (5.0 inches) up from the lateral axis. In addition, there were three groups of blood stains: one at 15.2 centimeters (6.0 inches) right and 2.5 centimeters (1.0 inch) up, a second at 27.9 centimeters (11 inches) right and 5.1 centimeters (2.0 inches) up, and a third at 25.4 centimeters right (10.0 inches) and 12.7 centimeters (5.0 inches) up. On the lower right quadrant of the driver's air bag there was a blood stain centered at 17.8 centimeters (7.0 inches) right of the longitudinal axis and 2.5 centimeters (1.0 inches) down from the lateral axis. There was also a blood stain at the bottom of the fabric that straddled the longitudinal axis. On the reverse side of the driver's air bag (**Figure 10**), at the top (approximate 2 o'clock position), there was a blood stain on the seam. In addition, an unmeasured series of blood stains were located along the right vertical surface of the fabric, extending outwards from the circumferential seam.

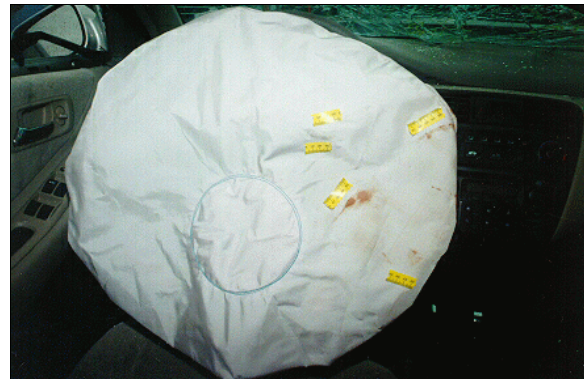
Figure 9: Case vehicle's driver air bag; Note: blood stains and scuffs to right third of fabric (case photo #58)

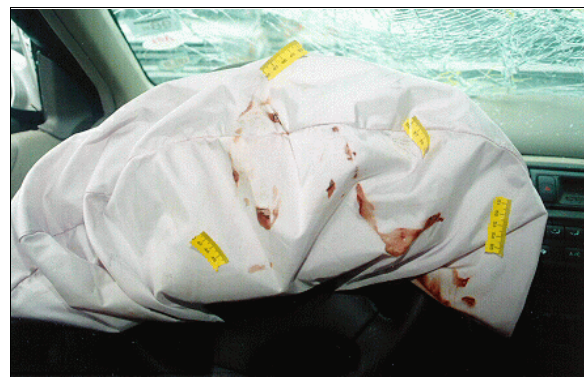
Figure 10: Case vehicle's driver air bag; Note: blood stains on bottom, back side of fabric (case photo #64)

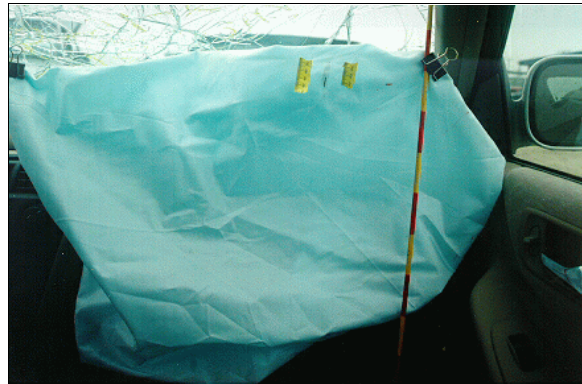
The front right passenger air bag also deployed on the case vehicle's second impact (i.e., with the largest of the three contacted trees). The front right passenger's air bag was located in the top of the instrument panel. The module cover consisted of slightly asymmetrical "H"-configuration cover flaps made of thick vinyl with overall dimensions of 26 centimeters (10.2 inches) at the horizontal seam and 4 centimeters (1.6 inches) vertically for the upper flap and 6 centimeters (2.4 inches) vertically for the lower flap. The profile of the case vehicle's instrument panel resulted in a 20 centimeter (7.9 inch) setback of the leading edge of the cover flap relative to the protruding right instrument panel. An inspection of the front right air bag module's cover flaps and air bag revealed that both the upper and lower cover flaps opened at the designated tear points, and there was no evidence of damage during the deployment to the air bag or the cover flaps. It is not known whether the top cover flap contacted the windshield. The front right passenger's air bag was designed without any tethers. The front right air bag had two vent ports, approximately 6 centimeters (2.4 inches) in diameter, located at the 3 and 9 o'clock positions. The deployed front right air bag was rectangular with a height of approximately 55 centimeters (21.7 inches) and a width of approximately 76 centimeters (29.9 inches). There was no evidence of occupant contact to the front right passenger air bag, but there were three blood splashes located at the top right quadrant of the fabric (**Figure 11**).

Figure 11: Case vehicle's front right passenger air bag; Note: three blood splatters on top right quadrant of the fabric (case photo #67)

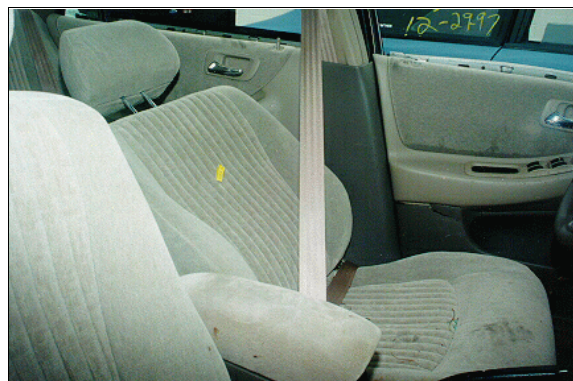
Figure 12: Case vehicle's driver seat; Note: seat back angle caused by folding lock failure (case photo #54)

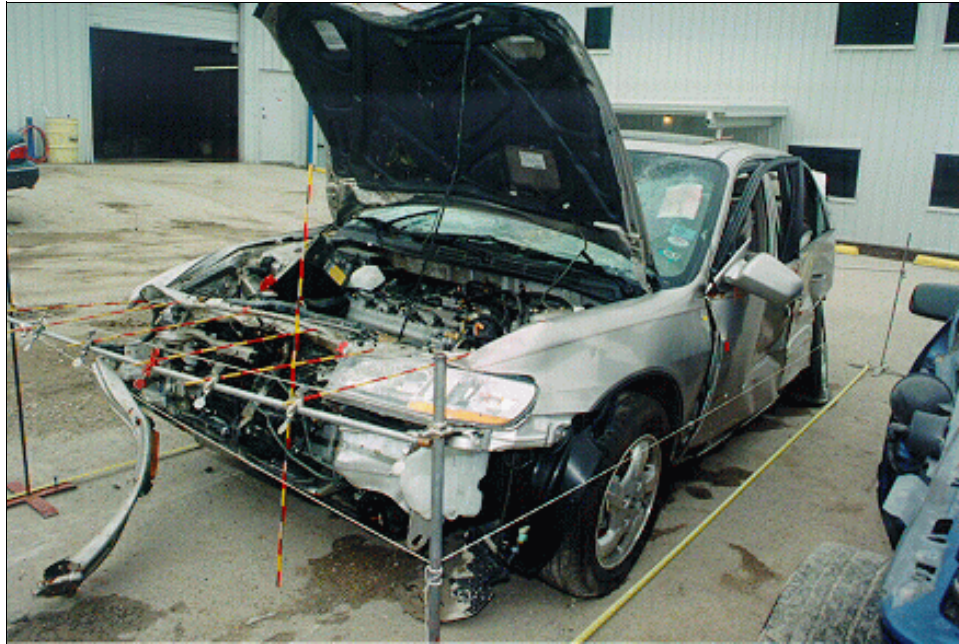
Figure 13: Case Vehicle's damaged left side; Note: left front door forward seam and mid-panel damage (case photo #23)

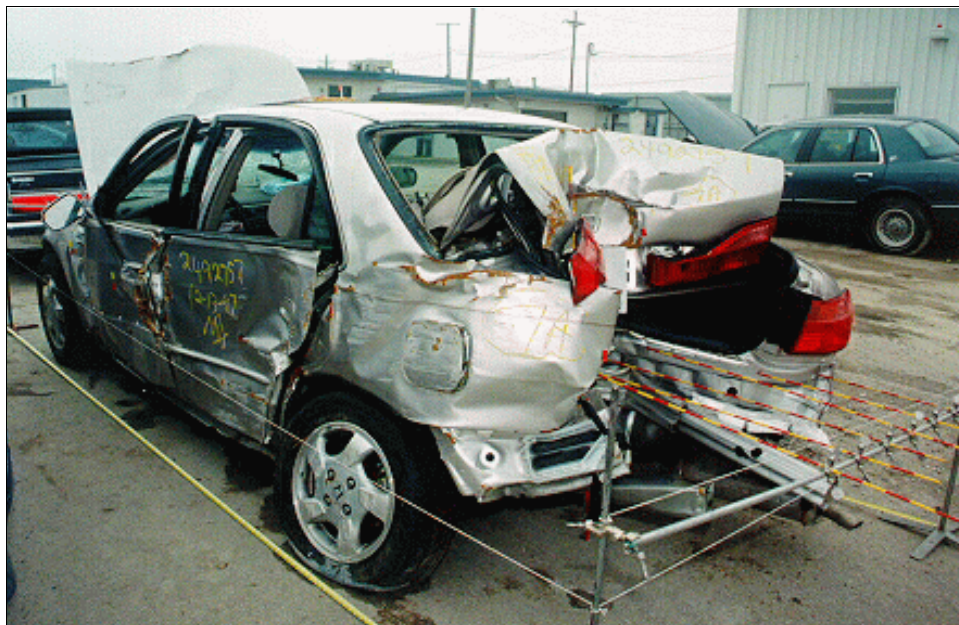
Figure 14: Case vehicle's left side damage; Note: first impact at left front door's forward seam, third impact at mid-left front door, and fourth impact goes forward from left rear corner to left front door's rear seam (case photo #28)

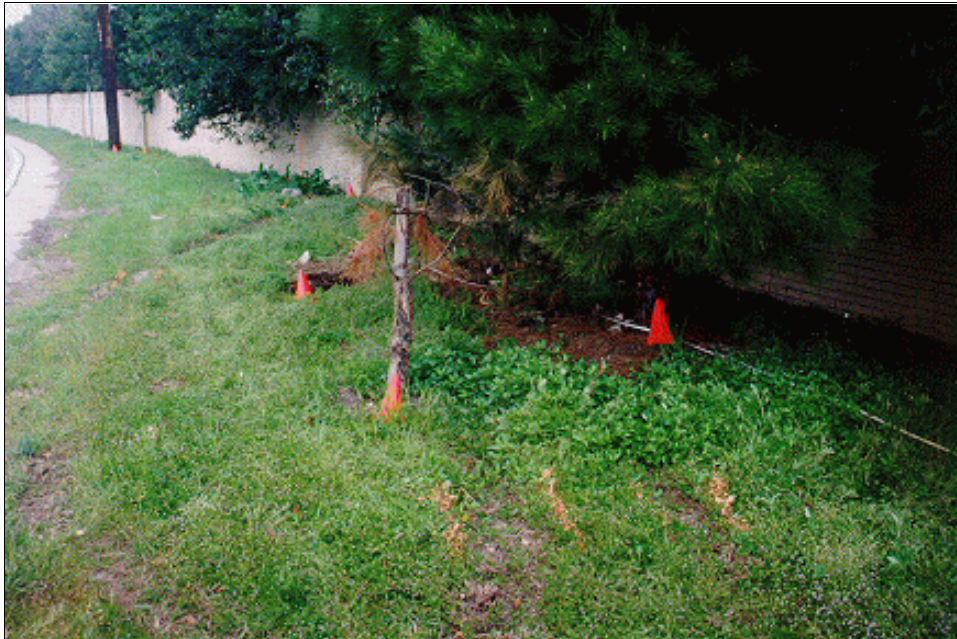
Figure 15: Case vehicle's five impacts; Note: center cone shows impact #1, right cone shows impact #2, left cone shows impact #3, cone at wall shows #4, and utility pole was impact #5 (case photo #06)

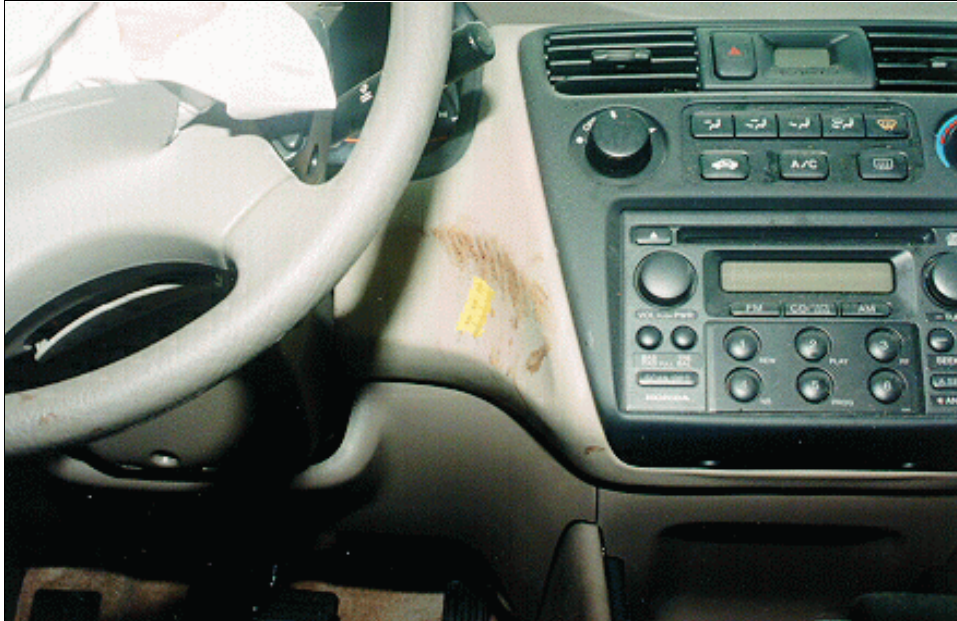
Inspection of the case vehicle's interior revealed other evidence of the driver's contact on the interior surfaces. Specifically, there was a blood stain on the bottom of the steering wheel rim, a possible skin transfer on the upper right steering wheel spoke, a significant blood stain to the middle instrument panel just left of the stereo (see **SELECTED PHOTOGRAPHS, Figure 16** below), and blood and hair transfers within the spider web-shaped damage to the windshield's glazing above the steering wheel.

Figure 16: Case vehicle's lower dash just right of the steering column; Note: yellow tape marks area of significant blood stain (case photo #52)
