Remote, Redesigned Air Bag Special Study

Dynamic Science, Inc., Case Number (1998-048-149C)

1998 Ford F-150

1. Report No. 1998-048-149C	2. Government Accession No.	3. Recipient Catalog No.	
4. Title and Subtitle		5. Report Date February 24, 2000	
		6. Performing Organization Report No.

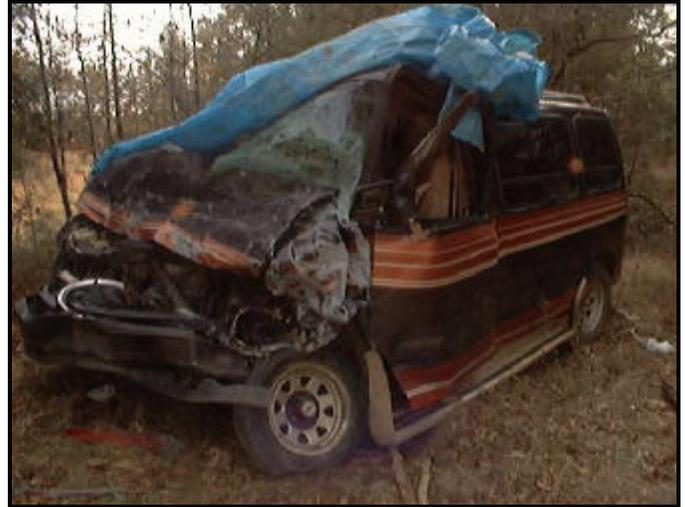
Figure 1. Exterior, Vehicle 1 (Chevrolet Astro)

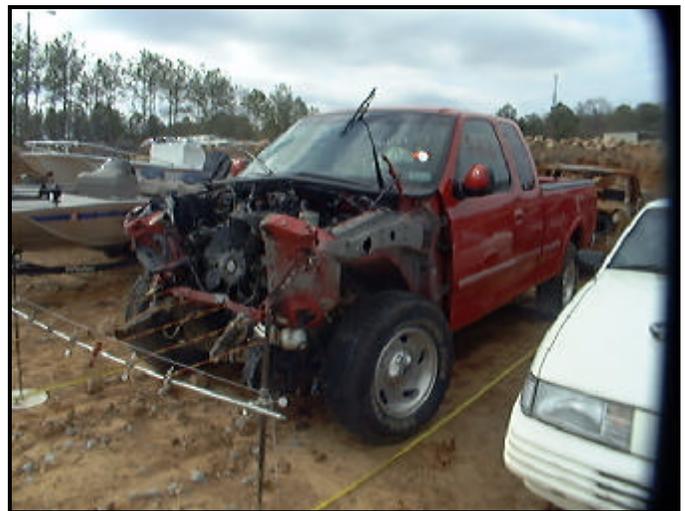
Figure 2. Exterior, Vehicle 2 (Ford F-150)

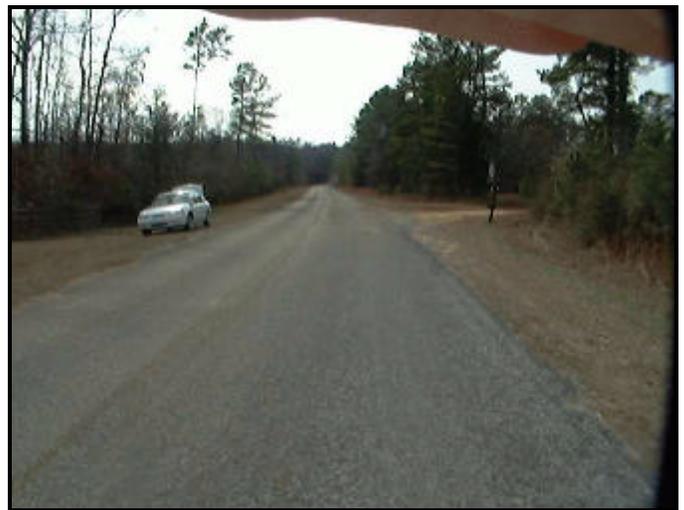
Figure 3. Crash scene. Vehicle 2 approach path.

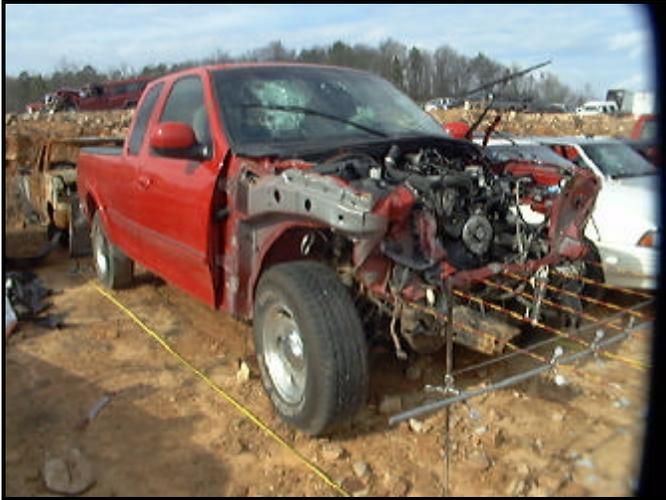
Figure 4. Exterior, Vehicle 2 (1998 Ford F-150)

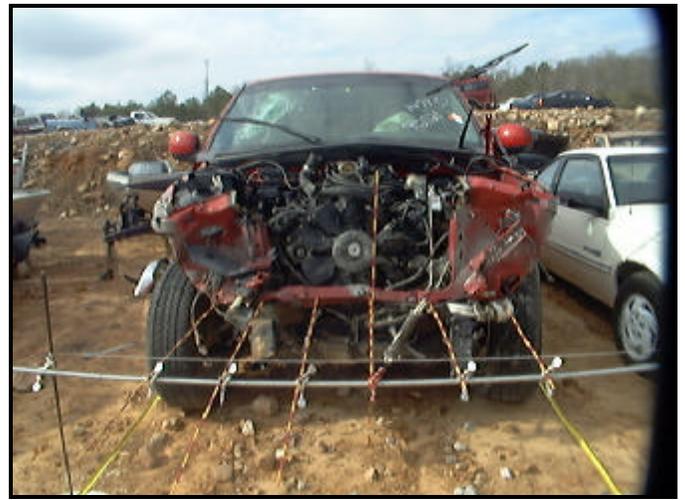
Figure 5. Exterior, Vehicle 2 (1998 Ford F-150)

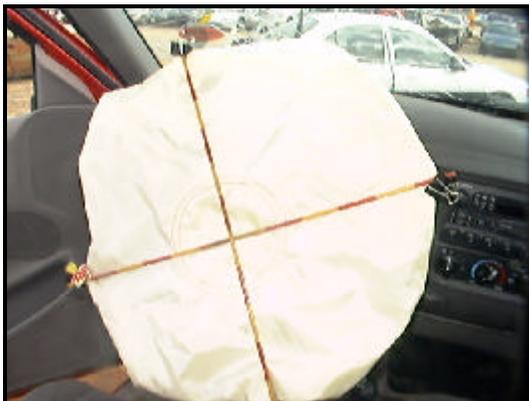
The front left air bag was housed in the steering wheel hub and was concealed by asymmetrical H-configuration cover flaps which were not damaged. The circular air bag was equipped with two tether straps and two vent ports. No contact evidence was found on the air bag and the bag was not damaged.

Figure 6. Interior, case vehicle. Driver's frontal air bag.

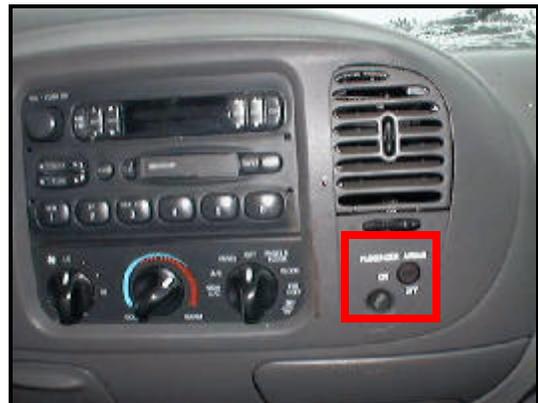
The front right air bag shut off switch was located on the center-instrument panel. The switch is key activated and was turned to the “off” position (see Figure 7). The switch is marked “Passenger Airbag” and the “Off” lamp was illuminated at the time of the crash.

Figure 7. Interior, case vehicle. Box indicates location of passenger's air bag shut off switch.

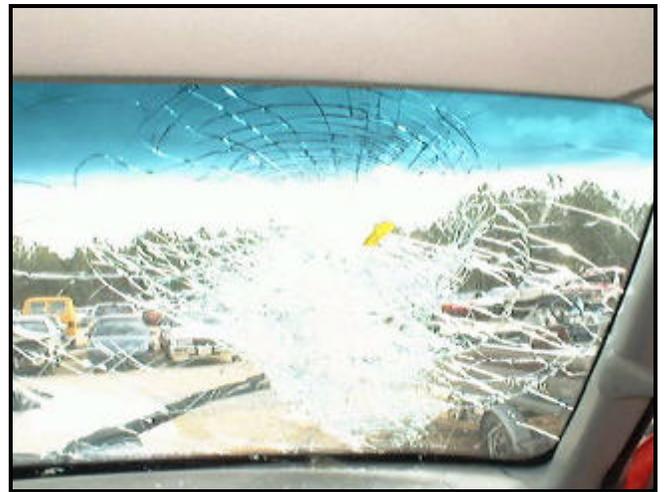
Figure 8. Interior, case vehicle. Windshield contact.
