**REDESIGNED AIR BAG SPECIAL STUDY (RABSS)
SCI TECHNICAL SUMMARY REPORT**

NASS RABSS CASE NO. 1998-08-804F

RABSS VEHICLE - 1998 DODGE NEON

CRASH DATE - OCTOBER, 1998

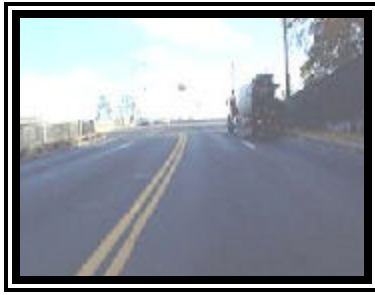
The 30 year old female driver of the 1992 Buick Regal was operating the vehicle eastbound (**Figure 1**) and attempted to turn left (north) at the 3-leg intersection. The 28 year old female driver of the 1998 Dodge Neon was operating the vehicle westbound in the curb lane (**Figure 2**) and proceeding straight. Upon recognition of the impending harmful event, the driver braked in avoidance.

Figure 1. Eastbound approach for the 1992 Buick Regal.

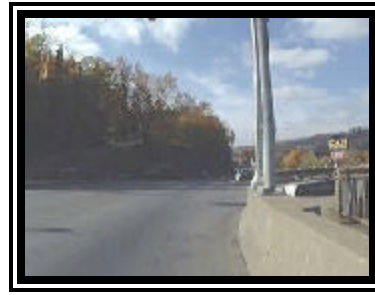
Figure 2. Westbound approach for the 1998 Dodge Neon.

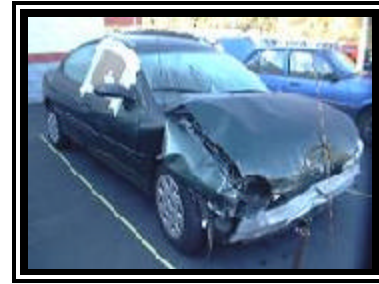
The Dodge Neon sustained moderate frontal damage as a result of the impact with the Buick Regal (**Figure 3**). The direct contact damage encompassed the full frontal width resulting in a combined direct and induced damage length (Field L) of 121.0 cm (47.6 in). Six crush measurements were documented at the level of the reinforcement bar (bumper cover separation): C1 = 8.0 cm (3.1 in), C2 = 13.0 cm (5.1 in), C3 = 21.0 cm (8.3 in), C4 = 24.0 cm (9.4 in), C5 = 26.0 cm (10.2 in), C6 = 29.0 cm (11.4 in). Damage was noted to the hood which was displaced up and rearward from engagement against the side surface of the Buick. Induced damage was identified at the right fender which restricted the right front door opening. The windshield was undamaged.

Figure 3. Frontal damage to the 1998 Dodge Neon.

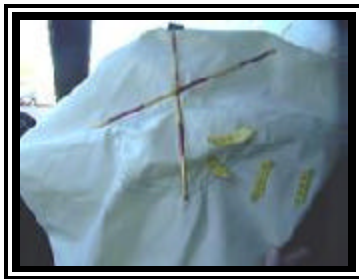
contact evidence was identified on the exterior surface of the module cover flap, a makeup transfer was documented at the upper left quadrant of the air bag. The NASS researcher measured the diameter of the driver air bag at 50.0 cm (19.7 in) in its deflated state (**Figure 6**). The bag was tethered by two internal straps and vented by two ports located at the 11 o'clock and 1 o'clock sectors on the rear aspect of the air bag.

Figure 6. 1998 Dodge Neon redesigned driver air bag.

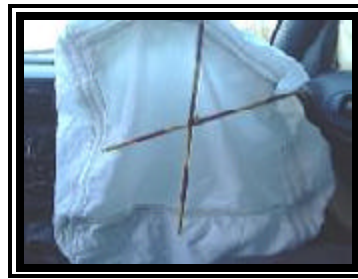
The front right passenger air bag deployed from the right mid-instrument panel area with a single cover flap design hinged at the top aspect. There was no contact evidence identified on the redesigned passenger air bag or exterior surface of the module cover flap. The cover flap was rectangular in shape and measured 35.0 cm (13.8 in) in width and 16.0 cm (6.3 in) in height. The NASS researcher measured the passenger air bag at 55.0 cm (21.7 in) in width and 54.0 cm (21.3 in) in height in its deflated state (**Figure 7**). No tether straps were present. The bag was vented by one port at the 12 o'clock sector on the rear aspect of the air bag.

Figure 7. 1998 Dodge Neon redesigned passenger air bag.

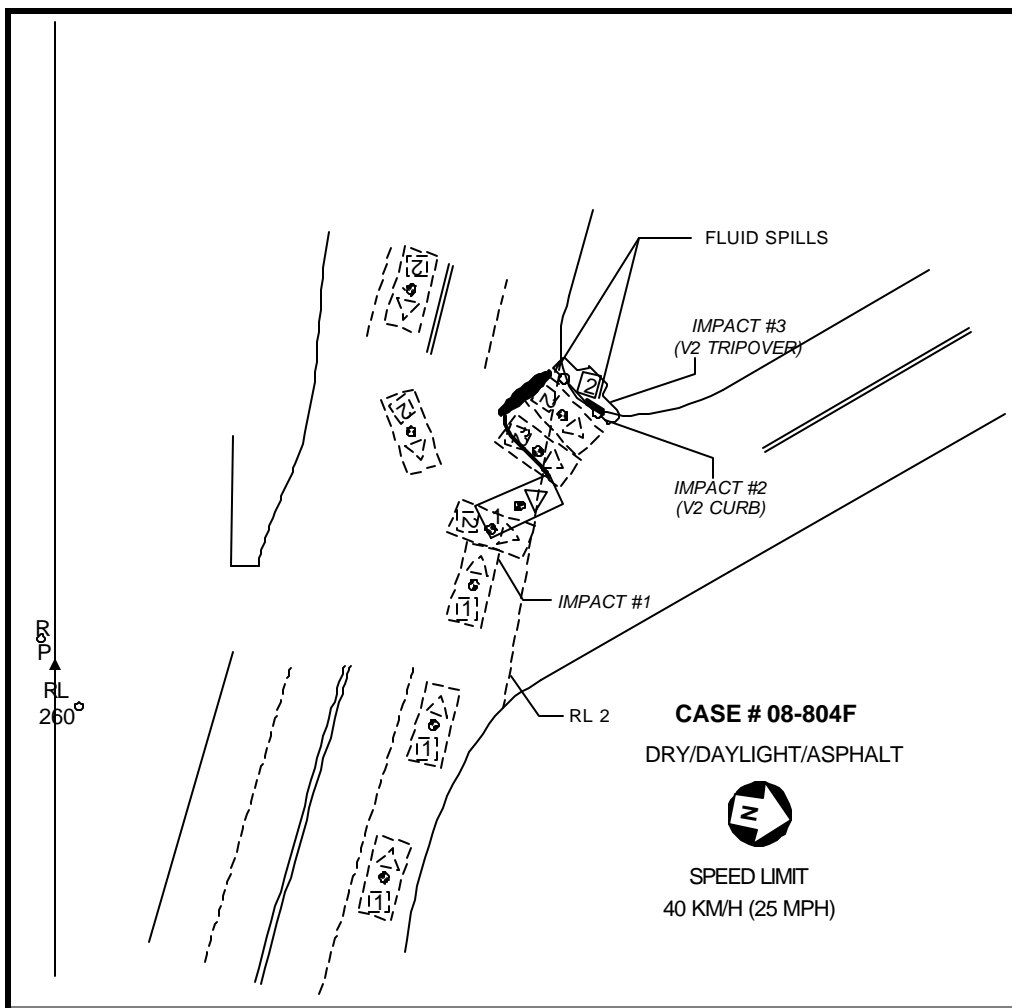
Figure 8. NASS Scene Diagram

This two-vehicle crash occurred during the afternoon hours of October, 1998. At the time of the crash, it was daylight with no adverse conditions as the roads were dry. The crash occurred in the westbound lanes of a (asphalt) 3-leg intersection which consisted of four travel lanes bordered on the north side by barrier curbs. The roadway curved right for westbound traffic with a negative grade to the west. Traffic flow through the intersection was controlled by an overhead traffic signal system (see **Figure 8-page 5**) which had a posted speed limit of 40 km/h (25 mph).
