**VERIDIAN REMOTE REDESIGNED AIR BAG INJURY
INVESTIGATION
SCI TECHNICAL SUMMARY REPORT**

NASS CDS CASE NO. 1998-09-053A

VEHICLE - 1998 SATURN SL

LOCATION - STATE OF MARYLAND

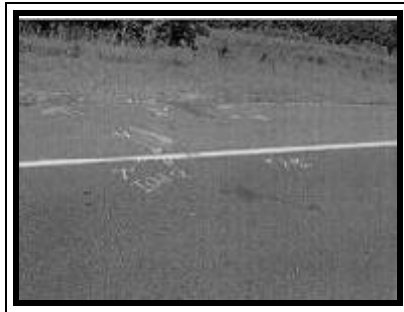
The two vehicles collided in an oblique frontal impact configuration (**Figure 3**). The resultant directions of force associated with the crash were 1 o'clock for the Saturn and 11 o'clock for the GMC Jimmy. The velocity changes experienced by each vehicle during the crash were estimated at 60.0 km/h (37.3 mph) for the Saturn and 43.0 km/h (26.7 mph) for the GMC Jimmy using the WinSMASH program.

Figure 3. Northeast view of impact area.

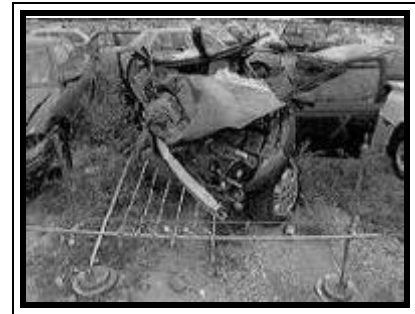
The 1998 Saturn SL sustained severe frontal damage as a result of the impact with the GMC Jimmy (**Figure 4**). The direct contact damage began at the front right bumper corner and extended 57.0 cm (22.4") inboard. The impact deformed the full frontal end width resulting in a direct and induced contact length (Field L) of 110.0 cm (43.3"). Six crush measurements were documented at the level of the reinforcement bar (*bumper fascia separation*): C1= 0 cm, C2= 23.0 cm (9.1"), C3= 41.0 cm (16.1"), C4= 59.0 cm (23.2"), C5= 78.0 cm (30.7"), C6= 96.0 cm (37.8"). Damaged components included the front bumper, both headlight assemblies, the grille and surrounding area, hood and both fenders, windshield, roof panel, right doors, and rear quarter panel. The right wheelbase dimension was reduced 74.0 cm (29.1") and the left wheelbase dimension was elongated 42.0 cm (16.5"). The Collision Deformation Classification (CDC) for this impact to the Saturn was 81-FZEW-4 (1 o'clock direction of force incremented by 80 to indicate end shifting). The delta V associated with this impact damage was estimated at 60.0 km/h (37.3 mph) using the WinSMASH program.

Figure 4. Frontal damage to the 1998 Saturn SL.

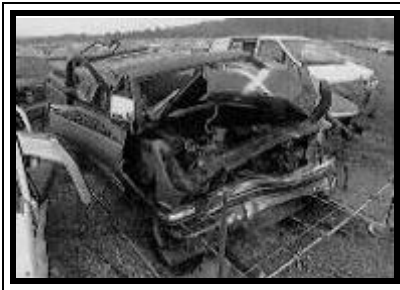
Figure 5. Frontal damage to the 1998 GMC Jimmy Typhoon.

Exterior damage to the 1998 GMC Jimmy Typhoon was also rated as severe (**Figure 5**). The direct contact damage encompassed the full frontal end width resulting in a direct and induced damage length (Field L) of 141.0 cm (55.5"). Six crush measurements were documented at the level of the bumper: C1= 37.0 cm (14.6"), C2= 28.0 cm (11.0"), C3= 39.0 cm (15.4"), C4= 56.0 cm (22.0"), C5= 57.0 cm (22.4"), C6= 60.0 cm (23.6"). The CDC for this impact to the GMC was 11-FDEW-3.

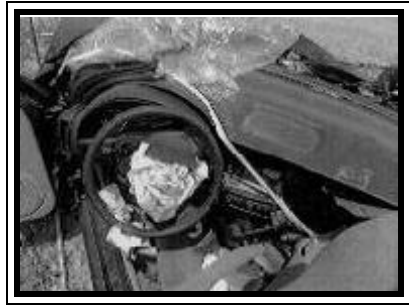
At impact, the driver moved forward and to the right with respect to the vehicle interior. He loaded the lap and shoulder belt and redesigned driver air bag. He then apparently continued to the right, sliding off the air bag and contacting the center instrument panel with the facial area (**Figure 7**). While he was moving forward, he loaded the knee bolster and mid-instrument panel on both sides of the steering column with his knees and lower legs.

Figure 7. 1998 Saturn SL driver space.
