**REDESIGNED AIR BAG SPECIAL STUDY (RABSS)  
SCI TECHNICAL SUMMARY REPORT**

**NASS CDS CASE NO. 1998-09-108E**

**RABSS VEHICLE - 1998 CHEVROLET S-10 BLAZER LS**

**CRASH DATE - OCTOBER, 1998**

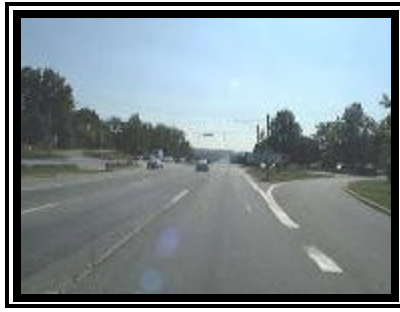
The 25 year old male driver of the 1998 Chevrolet S-10 Blazer was operating the vehicle southbound (**Figure 1**) in the outboard lane of the seven lane divided roadway when he failed to observe the red overhead traffic signal or westbound Ford as he proceeded straight through the 4-leg intersection. The 28 year old male driver of the 1991 Ford Mustang LX was operating the vehicle northbound (**Figure 2**) on the inboard lane of the seven lane divided roadway when he proceeded to turn left (west) at the 4-leg intersection. The NASS researcher reported no brake marks at the scene indicative of driver avoidance maneuvers.

**Figure 1. Southbound approach for the 1998 Chevrolet S-10 Blazer.**

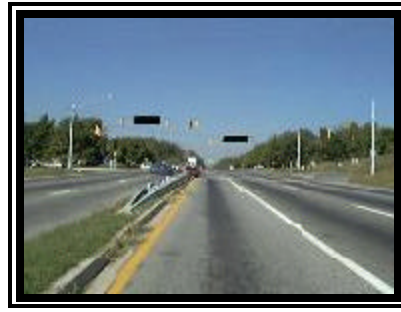
**Figure 2. Northbound approach for the 1991 Ford Mustang LX.**

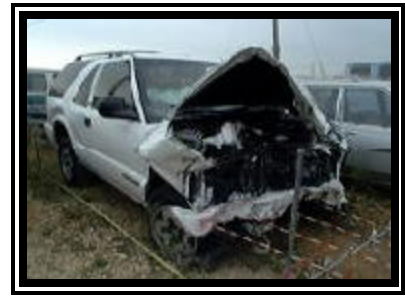
The 1998 Chevrolet S-10 Blazer sport utility vehicle sustained severe frontal damage as a result of the impact with the Ford Mustang (**Figure 3**). The direct contact damage encompassed the entire frontal width resulting in a combined direct and induced damage length (Field L) of 137.0 cm (53.9 in). Six crush measurements were documented at the level of the bumper: C1= 24.0 cm (9.4 in), C2= 22.0 cm (8.7 in), C3= 35.0 cm (13.8 in), C4= 43.0 cm (16.9 in), C5= 51.0 cm (20.1 in), C6= 52.0 cm (20.5 in). The Collision Deformation Classification (CDC) for this initial impact to the Chevrolet was 12-FDEW-3 with a principal direction of force of (-)10 degrees. The grille and headlight assemblies fractured and separated from the vehicle during the collision sequence. The hood was deformed up and rearward from engagement against the side surface of the Ford. Both fenders were displaced rearward which restricted/deflated the front wheels/tires and jammed the left door. Induced buckling was noted to the roof area at the left and right B-pillar. Reduction in the right side wheelbase measured 9.0 cm (3.5 in). The windshield was fractured from exterior impact forces (only).

**Figure 3. Frontal damage to the 1998 Chevrolet S-10 Blazer.**

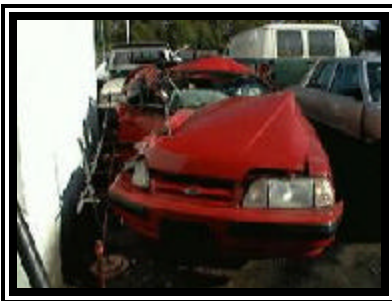
**Figure 4. Right side surface damage to the 1991 Ford Mustang LX.**

The 1991 Ford Mustang LX 2-door hatchback sustained severe right side surface damage as a result of the impact with the Chevrolet Blazer (**Figure 4**). The direct contact damage began at the front right bumper corner and extended 182.0 cm (71.7 in) rearward. The combined direct and induced damage length (Field L) began at the front right bumper corner and extended 256.0 cm (100.8 in) rearward. A maximum crush value of 79.0 cm (31.1 in) was identified at the C4 position. The CDC for this initial impact to the Ford was 63-RYEW-5 with a principal direction of force of (+)80 degrees (principal direction of force incremented to reflect structural bowing). Extensive deformation produced induced buckling (and interior component intrusion) of the roof and associated right B and C-pillars. Structural vehicle bowing also produced induced contact damage to the left side surface. The right front wheel/tire was restricted (not deflated). The windshield was fractured by exterior impact forces. All right side tempered glazing was disintegrated which resulted in integrity loss at the right door window area. Reduction in the right side wheelbase measured 52.0 cm (20.5 in) while the left side wheelbase was elongated 21.0 cm (8.3 in).

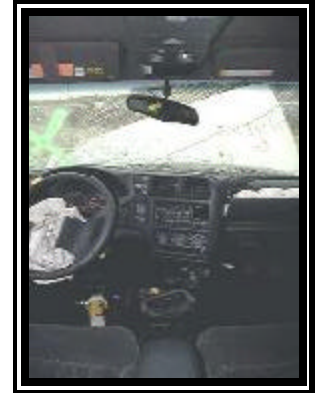
Damage to the interior surfaces of the Chevrolet Blazer were minimal and attributed to component intrusions and occupant contact. Scuff marks were identified on the left door panel, knee bolster and lower center instrument panel area. A scuff mark was also documented on the steering column with the cover panel out-of-place. The rear view mirror and floor mounted console were fractured and displaced to the right. Deformation to the upper portion of the steering wheel rim measured 1.0 cm (0.4 in). Longitudinal intrusions involved 3.0 cm (1.2 in) of front left and 7.0 cm (2.8 in) of front right toepan intrusion.

**Figure 5. Interior view.**

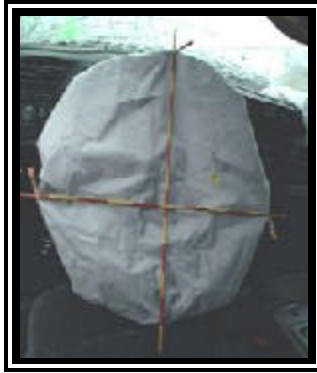
The 1998 Chevrolet S-10 Blazer LS was equipped with redesigned frontal air bags for the driver and front right passenger positions. The air bags had deployed as a result of the crash. The driver air bag was housed in the center of the steering wheel with a vertically oriented flap tear seam (I-configuration). The flaps were symmetrical in shape and measured 8.5 cm (3.3 in) in width and 10.0 cm (3.9 in) in height. Although no contact evidence was identified on the exterior surface of the module cover flaps, a smudge mark was documented on the upper right quadrant of the air bag face (**Figure 7**). The NASS researcher measured the diameter of the driver air bag at 72.0 cm (28.3 in) in its deflated state (**Figure 6**). The bag was tethered by four internal straps and vented by two ports located at the 11 o'clock and 1 o'clock sectors on the rear aspect of the air bag.

**Figure 6. 1998 Chevrolet S-10 Blazer redesigned driver air bag.**

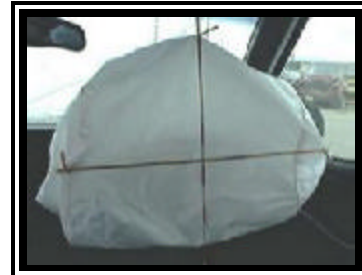
The front right passenger air bag deployed from the right mid-instrument panel area with a single cover flap design hinged at the bottom aspect. No contact evidence was identified on the air bag or exterior surface of the module cover flap. The cover flap was rectangular in shape and measured 32.0 cm (12.6 in) in width and 13.0 cm (5.1 in) in height. The NASS researcher measured the passenger air bag at 57.0 cm (22.4 in) in width and 122.0 cm (48.0 in) in height in its deflated state (**Figure 8**). No internal tether straps were present. The bag was vented by two ports located at the 9 o'clock and 3 o'clock sectors on the side aspect of the air bag. No cutoff switch was found for the front right air bag.

**Figure 8. 1998 Chevrolet S-10 Blazer redesigned passenger air bag.**

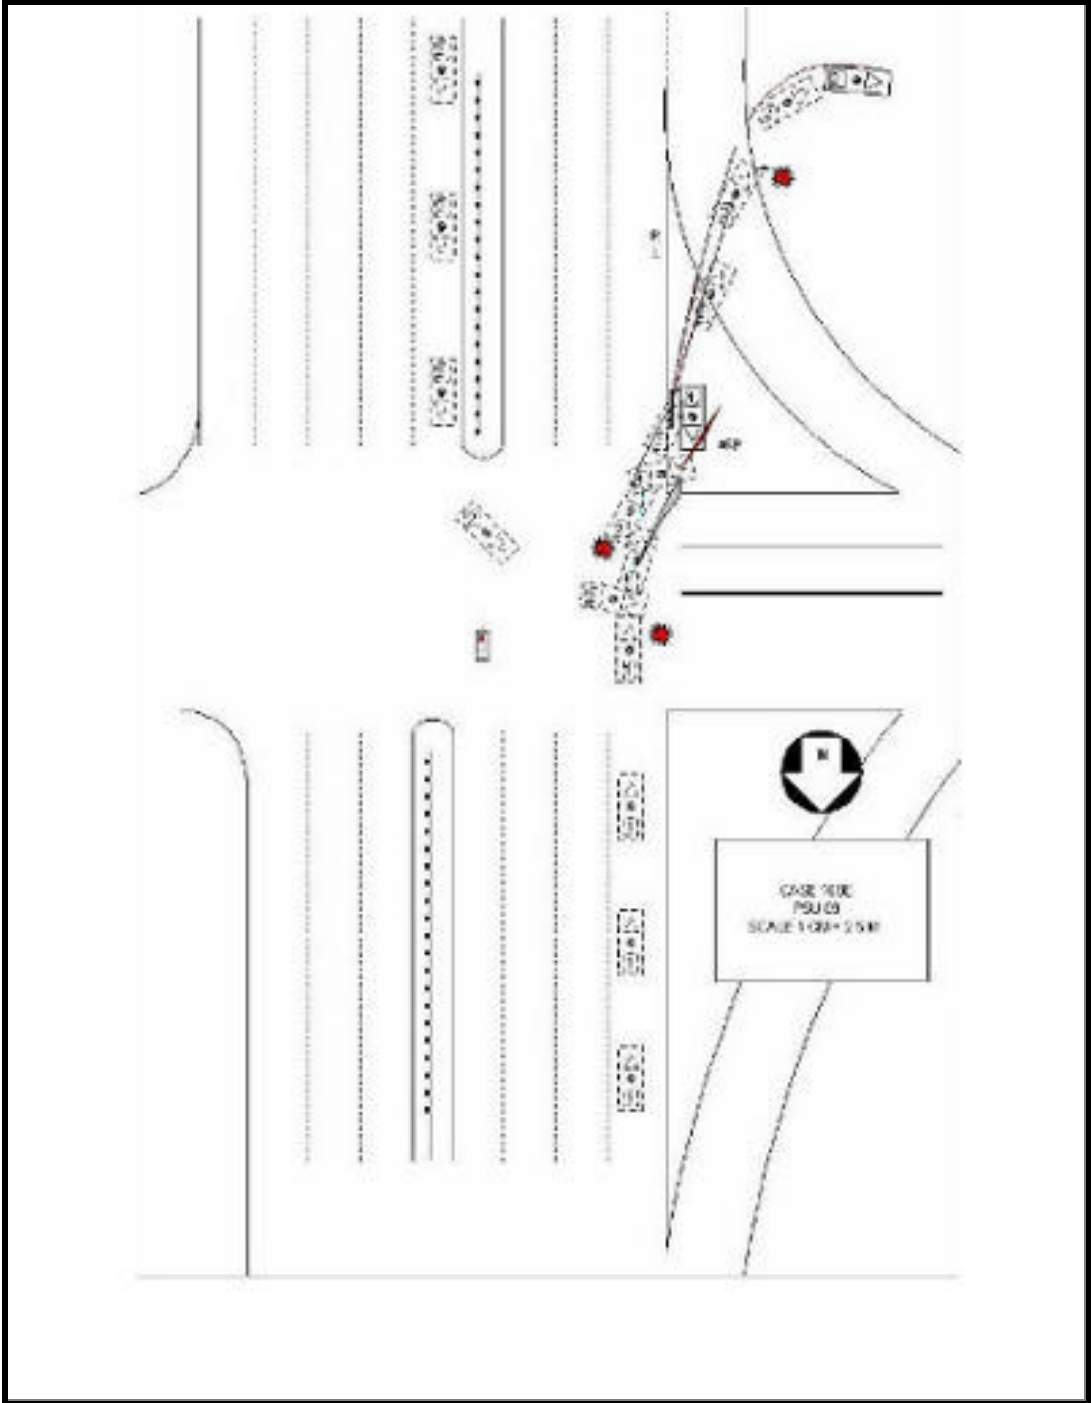
Figure 9. NASS Scene Diagram.

This two vehicle crash occurred during the early morning hours of October, 1998. At the time of the crash, it was dark (street lighted) with no adverse conditions as the roads were dry. The crash occurred in the southbound lanes of a straight and level 4-leg asphalt intersection (**see Figure 9 - page 6**). The north/southbound lanes were divided by a narrow grass median with a W-beam guardrail barrier. Traffic was controlled by an overhead signal system in green (dedicated arrow) phase for westbound (turning) traffic flow. The posted speed limit at the crash site was 89 km/h (55 mph).
