**REDESIGNED AIR BAG SPECIAL STUDY (RABSS)
SCI TECHNICAL SUMMARY REPORT**

NASS RABSS CASE NO. 1998-09-805D

RABSS VEHICLE - 1998 FORD WINDSTAR

CRASH DATE - NOVEMBER, 1998

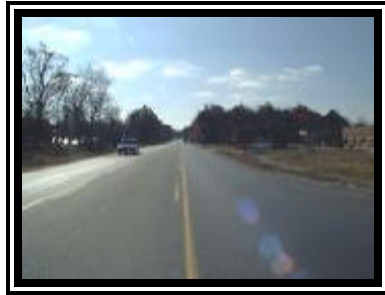
The 18 year old female driver of the 1988 Chevrolet S-10 pickup truck was operating the vehicle southbound (**Figure 1**) when she failed to observe southbound traffic stopped ahead. Upon recognition of the impending harmful event, the driver steered left and braked initiating a counterclockwise yaw on the wet pavement (hydroplaned) as she entered the northbound lane. The 41 year old female driver of the 1998 Ford Windstar was operating the vehicle northbound (**Figure 2**) when she observed the Chevrolet S-10 pickup truck encroach into her path of travel. Although no avoidance maneuvers were attempted, she extended her right arm outward to “brace” the child occupant prior to the crash.

Figure 1. Southbound approach for the 1988 Chevrolet S-10 pickup truck.

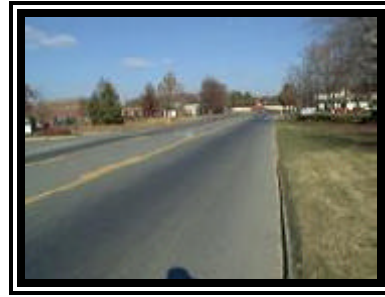
Figure 2. Northbound approach for the 1998 Ford Windstar.

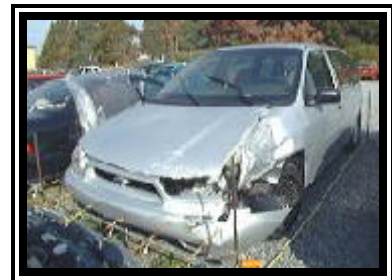
The Ford Windstar sustained moderate frontal damage as a result of the impact with the Chevrolet pickup truck (**Figure 3**). The direct contact damage began at the front left bumper corner and extended 50.0 cm (19.7 in) inboard. The impact deformed the full frontal width resulting in a combined direct and induced damage length (Field L) of 160.0 cm (63.0 in). Six crush measurements were documented at the level of the bumper: C1= 17.0 cm (6.7 in), C2= 10.0 cm (3.9 in), C3= 6.0 cm (2.4 in), C4= 5.0 cm (2.0 in), C5= 4.0 cm (1.6 in), C6= 4.0 cm (1.6 in). Damage was noted to the left fender and wheel/tire from sustained contact between the vehicles during spinout. This damage pattern restricted the left front wheel (not deflated). Superficial contact damage was documented along the front bumper fascia from the shrub impact. The windshield was undamaged in the crash.

Figure 3. Frontal damage to the 1998 Ford Windstar.

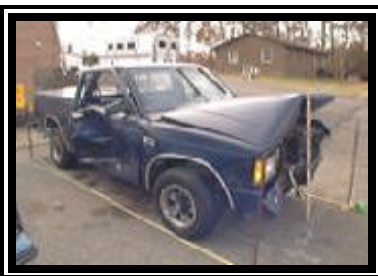
Figure 4. Frontal damage to the 1988 Chevrolet pickup truck.

The Chevrolet pickup truck sustained moderate frontal damage as a result of the impact with the Ford Windstar (**Figure 4**). The direct contact damage began at the front left bumper corner and extended 105.0 cm (41.3 in) inboard. The impact deformed the full frontal width resulting in a combined direct and induced damage length (Field L) of 141.0 cm (55.5 in). The end structure was displaced approximately 5.0 cm (2.0 in) to the left [>10.2 cm (4.0 in) of shift required to increment the principal direction of force]. This end shifting restricted the left front wheel/tire (not deflated). The left side wheelbase was displaced 2.0 cm (0.8 in). The hood was displaced up and rearward from the impact force. Damage was noted to the right door from impact with the 1988 Buick Century. The windshield was undamaged in the crash.

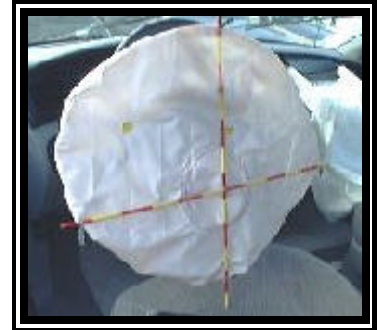
The 1998 Ford Windstar was equipped with redesigned frontal air bags for the driver and front right passenger positions. The air bags had deployed as a result of the crash. The driver air bag was housed in the center of the steering wheel with a horizontally oriented flap tear seam (H-configuration). The flaps were asymmetrical in shape as the upper flap measured 20.0 cm (7.9 in) in width and 11.0 cm (4.3 in) in height while the lower flap measured 19.0 cm (7.5 in) in width and 6.0 cm (2.4 in) in height. Although no contact evidence was identified on the exterior surface of the module cover flaps, black vinyl transfers were noted on the upper and lower sections of the air bag from expansion within the module. The NASS researcher measured the diameter of the driver air bag at 52.0 cm (20.5 in) in its deflated state (**Figure 5**). The bag was tethered by two internal straps and vented by two ports located at the 11 o'clock and 1 o'clock sectors on the rear aspect of the air bag.

Figure 5. 1998 Ford Windstar redesigned driver air bag.

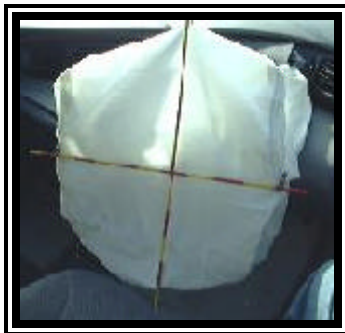
Figure 6. 1998 Ford Windstar redesigned passenger air bag.

The front right passenger air bag deployed from a mid-mount module in the right instrument panel with a single cover flap design hinged at the top aspect. The cover flap was rectangular in shape and measured 33.0 cm (13.0 in) in width and 18.0 cm (7.1 in) in height. No contact evidence was identified on the air bag or exterior surface of the module cover flaps. The NASS researcher measured the passenger air bag at 50.0 cm (19.7 in) in width and 56.0 cm (22.0 in) in height in its deflated state (**Figure 6**). No internal tether straps were present. The bag was vented by one port located at the 9 o'clock sector on the side aspect of the air bag. No cutoff switch was available for the front right air bag.

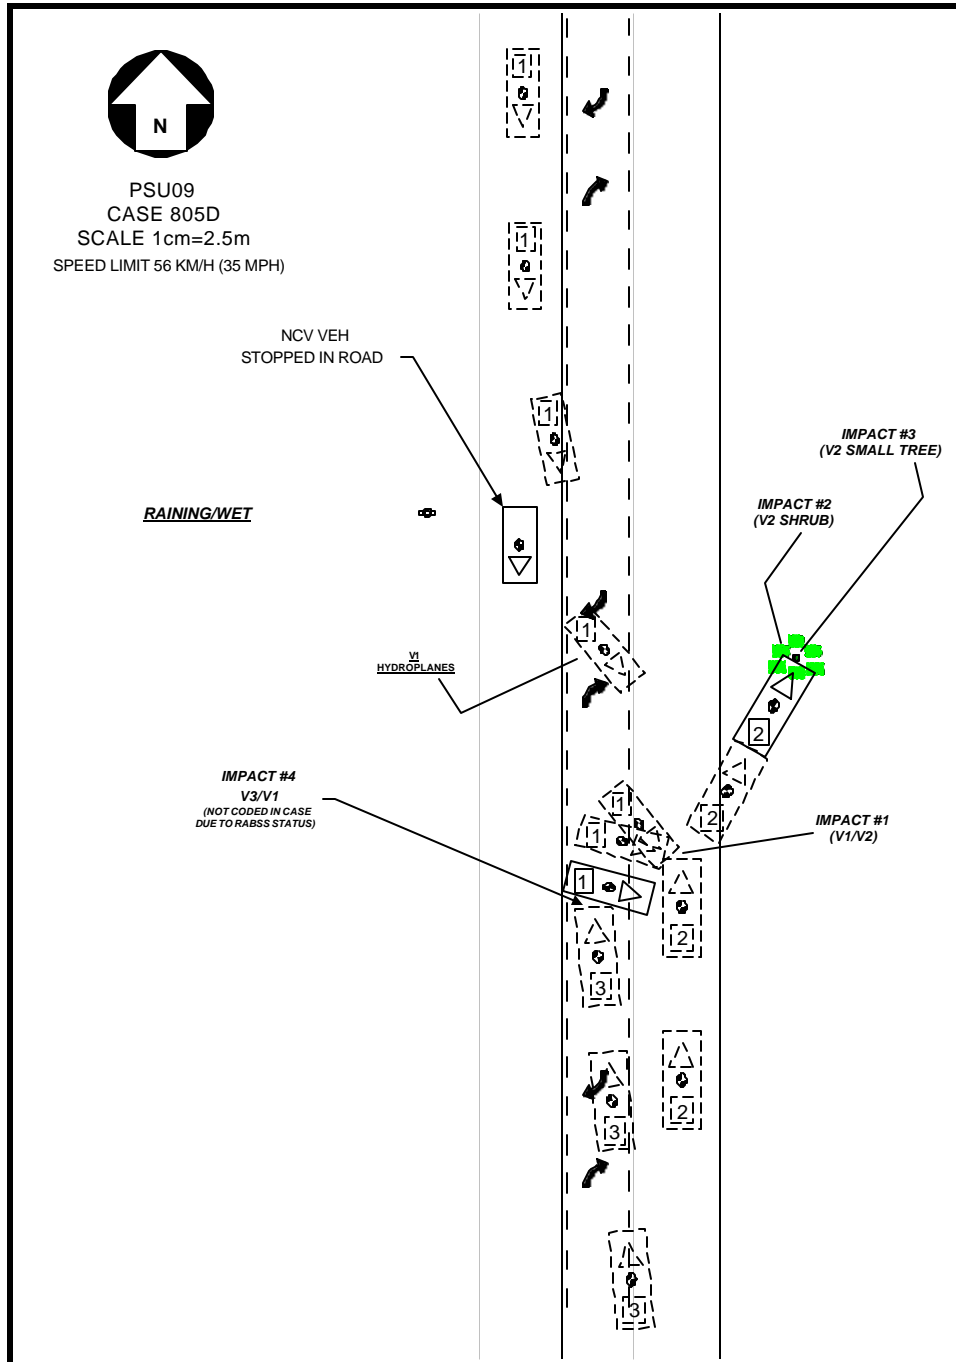
Figure 7. NASS Scene Diagram

This two vehicle crash occurred during the morning hours of November, 1998. At the time of the crash, it was daylight with rainy conditions as the roads were wet. The crash occurred in the northbound lane of a north/south two lane (straight/level) rural roadway with a center turn lane (see **Figure 7 - page 7**). The roadside environment included shrubbery and small diameter trees. No traffic controls were present at the scene which had a posted speed limit of 56 km/h (35 mph).
