**VERIDIAN REMOTE REDESIGNED AIR BAG INJURY
INVESTIGATION
SCI TECHNICAL SUMMARY REPORT**

NASS CDS CASE NO. 1998-11-102G

VEHICLE - 1998 FORD EXPLORER

CRASH DATE - JUNE, 1998

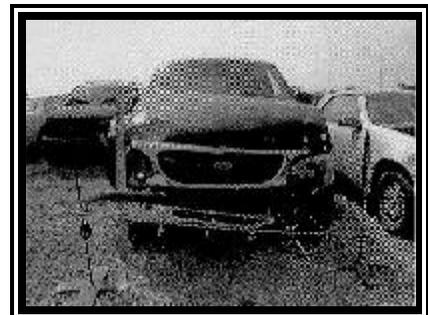
Exterior damage to the 1998 Ford Explorer was rated as moderately severe (**Figure 3**). Maximum frontal crush as a result of the initial tree impact was 20.0 cm (7.9") located at the front right corner of the vehicle. Maximum frontal crush as a result of the third impact was 21.0 cm (8.3") located at the front left corner of the vehicle. Crush was distributed across the frontal plane as a result of the second impact with the embankment. The right wheelbase dimension was reduced 3.0 cm (1.2") and the left wheelbase dimension was elongated 12.0 cm (4.7") during the crash sequence.

Figure 3. Frontal damage to the 1998 Ford Explorer.

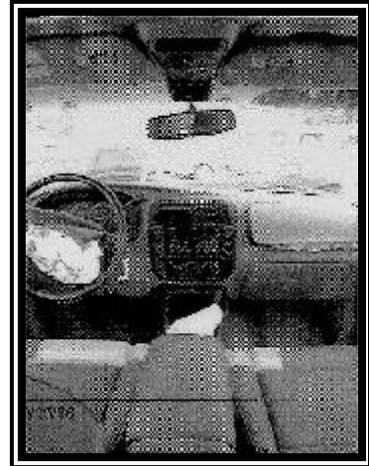
Interior damage to the Explorer was minor and was associated with the air bag deployment and occupant contact (**Figure 4**). The Explorer was equipped with depowered frontal air bags for the driver and right passenger seated positions. Both modules deployed as designed during the crash sequence. No damage or evidence of occupant contact was noted to either of the module cover flaps or air bags. Evidence of driver contact was noted to the left portion of the left sunvisor (deformed) and knee bolster on either side of the steering column (scuff marks). Evidence of passenger contact with interior components was noted to the front right seat back support (deformed rearward).

Figure 4. Interior view.
